JBCI Project No. 226418

The Devon Condominium

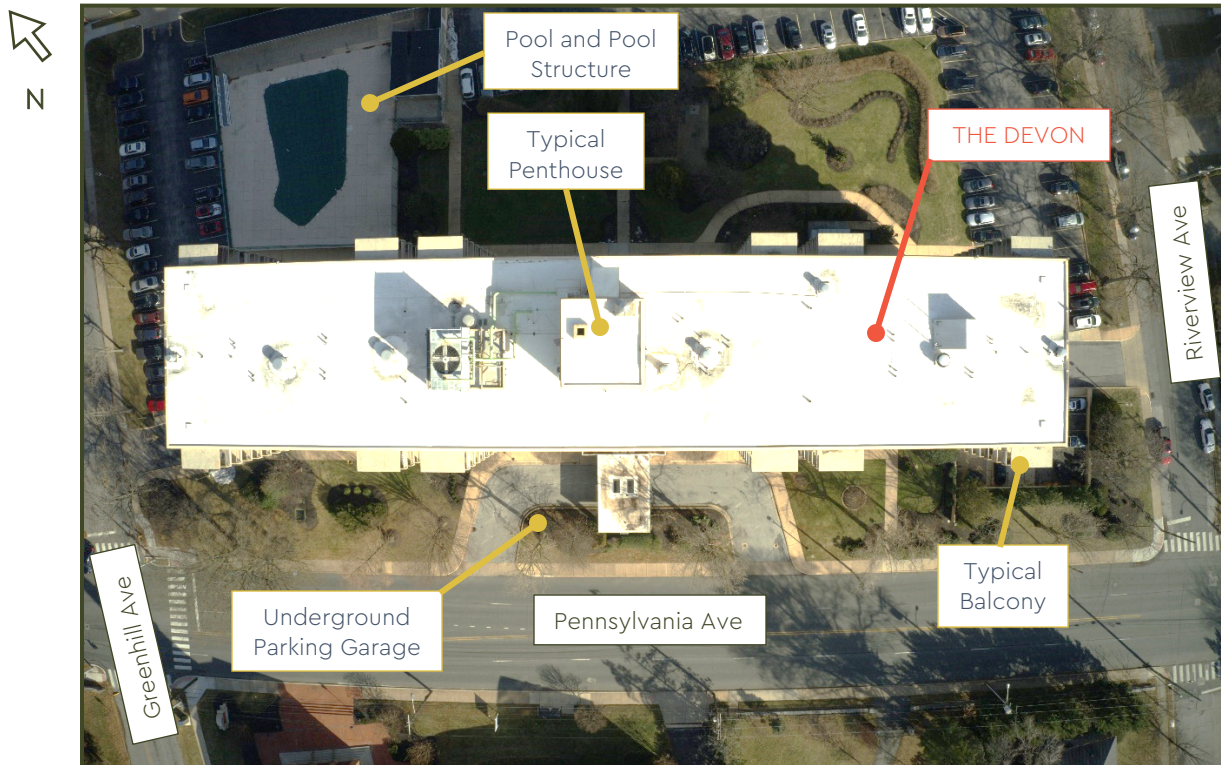
Figure 1 – Aerial View

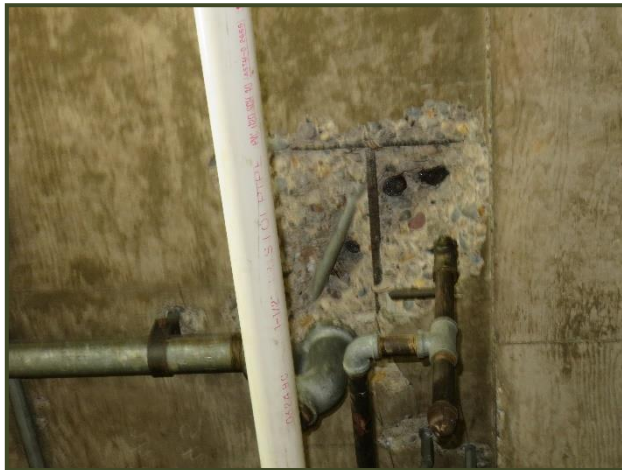
Photo No. 1 – Concrete spalling and exposed reinforcing at roof penetrations

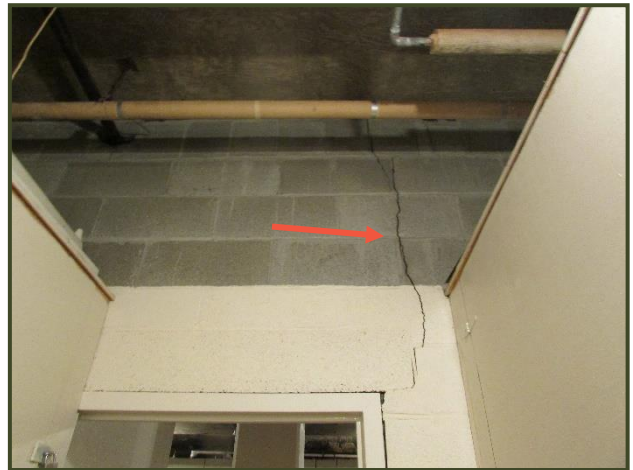
Photo No. 2 – Vertical cracking within CMU partition wall

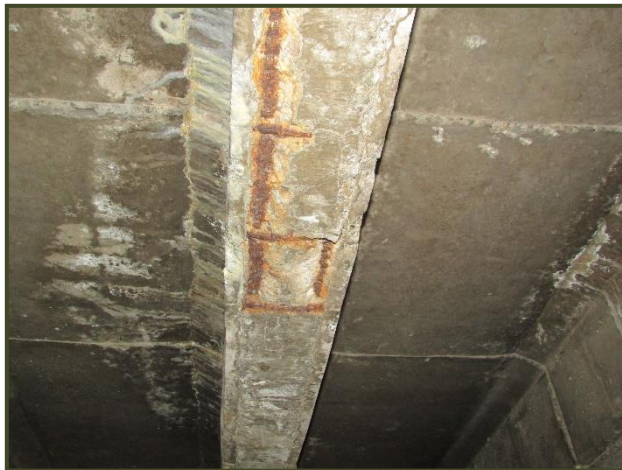
Photo No. 3 – Concrete spalling and exposed reinforcing in concrete beam; water staining

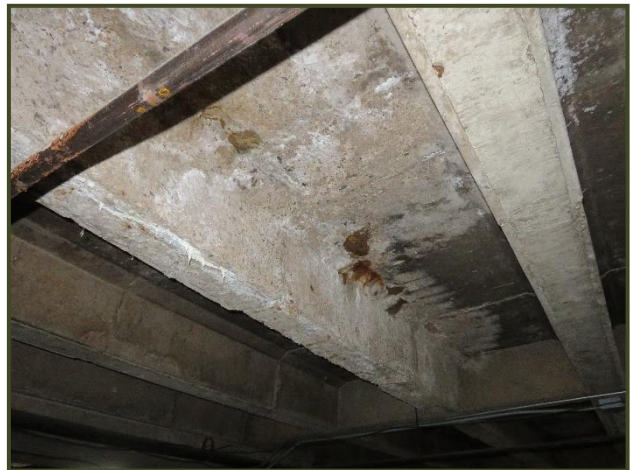
Photo No. 4 – Concrete spalling and water staining at parking garage ceiling

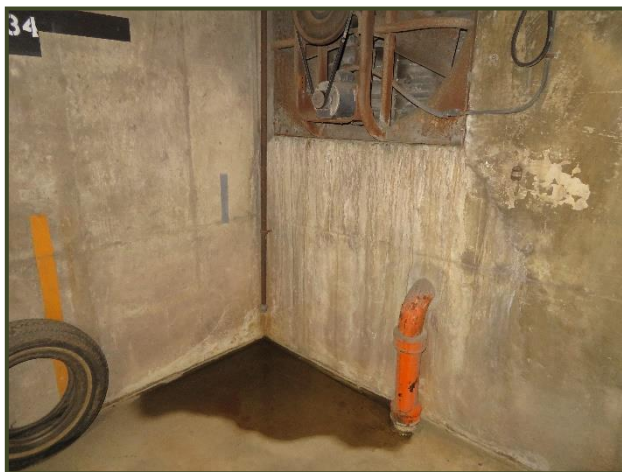
Photo No. 5 – Water infiltration and pooling at exterior perimeter wall of garage

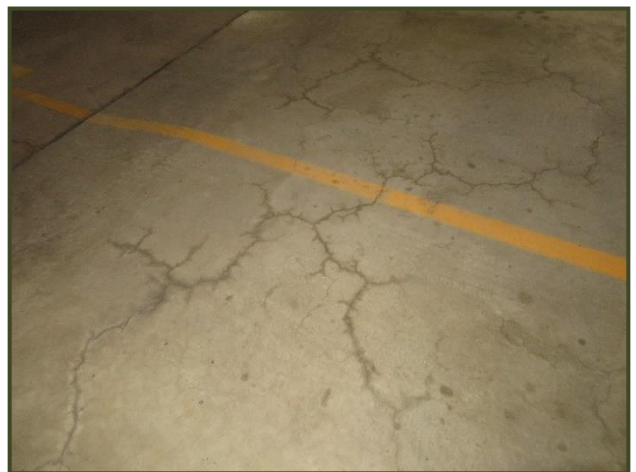
Photo No. 6 – Map cracking in concrete slab on grade

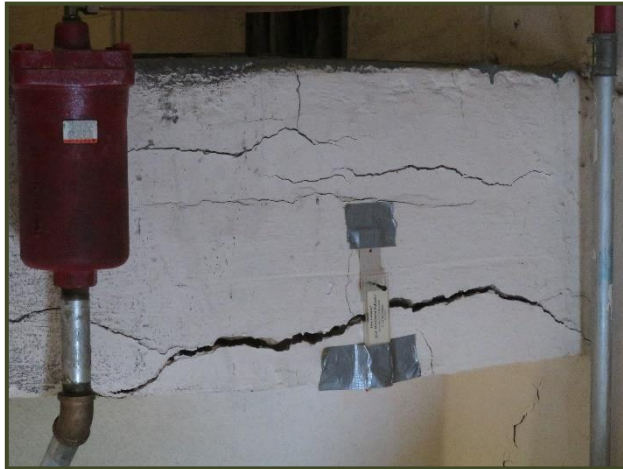
Photo No. 7 – Open cracking within concrete framing at top landing

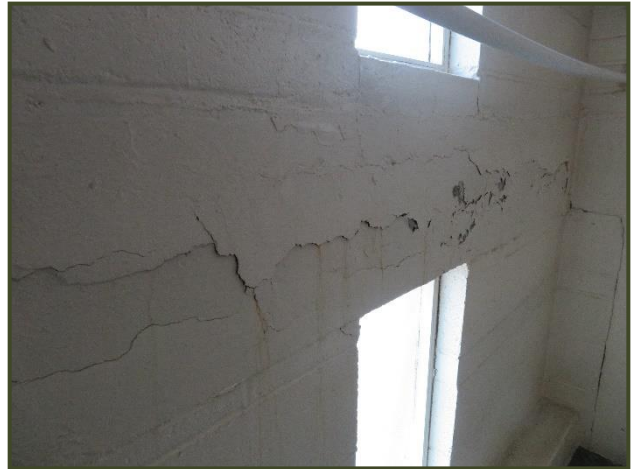
Photo No. 8 – Cracking, incipient spalling, and water staining at concrete framing

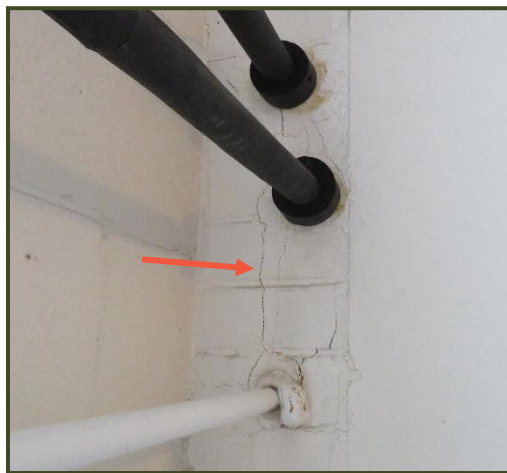
Photo No. 9 – Isolated cracking at CMU at pipe penetrations

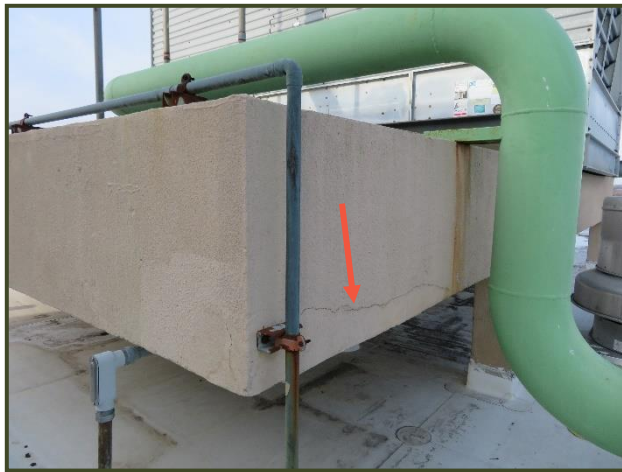
Photo No. 10 – Cracking on concrete equipment pad

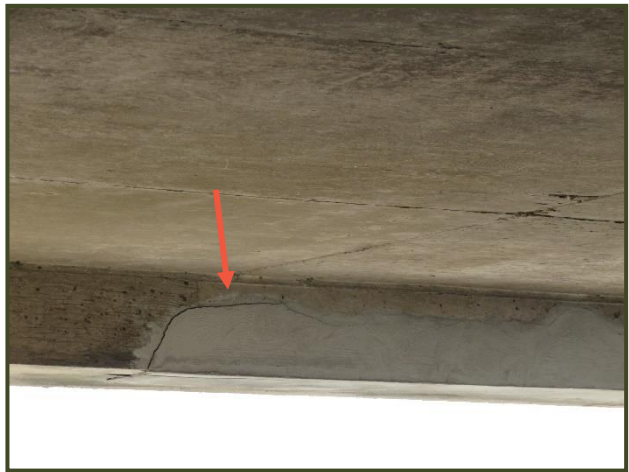
Photo No. 11 – Failing previous patches on concrete equipment pad

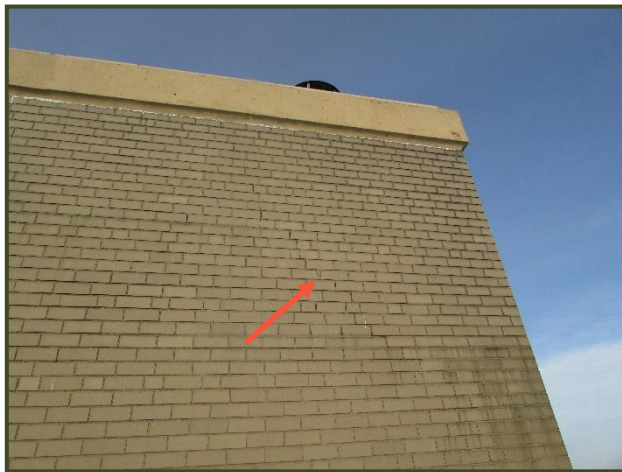
Photo No. 12 – Brick step cracking at exterior penthouse wall

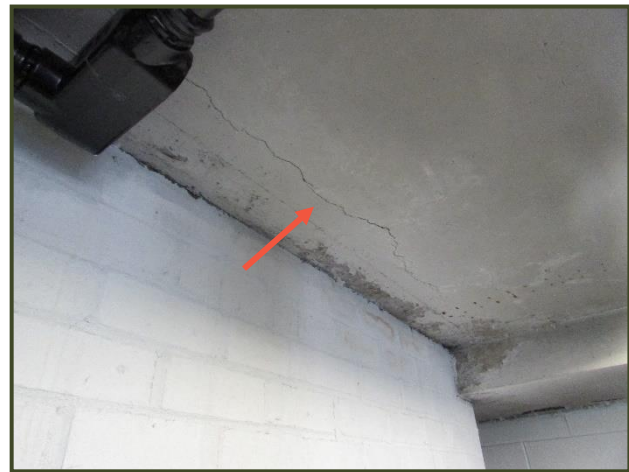
Photo No. 13 – Cracking at underside of penthouse roof

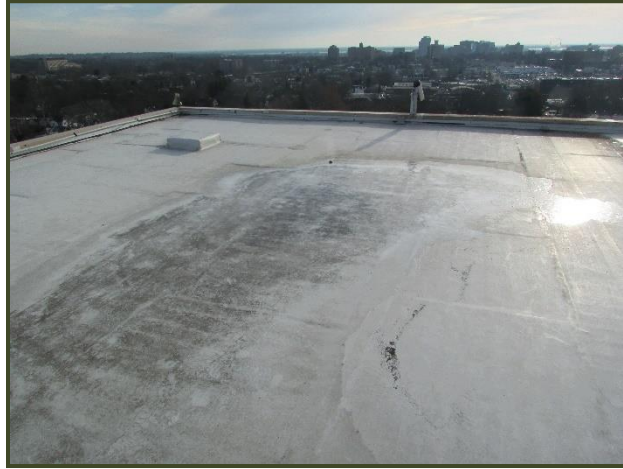
Photo No. 14 – Ponding on main roof surface

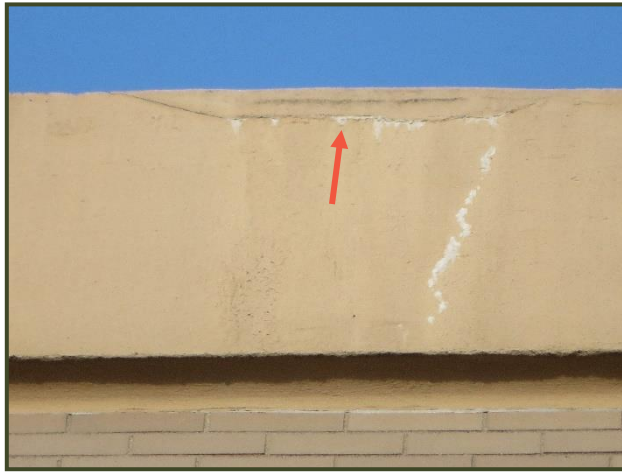
Photo No. 15 – Cracks and efflorescence on concrete roof framing

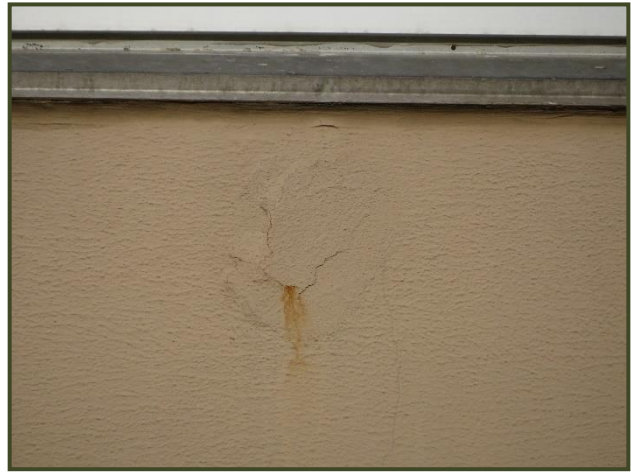
Photo No. 16 – Incipient spalling and corroding reinforcing at concrete framing

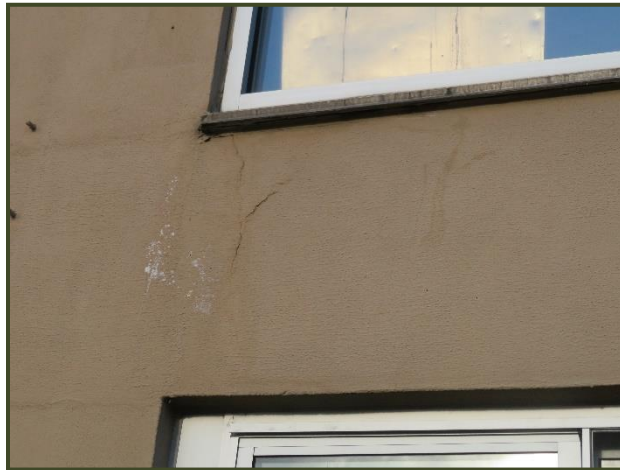
Photo No. 17 – Cracking and efflorescence at concrete framing

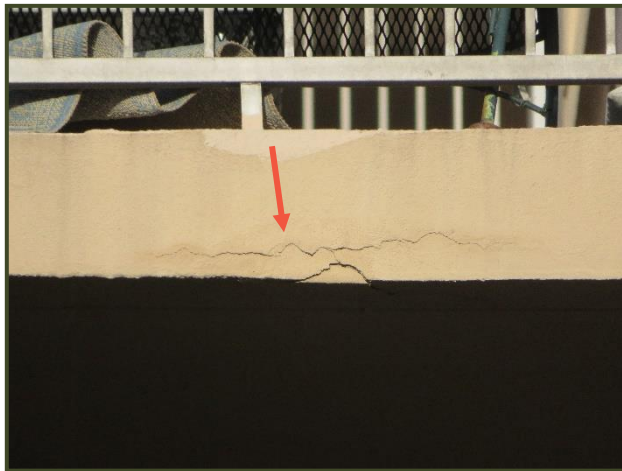
Photo No. 18 – Cracking at concrete balcony slab edge

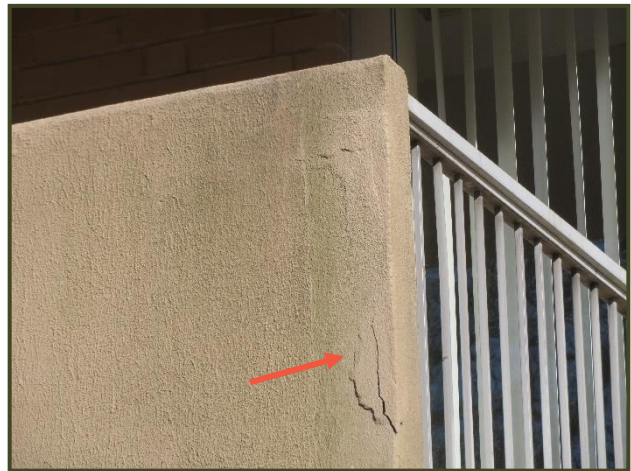
Photo No. 19 – Incipient spalling in concrete balcony wall

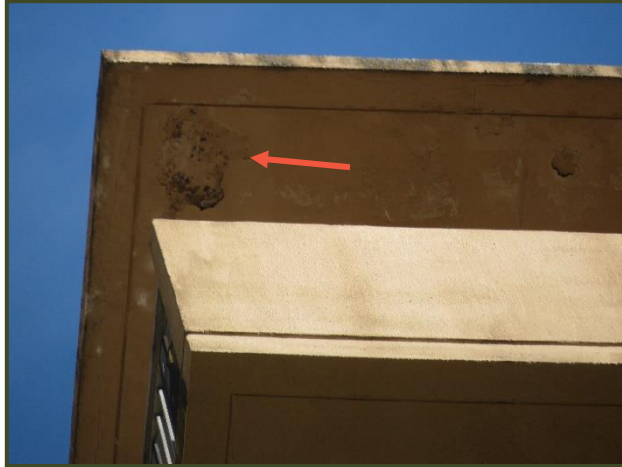
Photo No. 20 - Incipient spalling and peeling coating in underside of cantilever concrete balcony roof

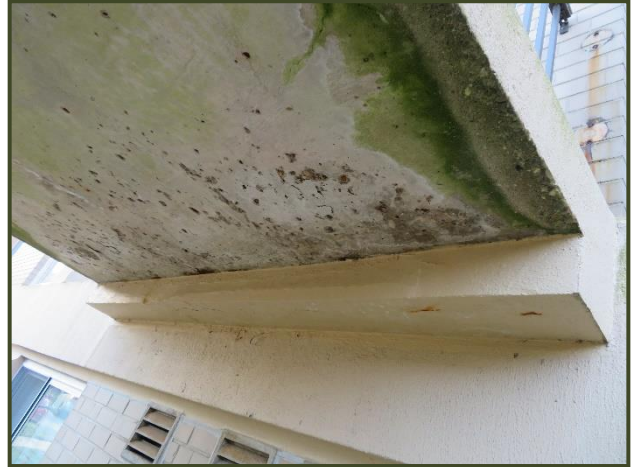
Photo No. 21 - Deterioration of underside of exterior concrete staircase

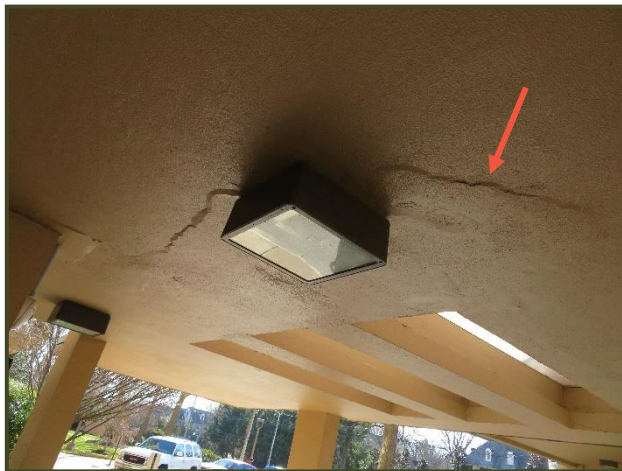
Photo No. 22 - Incipient spalling in underside of front entrance canopy

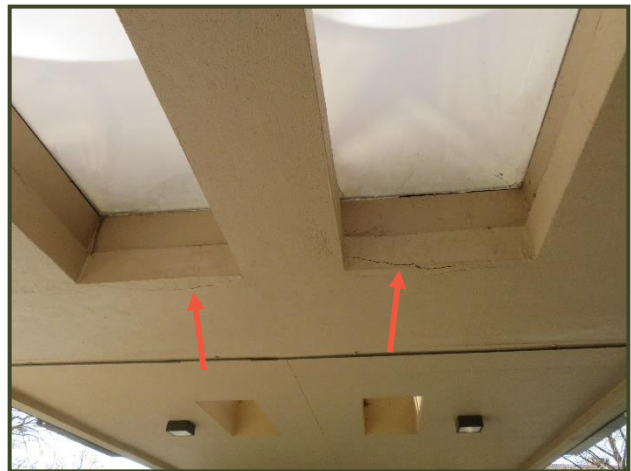
Photo No. 23 - Concrete cracking at underside of front entrance canopy

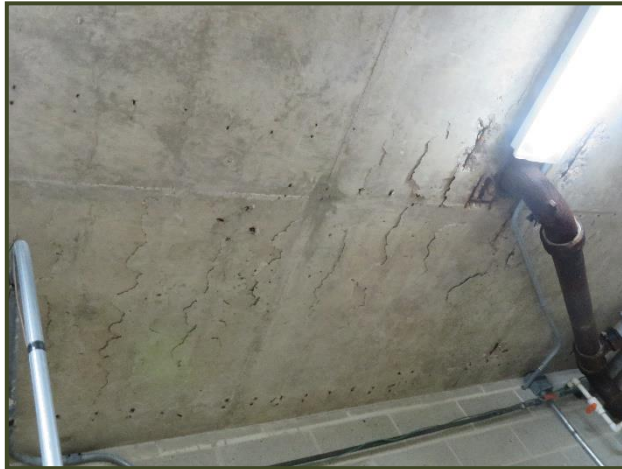
Photo No. 24 – Underside cracking and spalling at pool pump room ceiling

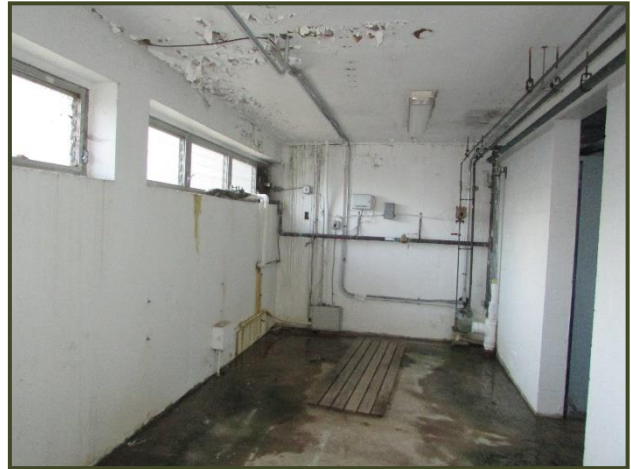
Photo No. 25 – Water infiltration in pool locker room

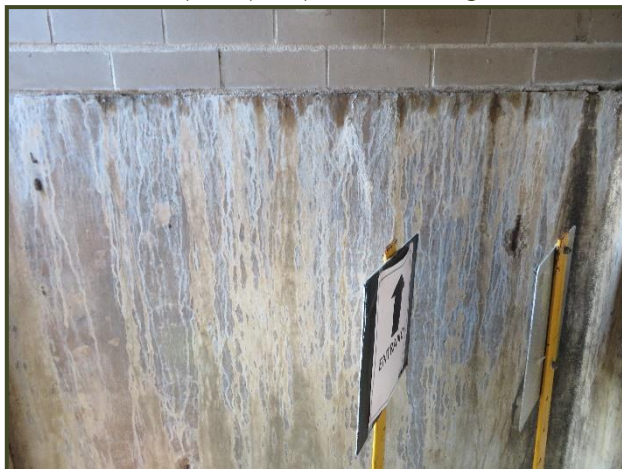
Photo No. 26 – Water staining and infiltration at top of concrete foundation wall

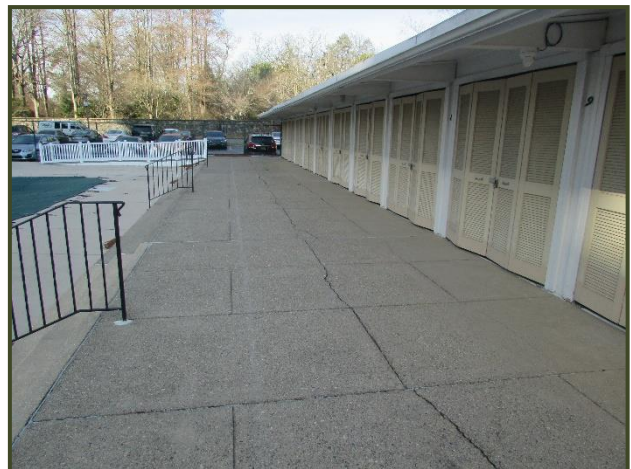
Photo No. 27 – Cracking in concrete pool deck perimeter walkway

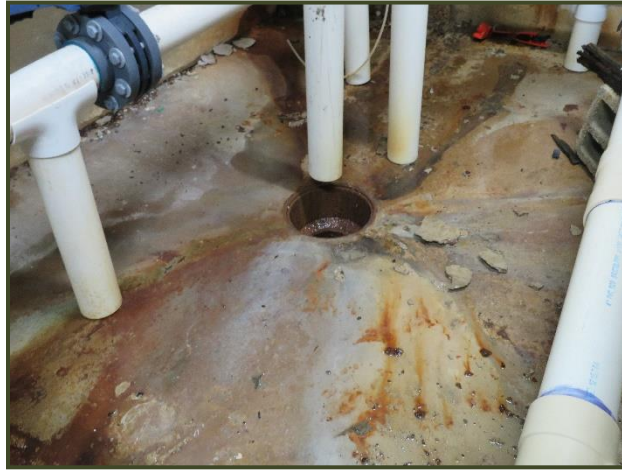
Photo No. 28 - Corrosion staining and efflorescence present at pool pump room drain
