**Re: Structural Assessment at:**  
2401 Pennsylvania Ave.  
Wilmington DE 19806

# Structural Assessment Report

Prepared for:  
Stacey Temple  
Devon Condominium  
2401 Pennsylvania Ave.  
Wilmington DE 19806

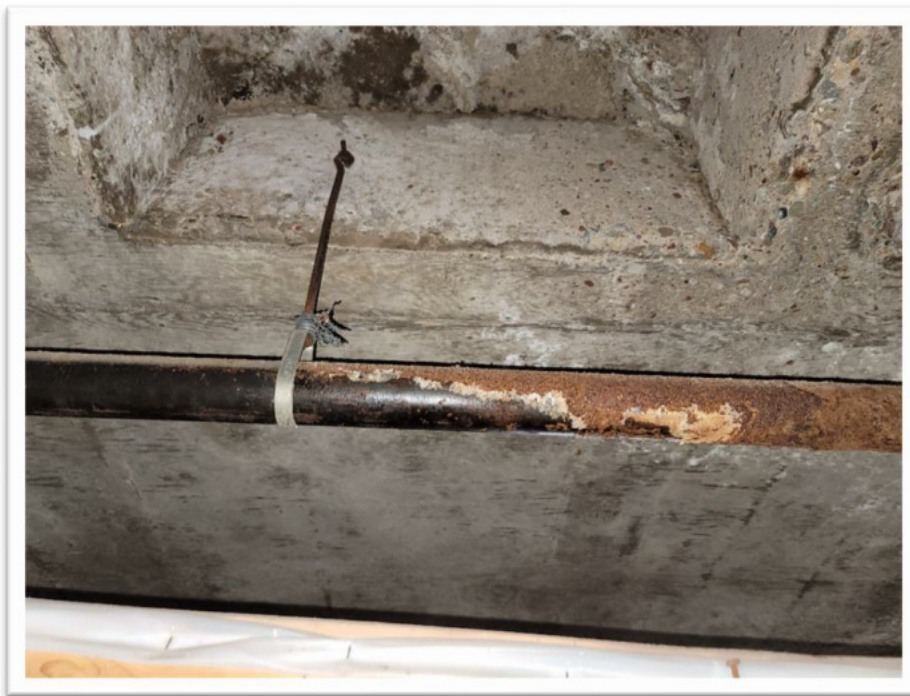
Figure 1.3 - Rusted fire sprinkler pipes.

- Change all the sprinkler pipes systems, including all the plumbing connections through the garage, and remove any hanging cover
- Clean the exposed reinforcement rebars, remove the rusted parts using a wire brush and high-pressure water, and use sandblasting if needed. Paint the exposed rebars with epoxy-supported sealants. Kiro Engineering, LLC will review the Contractor's means and methods at no additional cost.

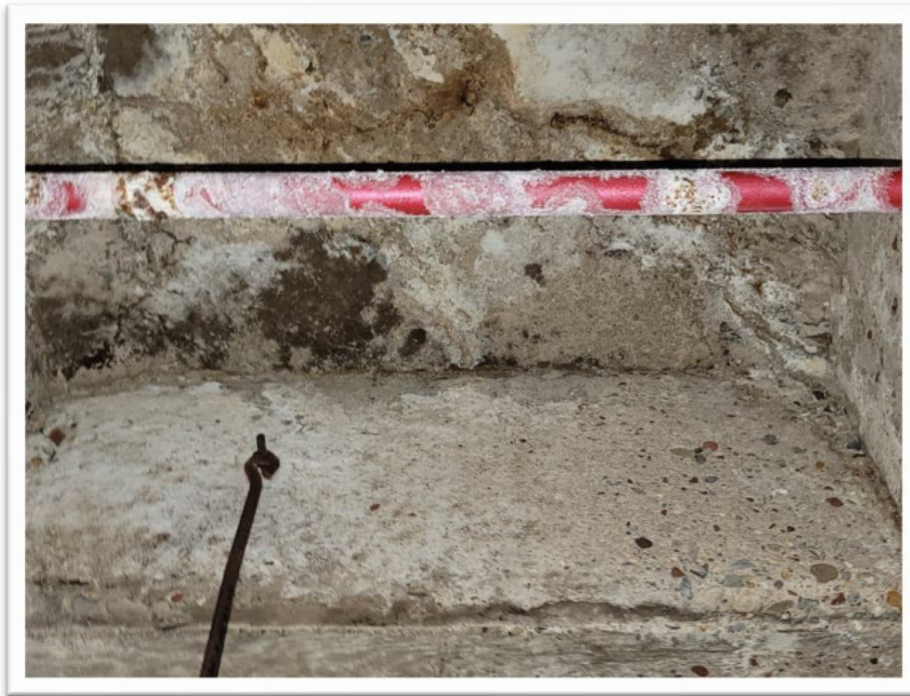
Figure 1.4 - Signs of an old water leakage.

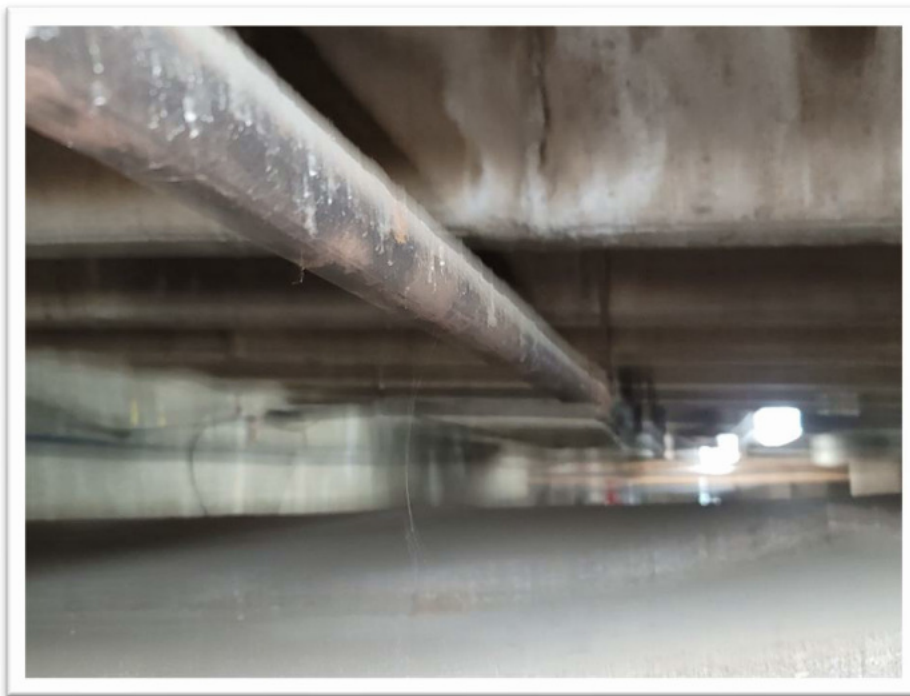
Figure 1.9 - Rusted fire sprinkler pipe.

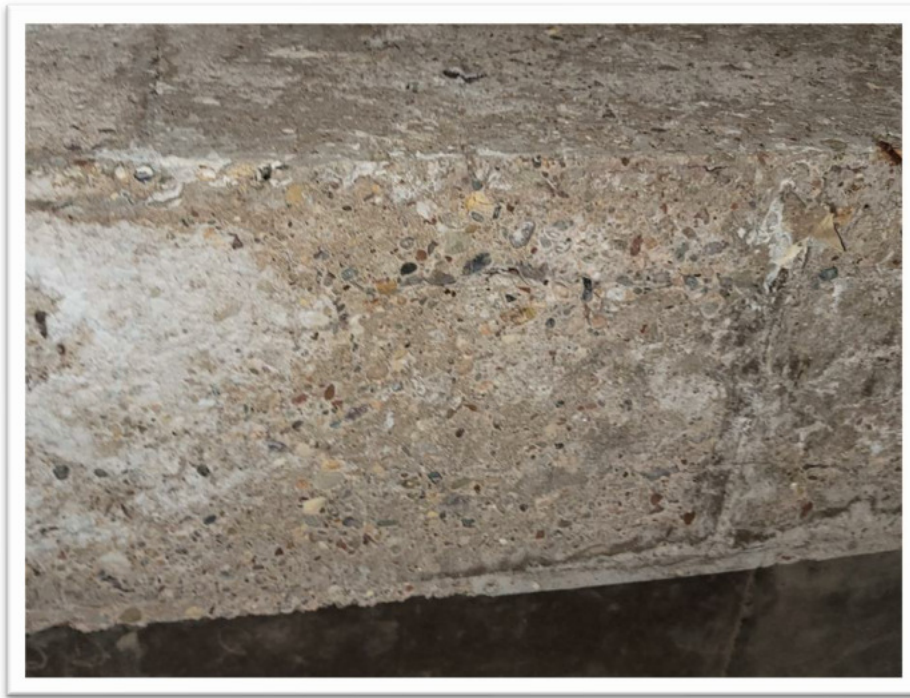
Figure 1.10 - Limited spalling surface that can lead to reinforcement corrosion.

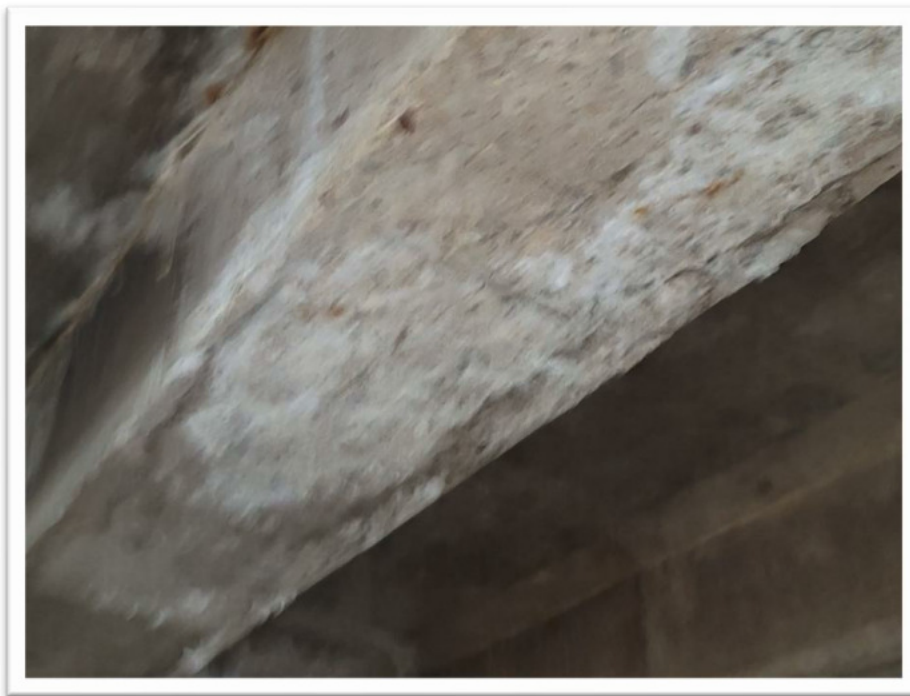
Figure 1.11 - Crumbling and spalling concrete surface with efflorescence deposits.

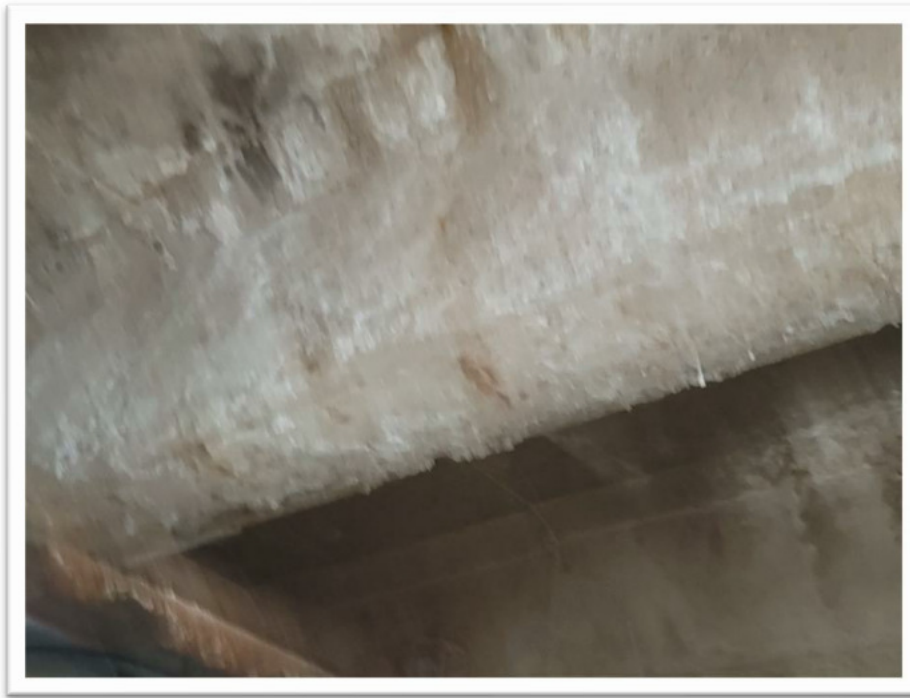
Figure 1.12 - Signs of old leakage with efflorescence deposits.

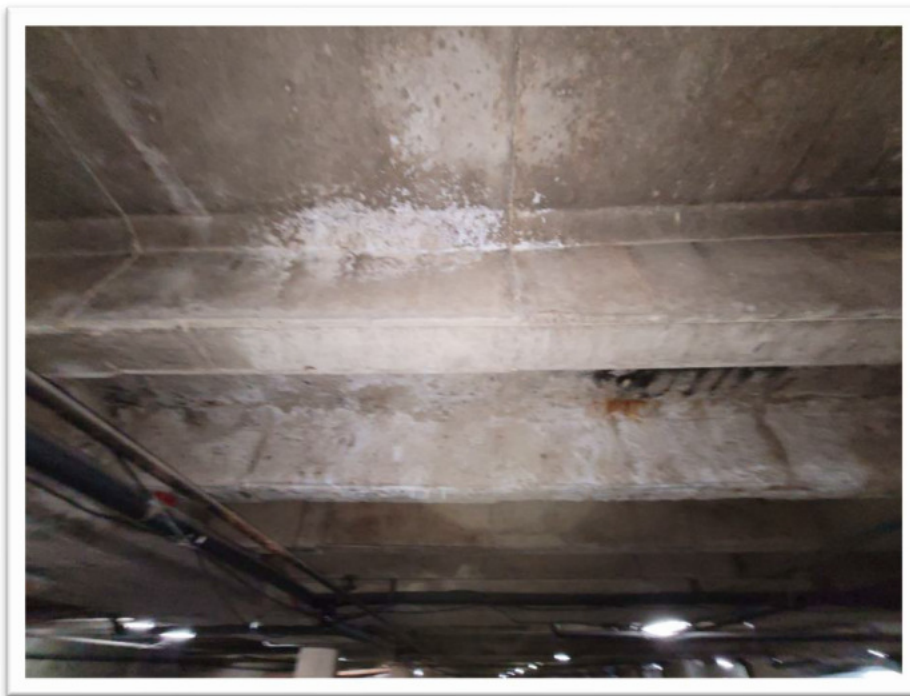
Figure 1.13 - Signs of old leakage with efflorescence deposits.

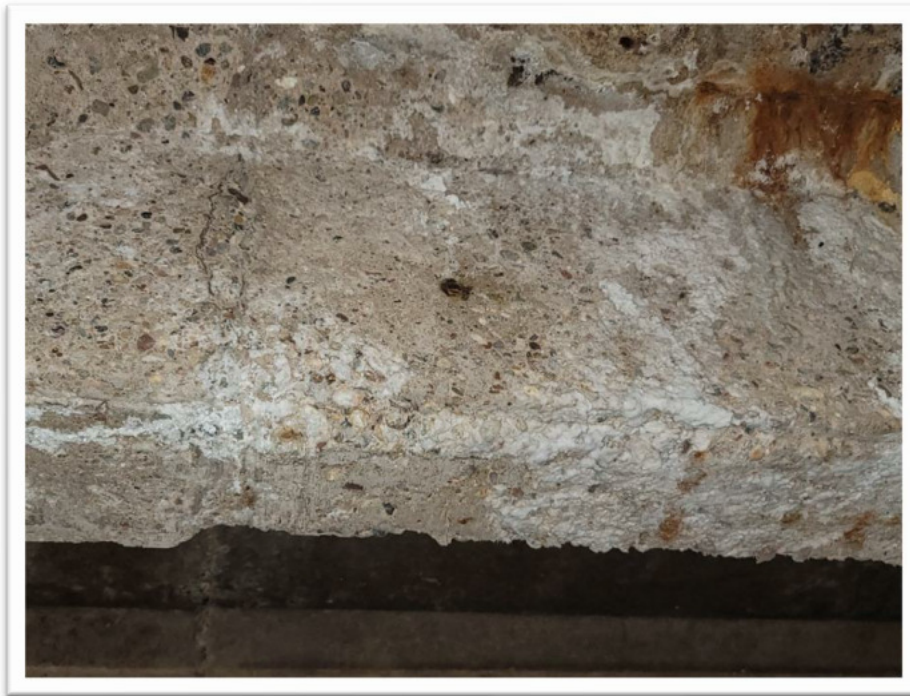
Figure 1.14 - Crumbling and spalling concrete surface.

- Add new reinforcement mesh (#4 rebars at 3-inches spacing) to connect the old concrete with the new concrete. Use epoxy-modified concrete overlay between the old concrete and the new concrete. Use shotcrete with a minimum strength of 3000 psi to install the new concrete cover to the exposed parts. Kiro Engineering, LLC will review the shotcrete and injection products at no additional cost.

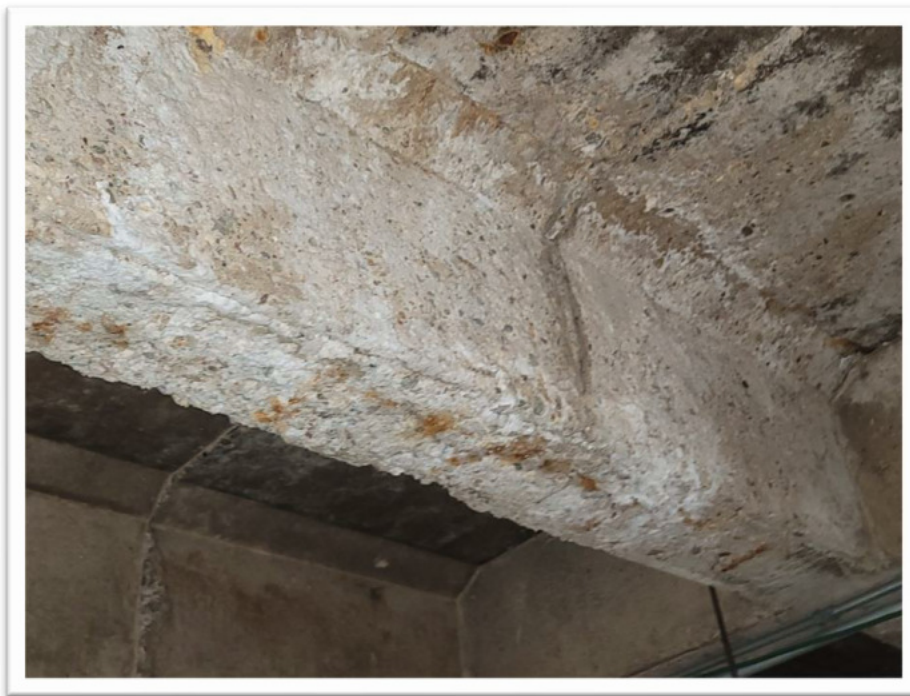
Figure 1.15 - Crumbling and spalling concrete surface.

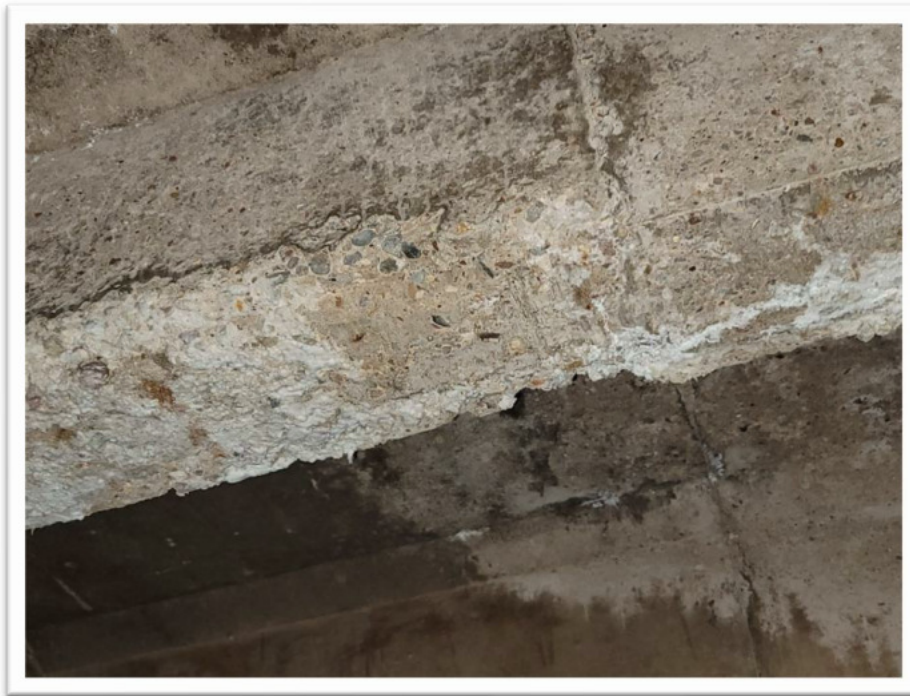
Figure 1.16 - Crumbling and spalling concrete surface.

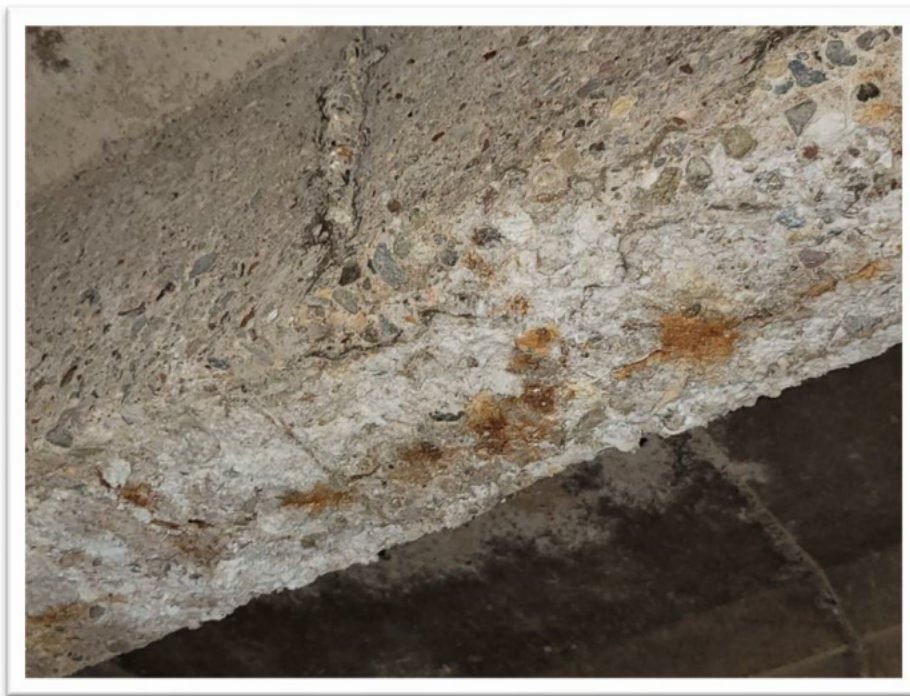
Figure 1.17 - Exposed corroded reinforcement of the beam girder and crumbling surface.

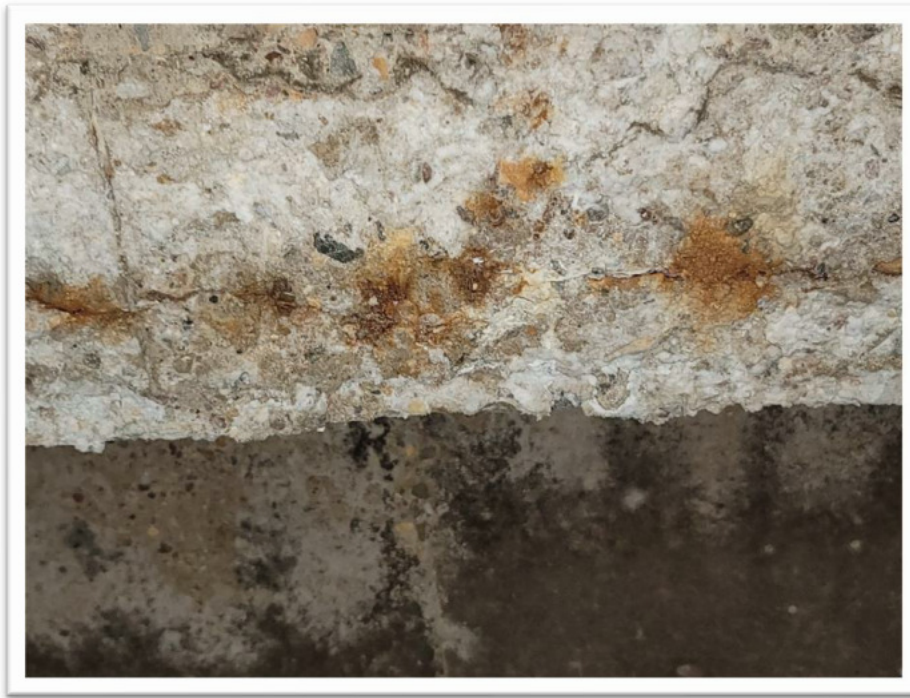
Figure 1.18 - Exposed corroded reinforcement of the beam girder and crumbling surface.

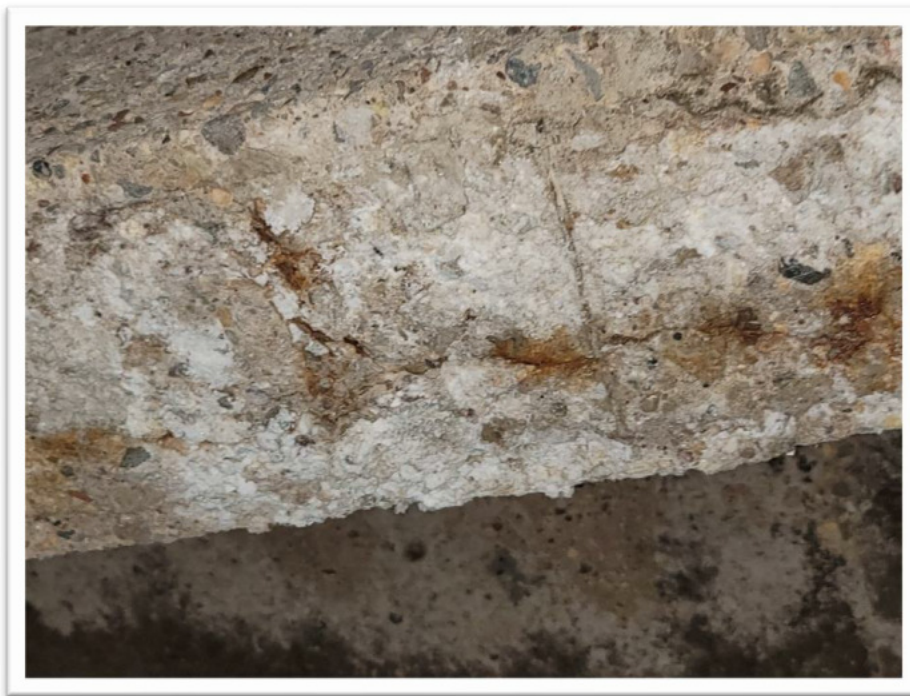
Figure 1.19 - Exposed corroded reinforcement of the beam girder and crumbling surface.

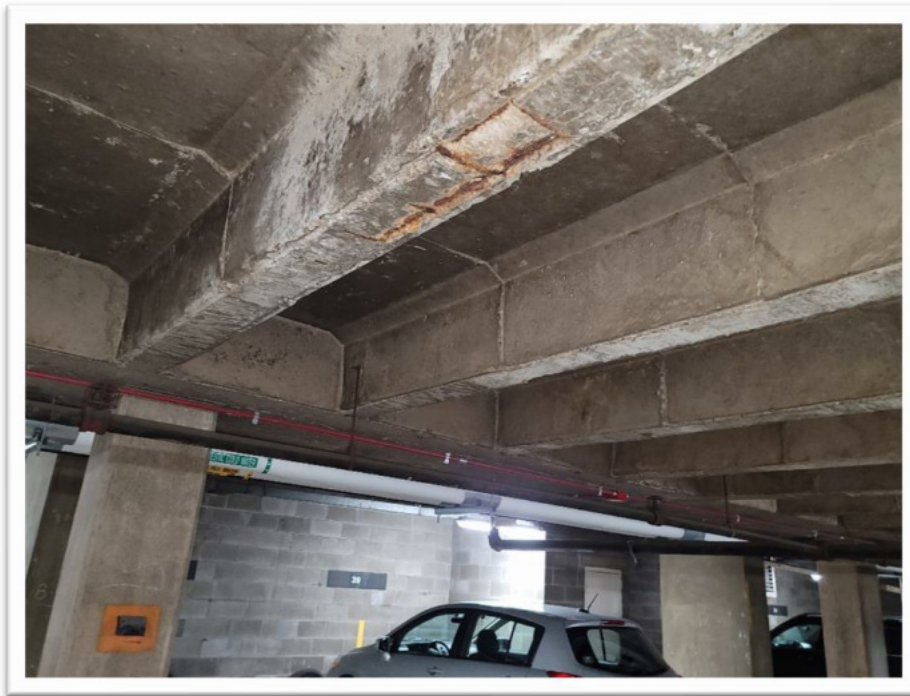
Figure 1.20 - Exposed corroded reinforcement of the beam girder.

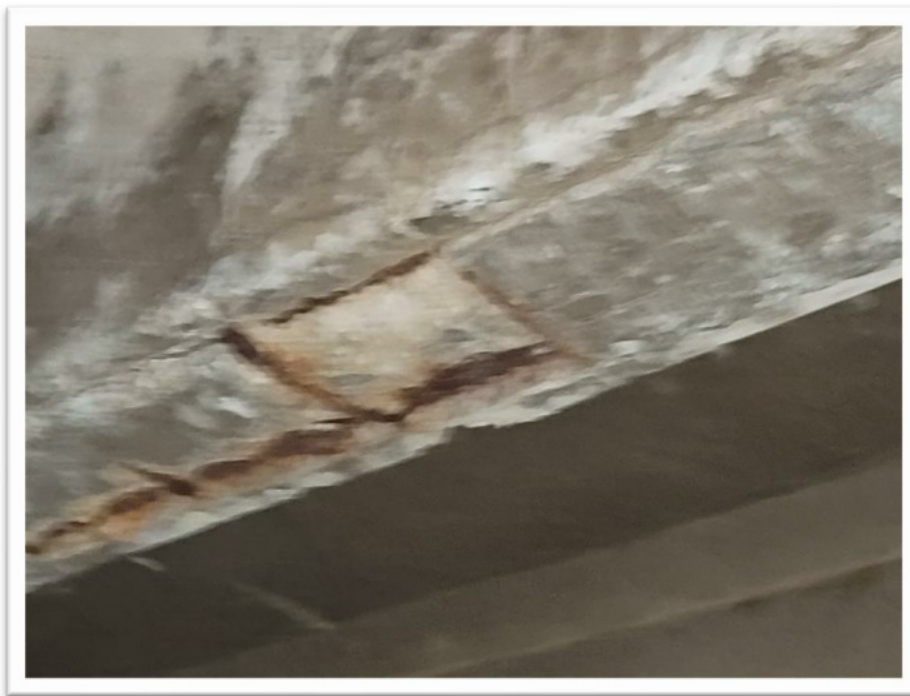
Figure 1.21 - Exposed corroded reinforcement of the beam girder.

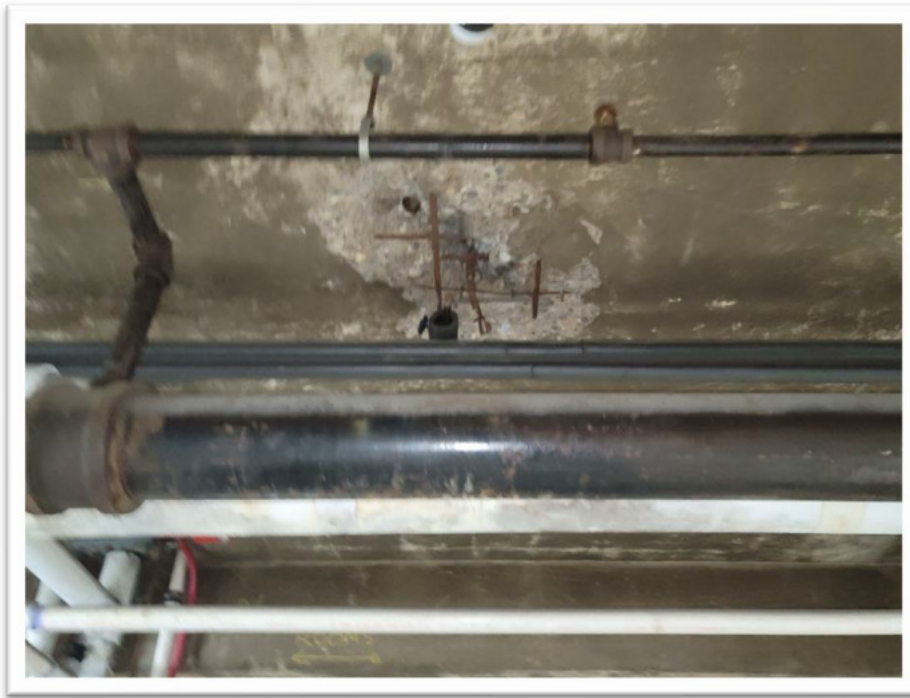
Figure 1.22 - Exposed corroded reinforcement of the ceiling slab.

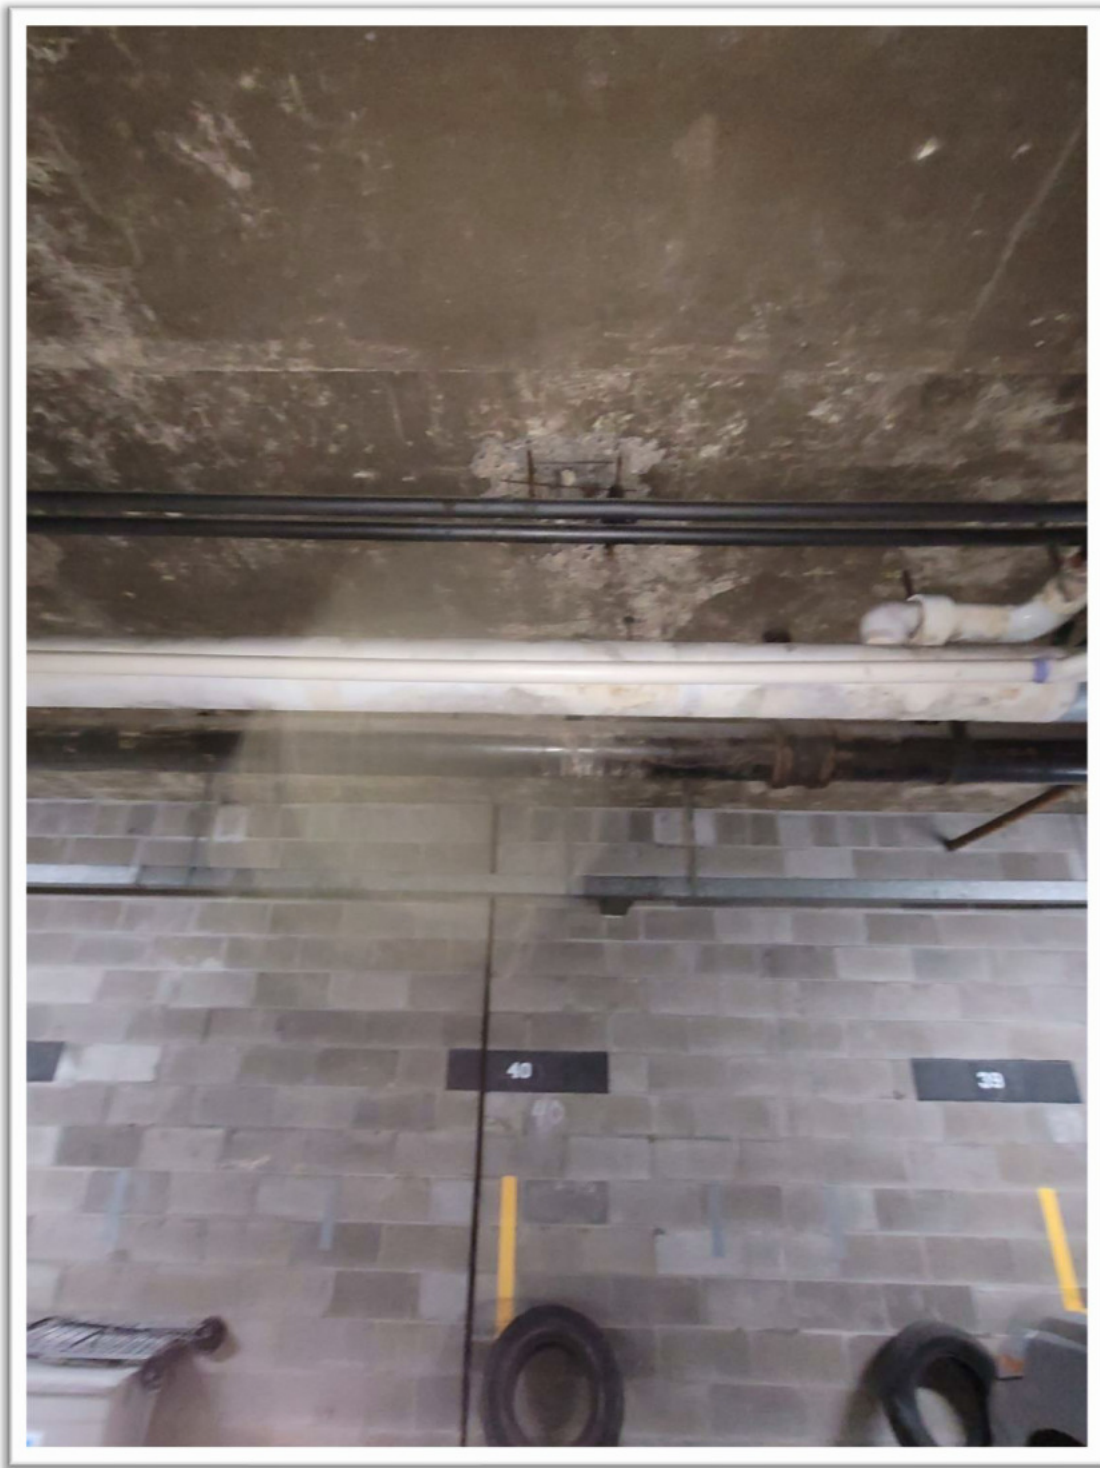
Figure 1.23 - Exposed corroded reinforcement of the ceiling slab.

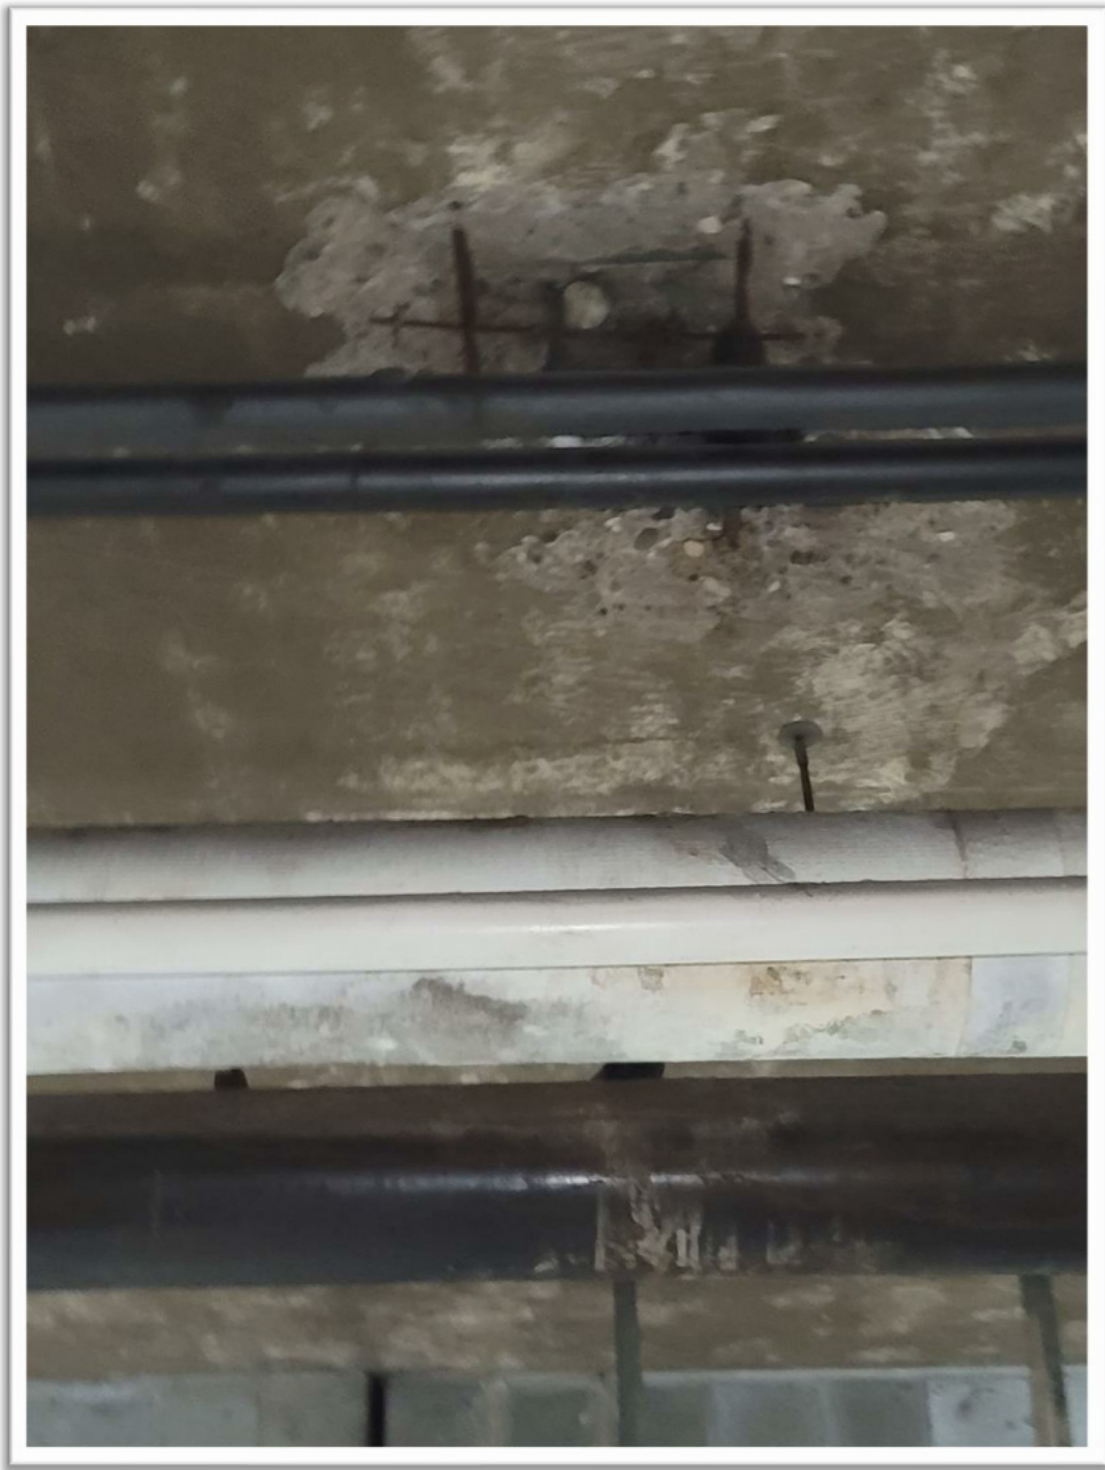
Figure 1.24 - Exposed corroded reinforcement of the ceiling slab.

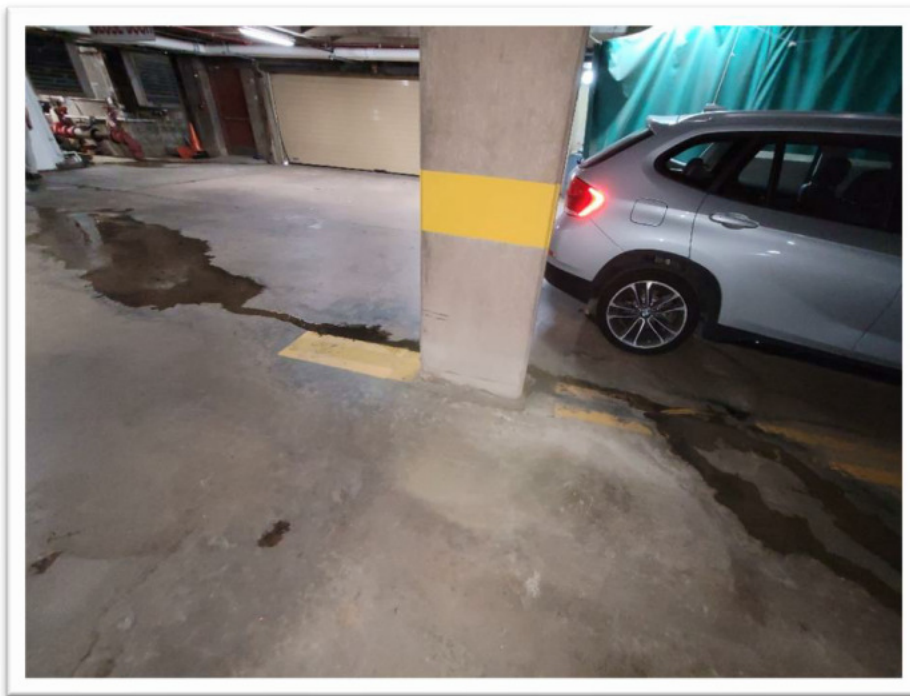
Figure 1.26 - Leakage from the boiler room.

- Further, investigate the leakage by the boilers room for any plumbing or connection repairs.
- It is recommended to seal all the wall and slab cracks using Epoxy-supported sealants (heavily-rubberized Heavy Duty Crack Filler / **QUIKRETE® Advanced Polymer Concrete Crack Sealant, Sikaflex® Concrete Fix, or similar**). The Contractor has to clean the cracks with high-pressure air or water before applying the sealant. It is required to **bevel the cracks** with a **minimum width of 0.2 inches and a minimum depth of 1 inches**. The cracks have to be dry before applying the sealant at a temperature at or above **50°F and dry condition for the next 48 hours**. Kiro Engineering, LLC will review the sealant and injection products at no additional cost.

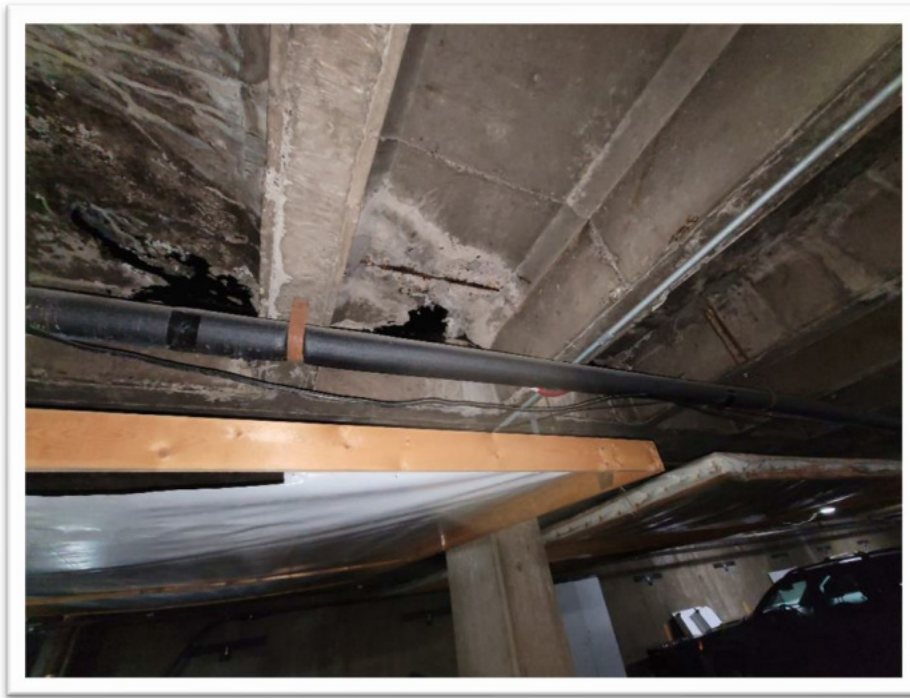
Figure 1.27 - Exposed corroded reinforcement of the ceiling slab with signs of old leakage.

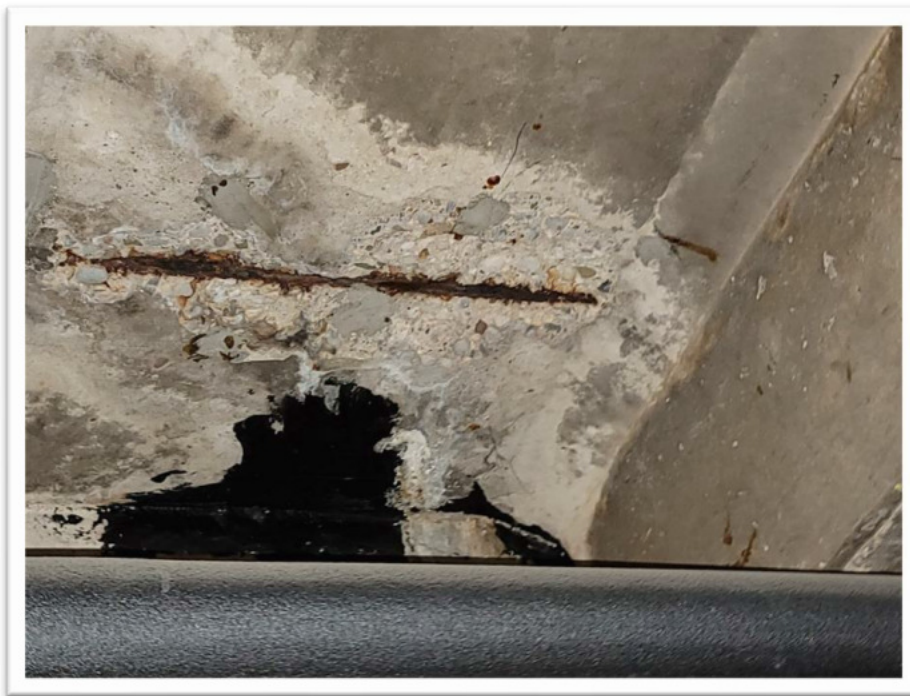
Figure 1.28 - Exposed corroded reinforcement of the ceiling slab.

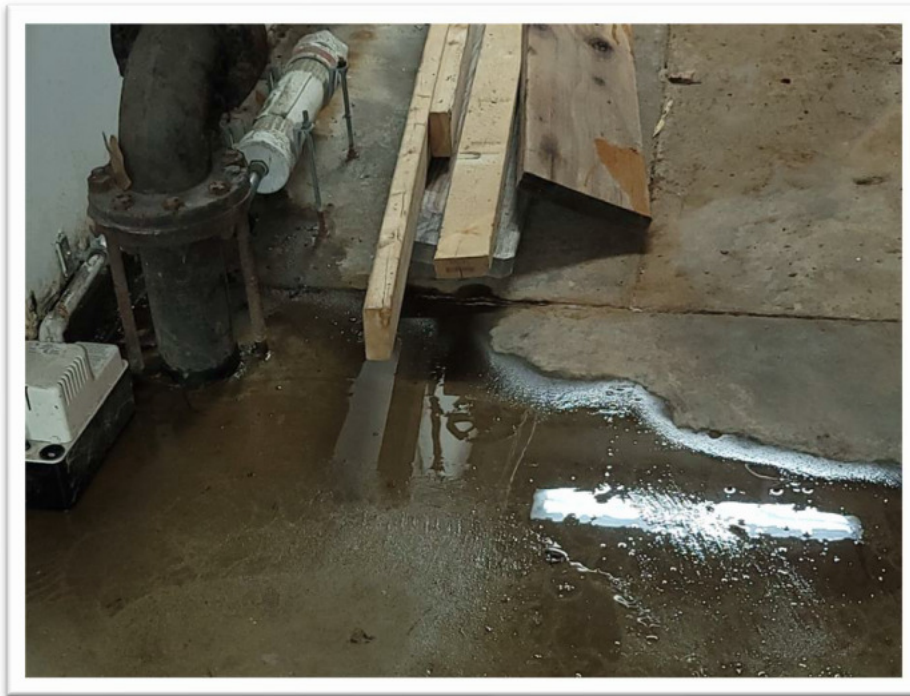
Figure 1.29 - Leakage from the boiler room.

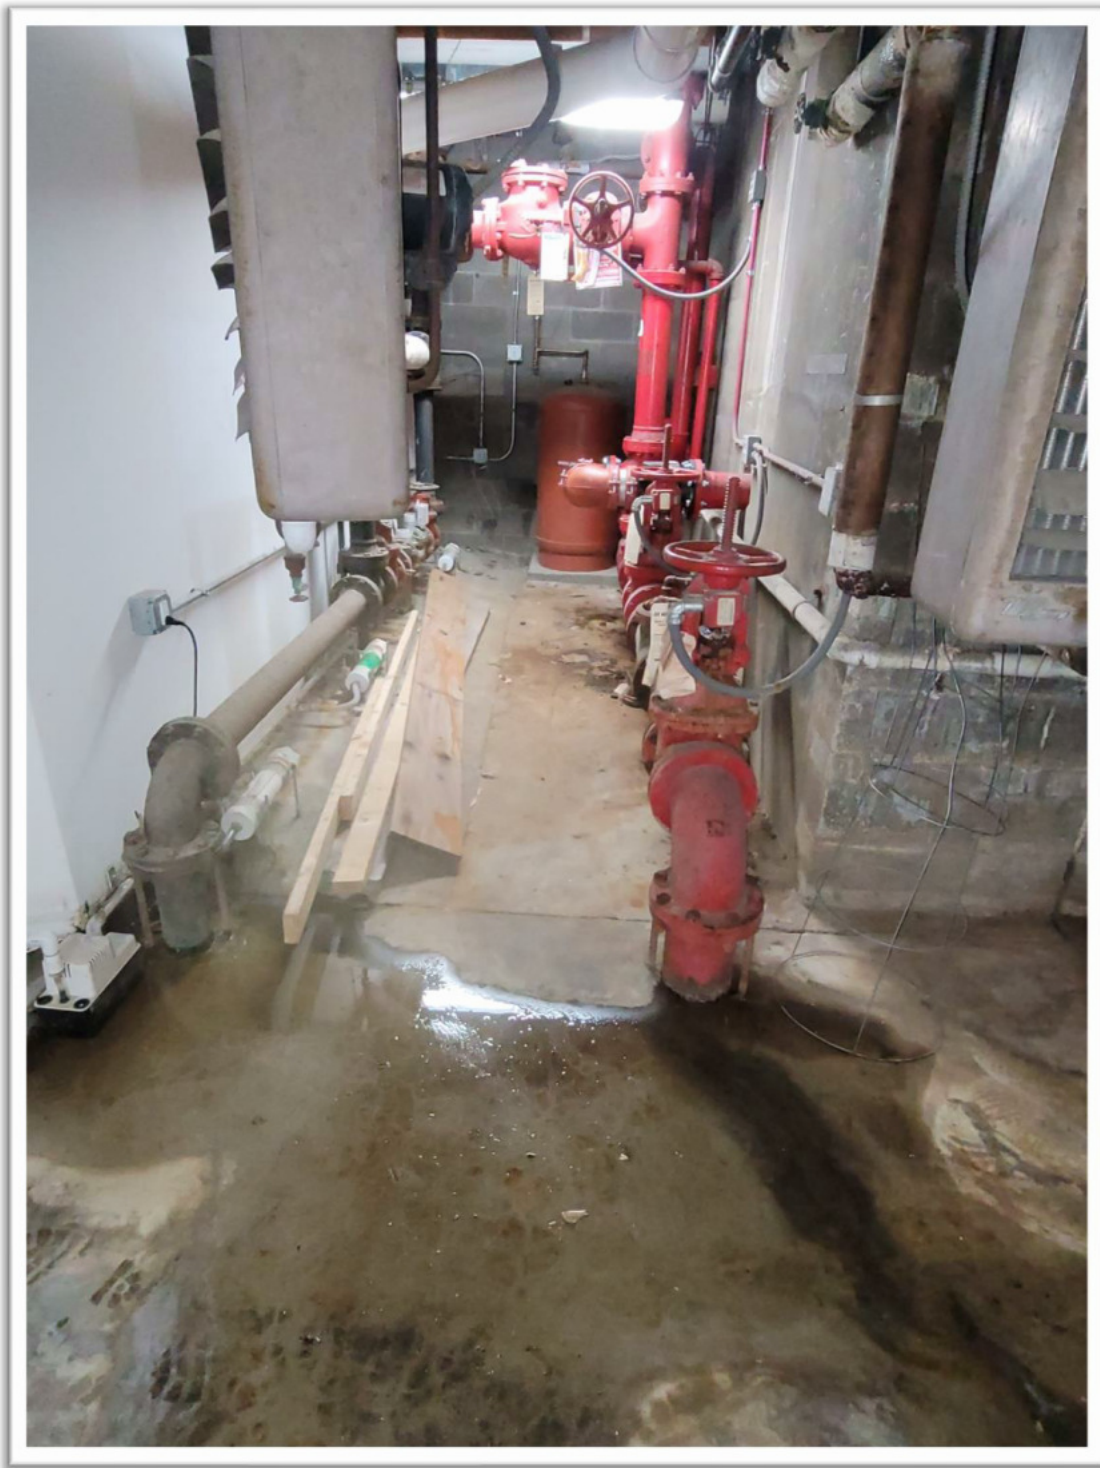
Figure 1.30 - Leakage from the boiler room.

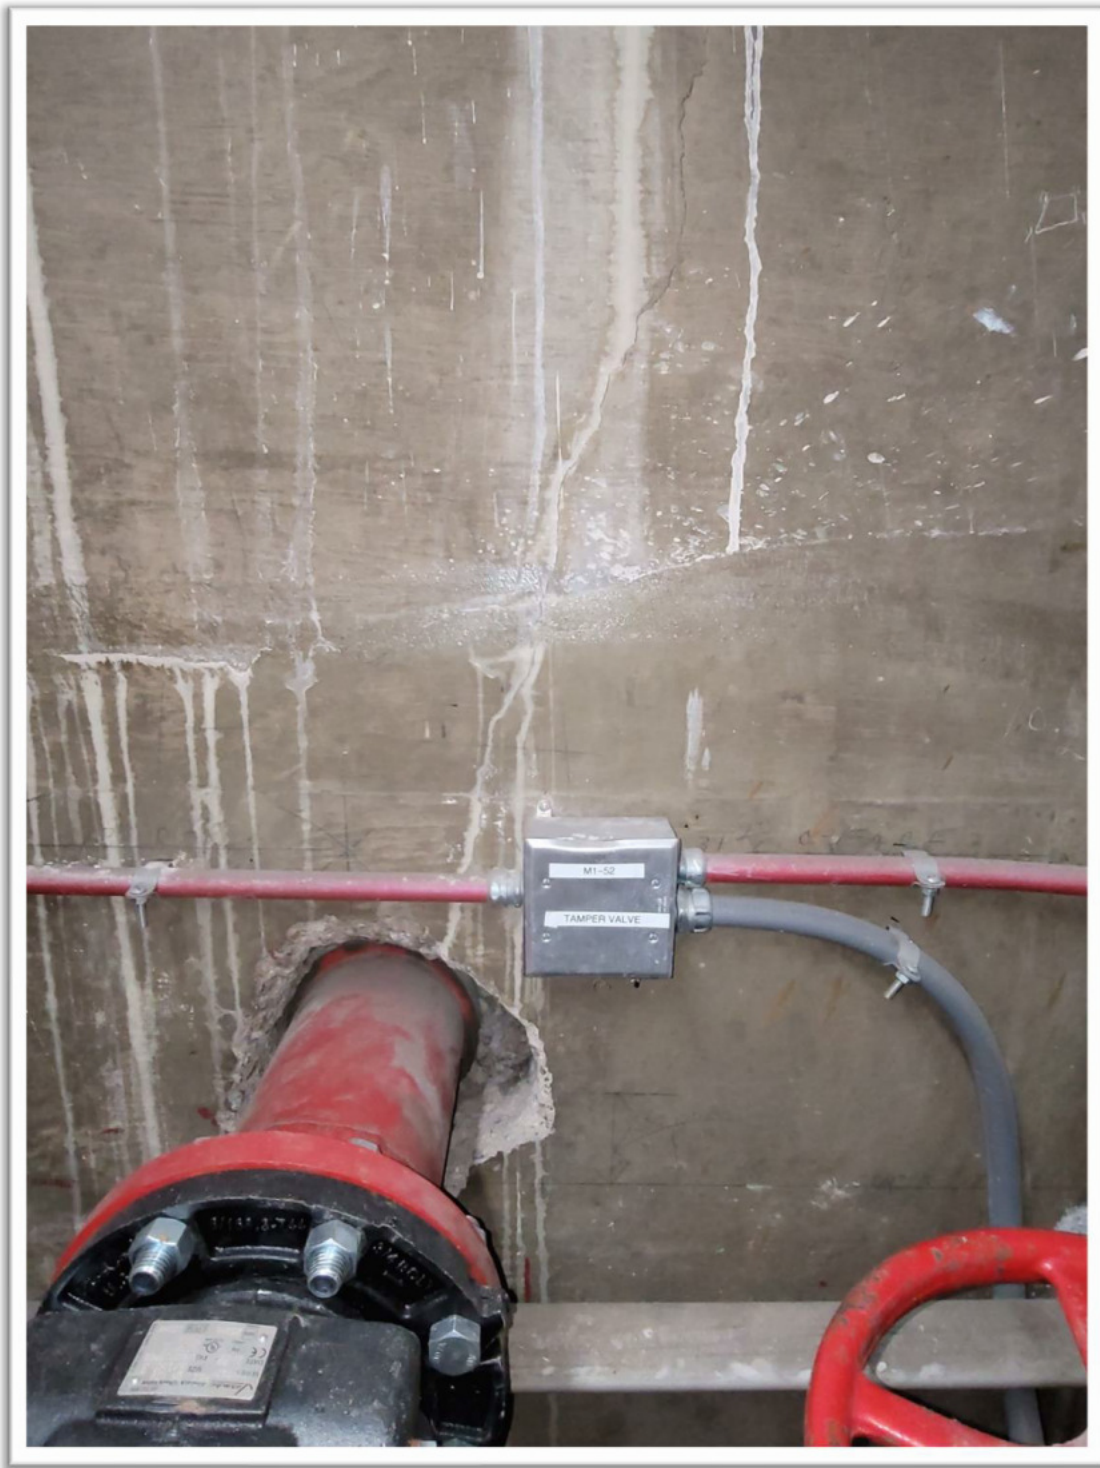
Figure 1.31 - Concrete wall mechanical cracks due to the pipe installation.

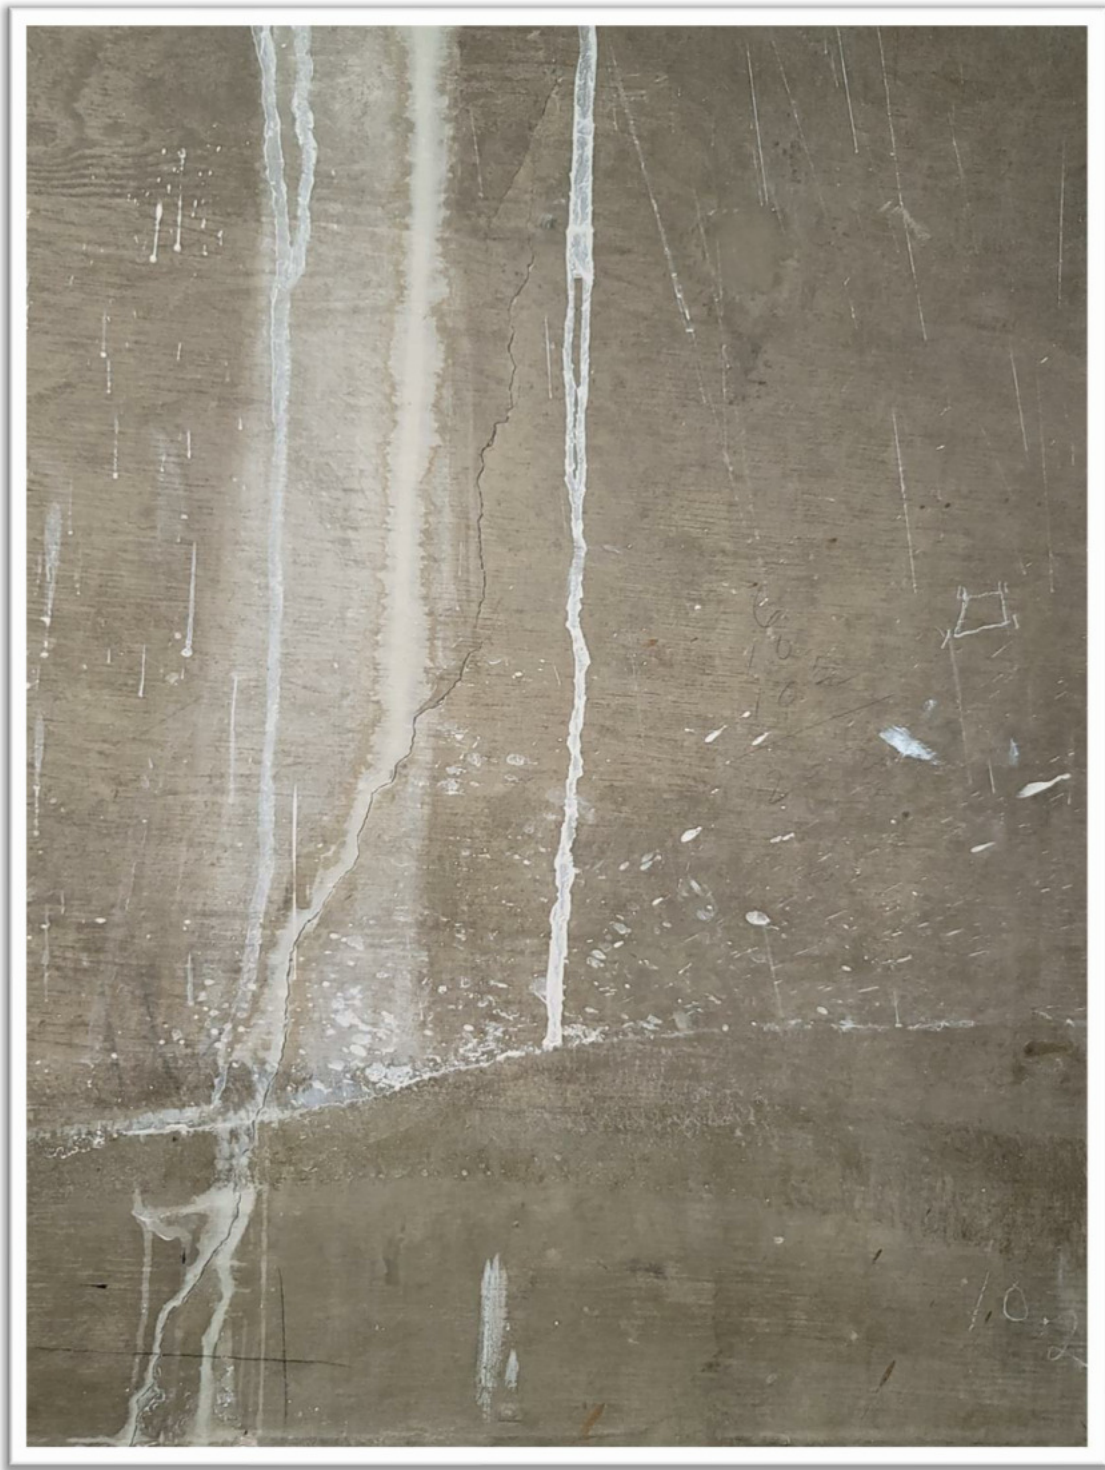
Figure 1.32 - Concrete wall mechanical cracks.

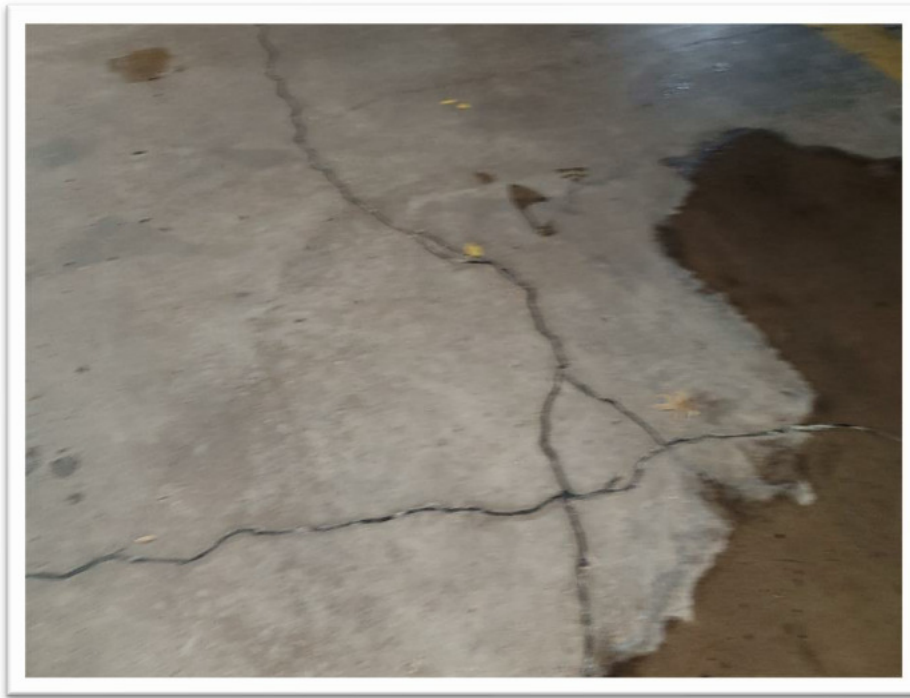
Figure 1.33 - Garage slab settlement cracks.
