**Re: Structural Assessment at:**  
2401 Pennsylvania Ave.  
Wilmington DE 19806

# Structural Assessment Report

Prepared for:  
Stacey Temple  
Devon Condominium  
2401 Pennsylvania Ave.  
Wilmington DE 19806

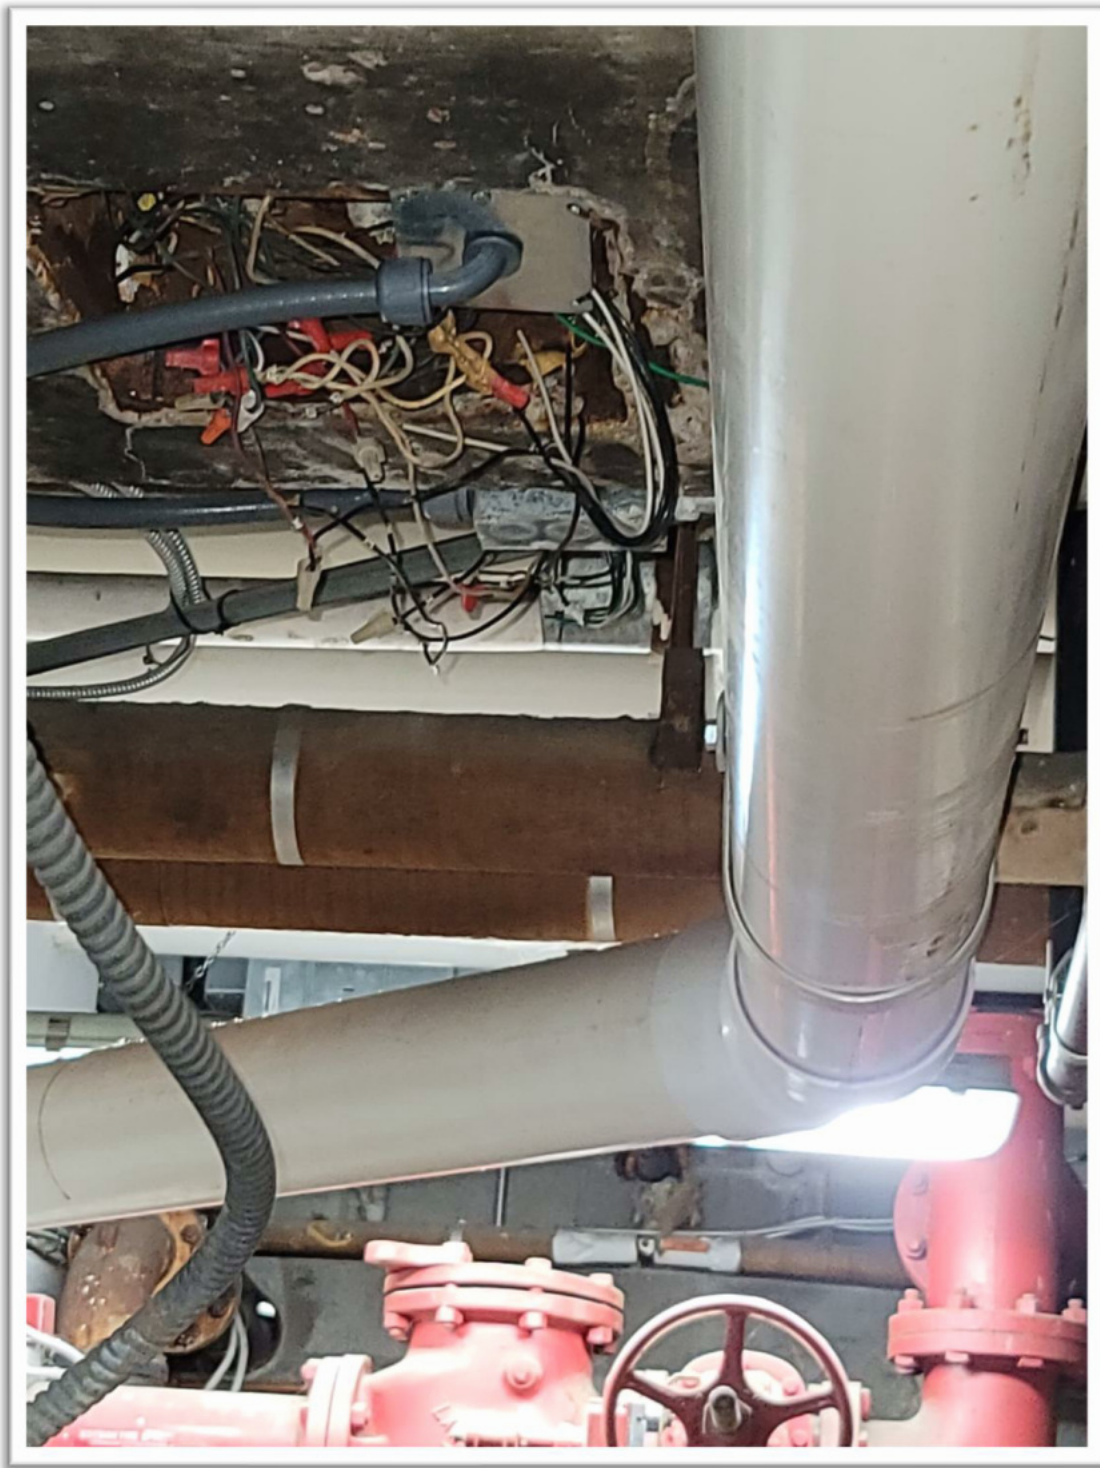
Figure 1.35 - Signs of old leakage around the wires.

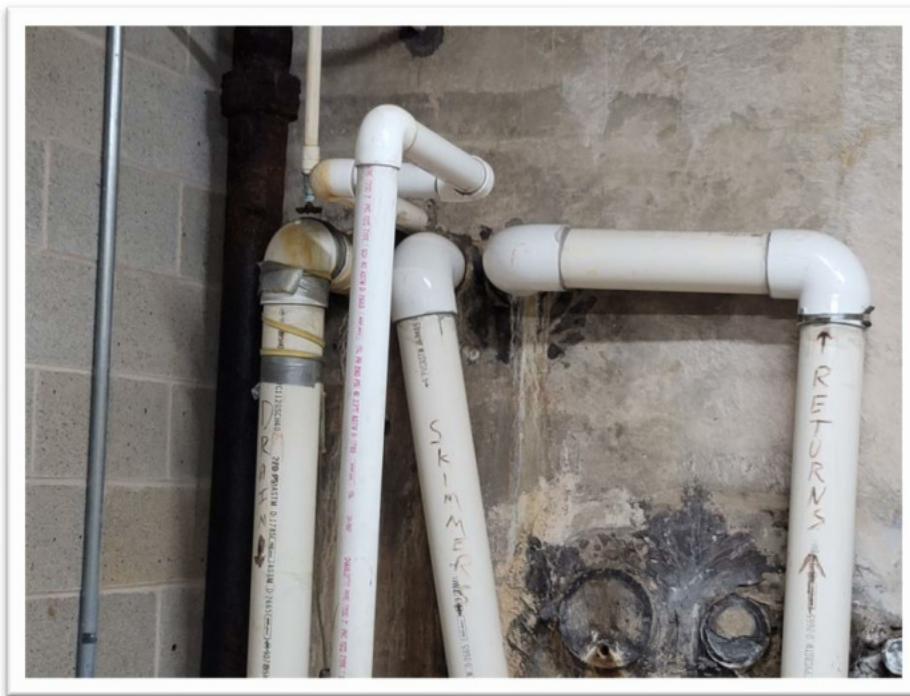
Figure 2.2 - Signs of old leakage through the mechanical room walls.

- Remove the efflorescence deposits, wall tiles, and peeled paints, and wash the walls with bleach before starting any repairs.
- Change all the plumbing systems, including all the plumbing connections through the walls.

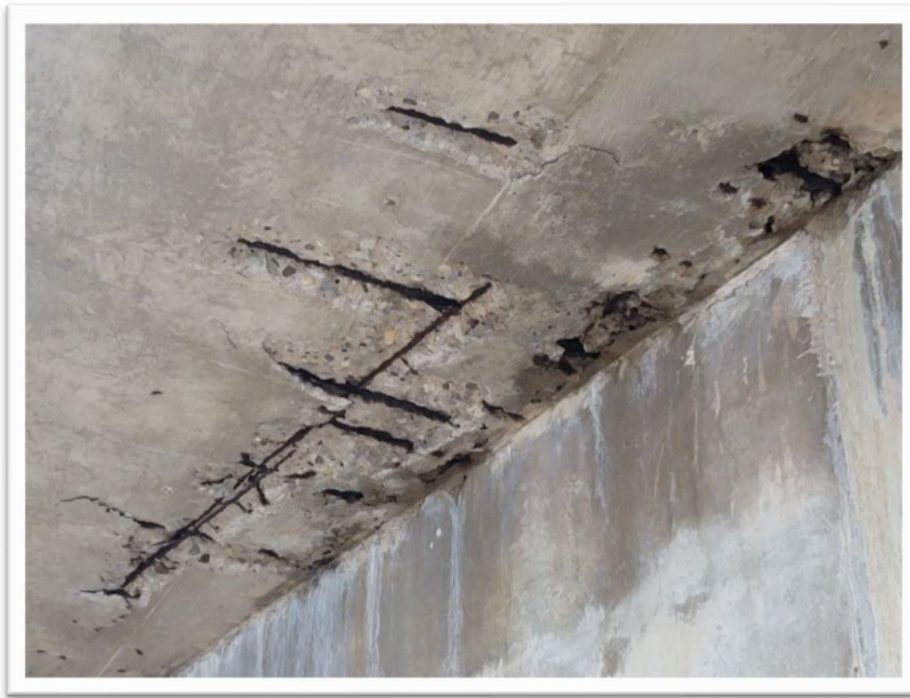
Figure 2.3 - Spalling and crumbling concrete surface through the ceiling slab and severely corroded reinforcement.

- Clean the exposed reinforcement rebars, remove the rusted parts using a wire brush and high-pressure water, and use sandblasting if needed. Paint the exposed rebars with epoxy-supported sealants. Kiro Engineering, LLC will review the Contractor's means and methods at no additional cost.

- Add new reinforcement mesh (#4 rebars at 3-inches spacing) to connect the old concrete with the new concrete. Use epoxy-modified concrete overlay between the old concrete and the new concrete. Use shotcrete with a minimum strength of 3000 psi to install the new concrete cover to the exposed parts. Kiro Engineering, LLC will review the shotcrete and injection products at no additional cost.

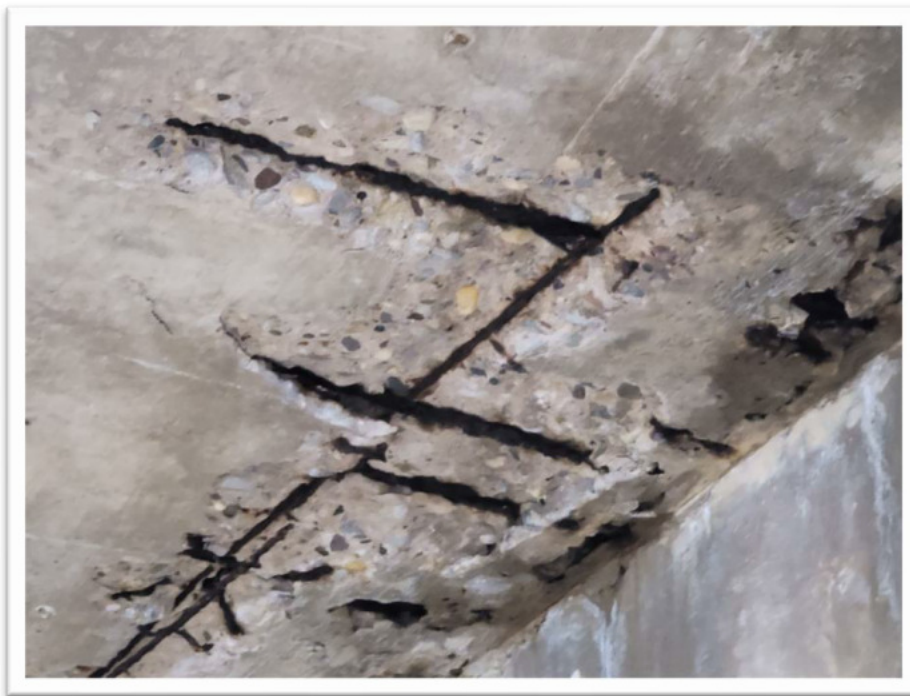
Figure 2.4 - Spalling and crumbling concrete surface through the ceiling slab and severely corroded reinforcement.

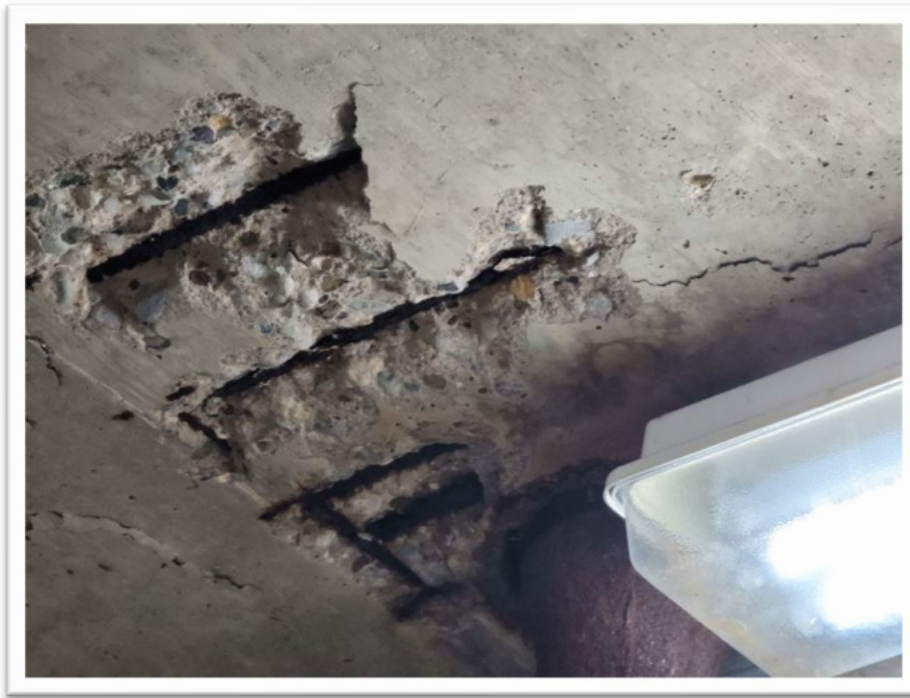
Figure 2.5 - Spalling and crumbling concrete surface through the ceiling slab and severely corroded reinforcement.

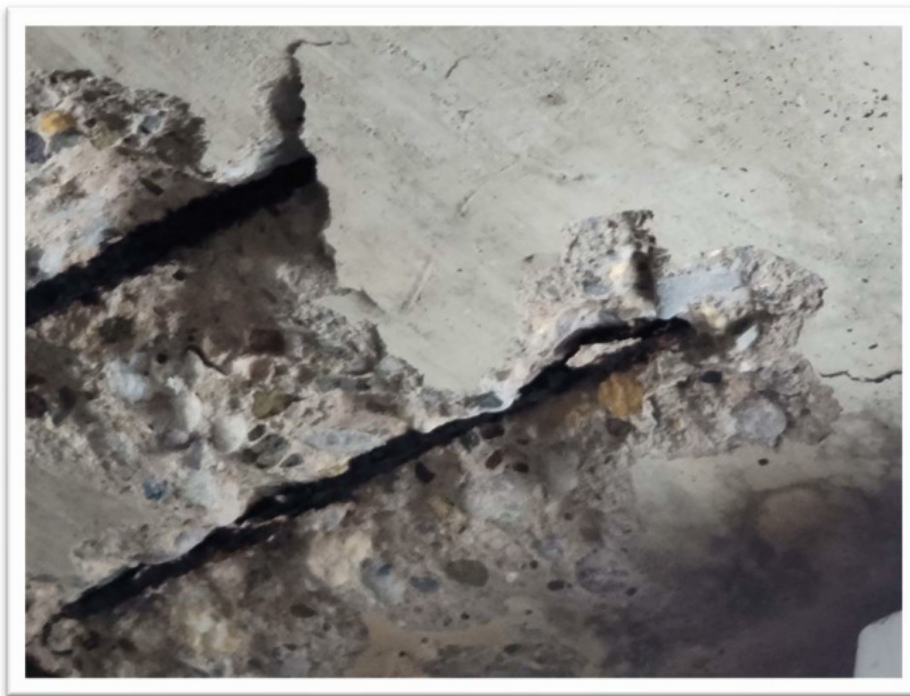
Figure 2.6 - Spalling and crumbling concrete surface through the ceiling slab and severely corroded reinforcement.

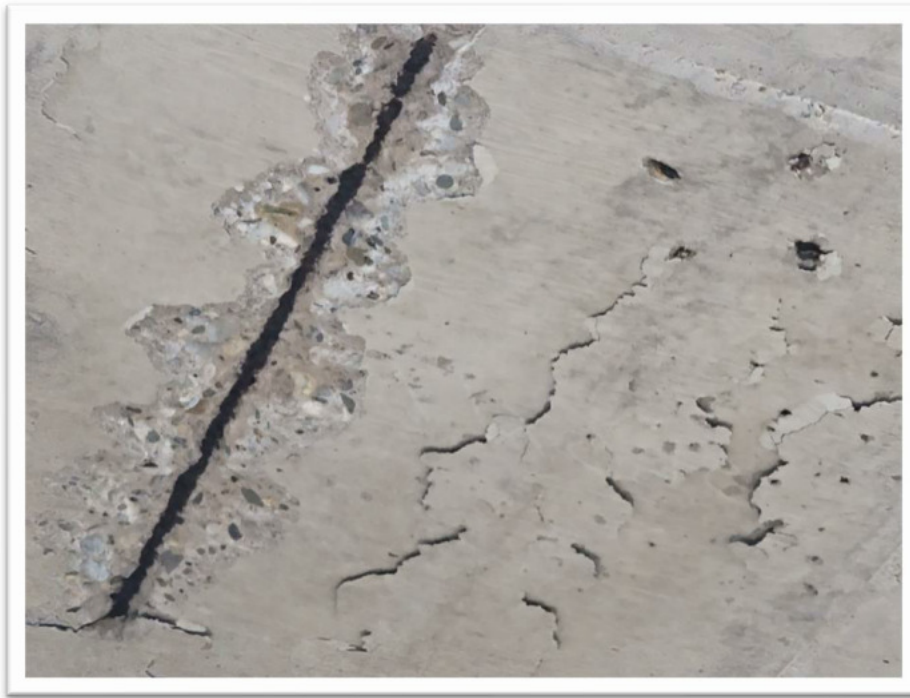
Figure 2.7 - Spalling and crumbling concrete surface through the ceiling slab and corroded reinforcement.

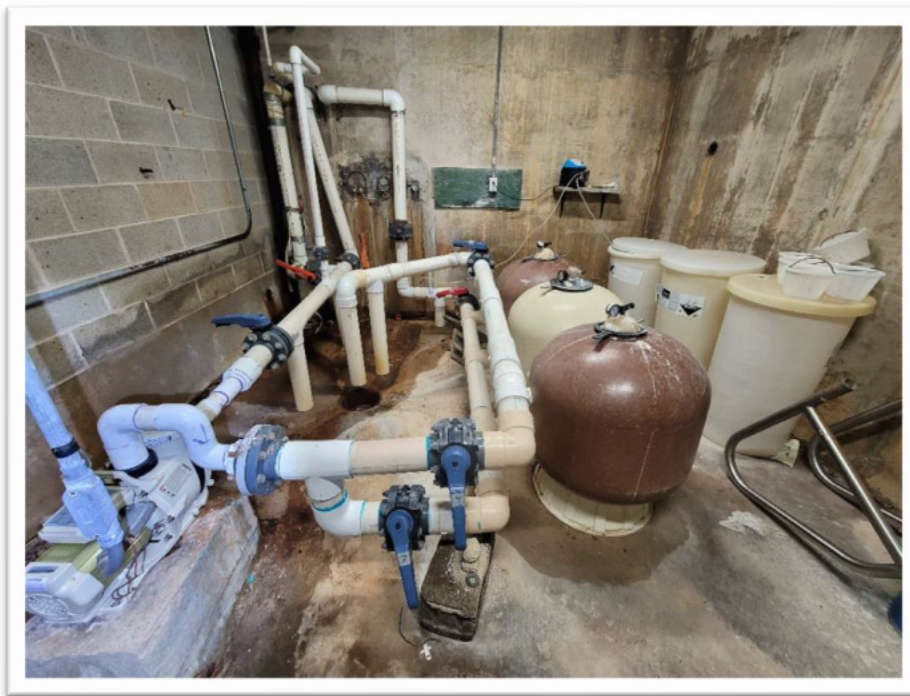
- a. The overall structural condition of the exterior is poor.
- b. The plumbing system is in very poor condition, with severe leakage. The plumbing connections through the walls are beyond repair and must be replaced. We noticed severe leakage through and around the mechanical system and pipes, with other signs of old leakage through the mechanical room walls.
- c. The severe leakage and moisture caused the wall paint to peel.

Figure 2.8 - Severe leakage through and around the mechanical system and pipes.

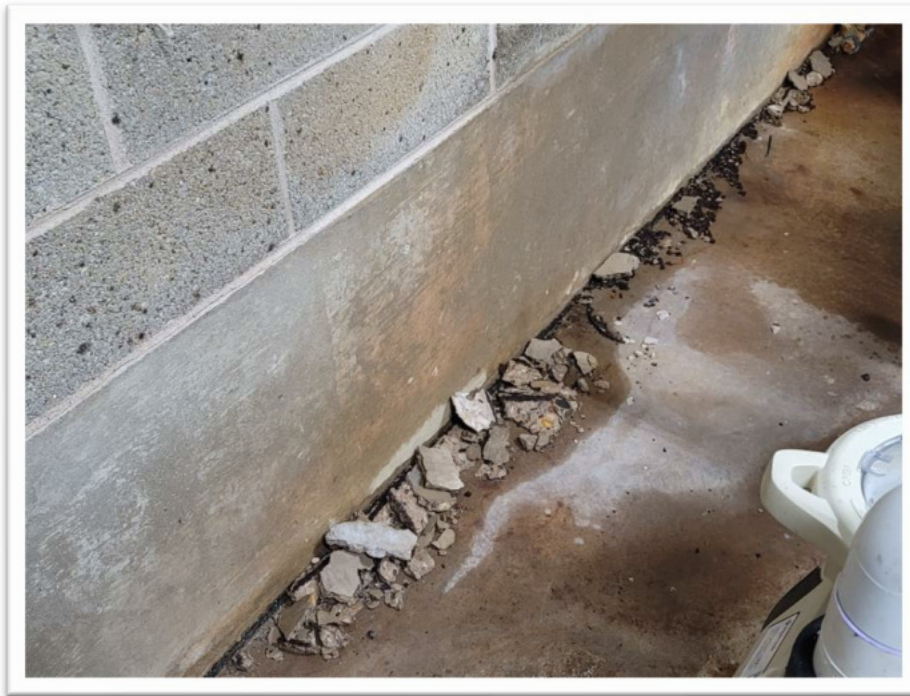
Figure 2.9 - Crumbling concrete pieces from the ceilings.

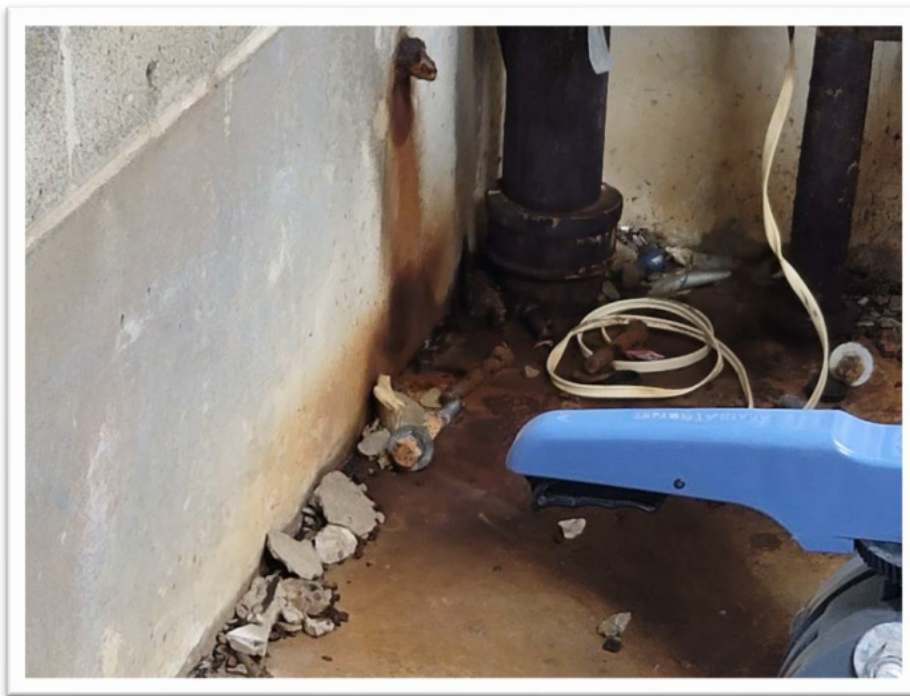
Figure 2.10 - Severe leakage through and around the mechanical system and pipes.

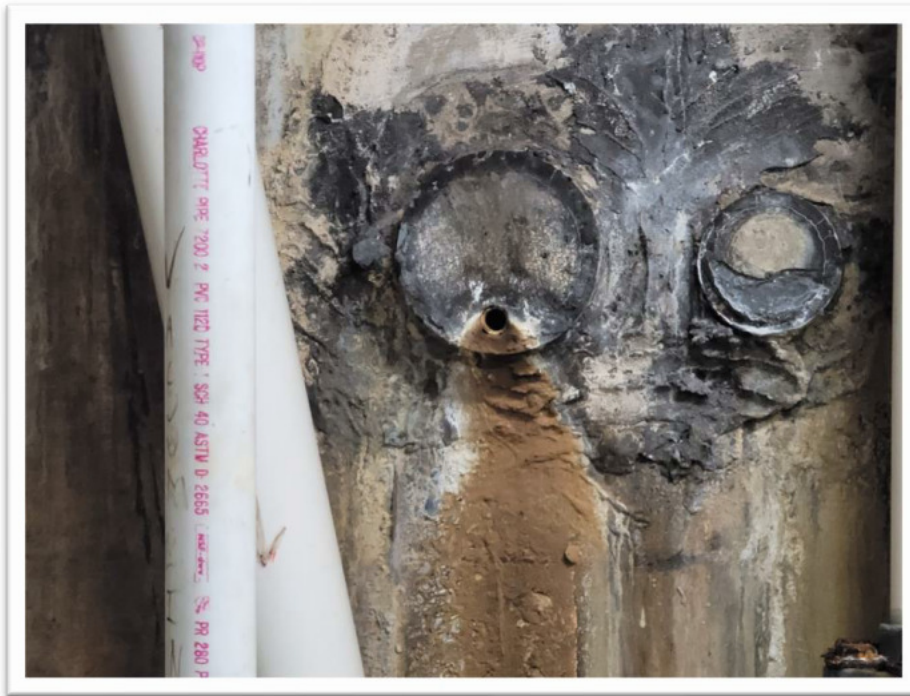
Figure 2.11 - Severe leakage through and around the mechanical system and pipes.

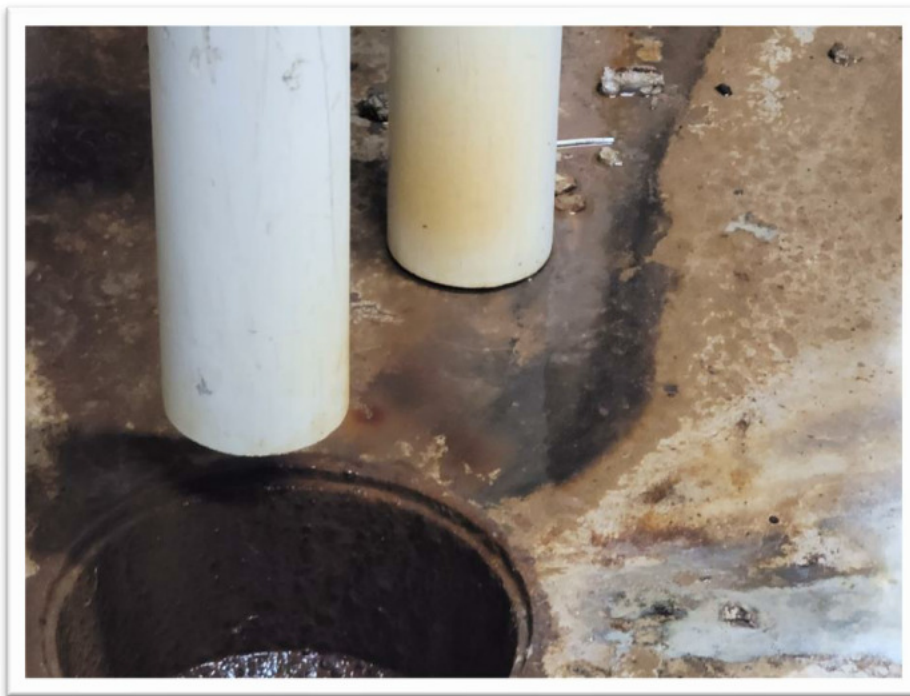
Figure 2.12 - Severe leakage through and around the mechanical system and pipes.

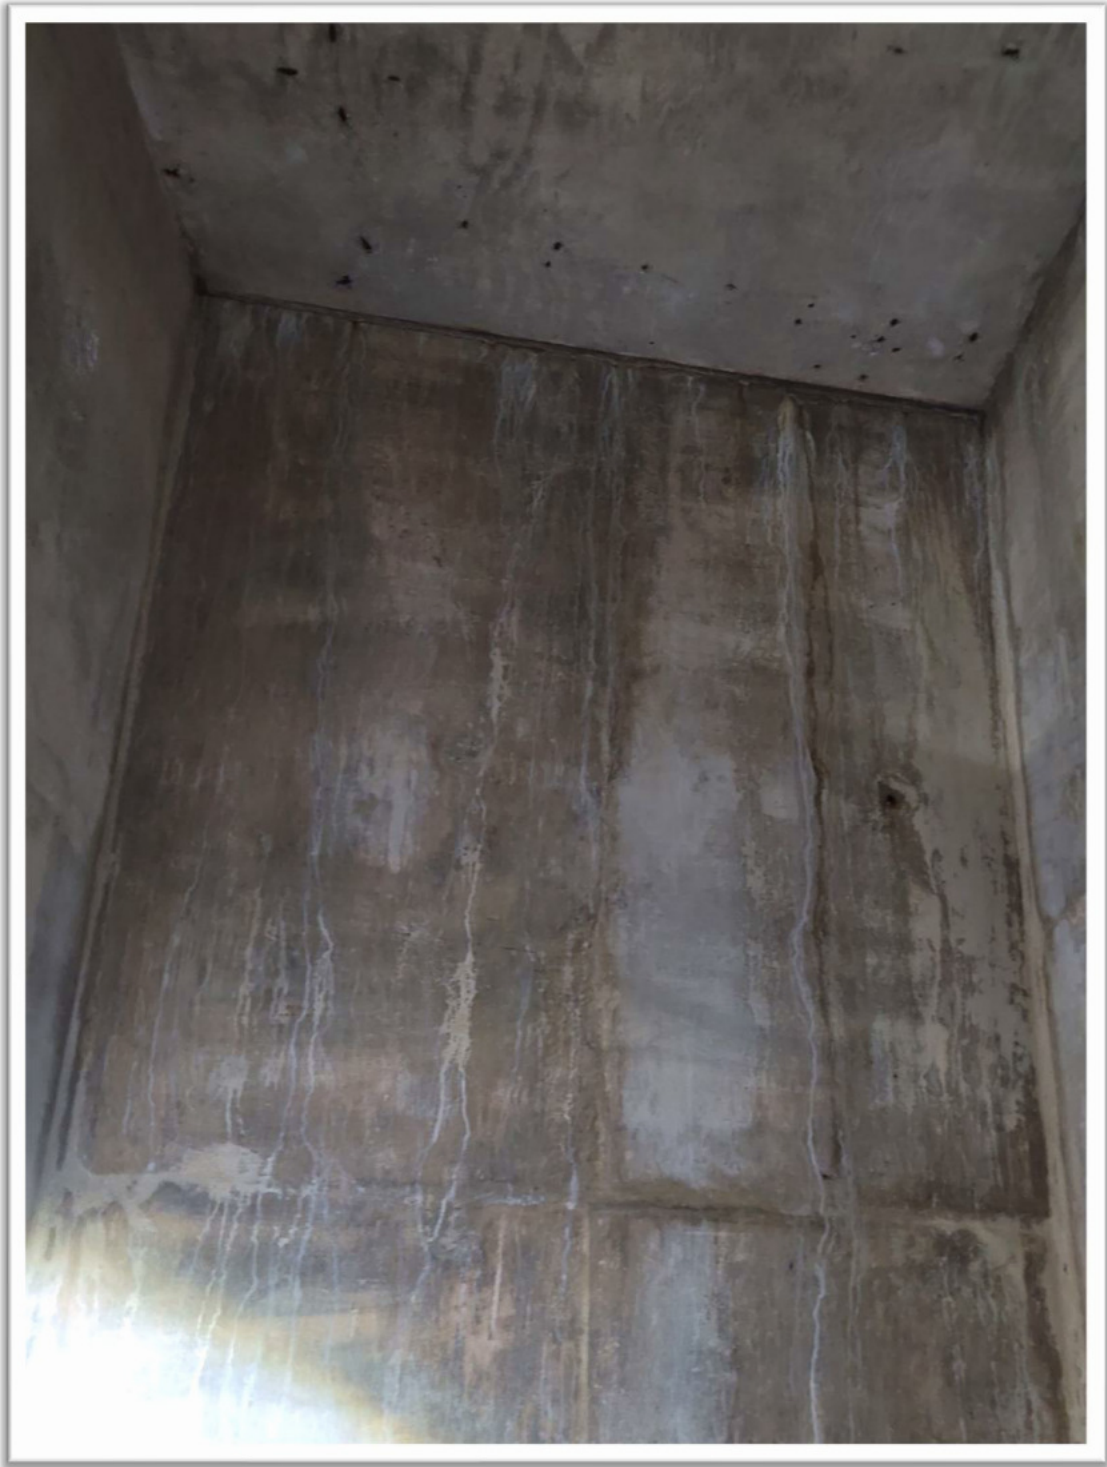
Figure 2.13 - Signs of old leakage through the mechanical room walls.

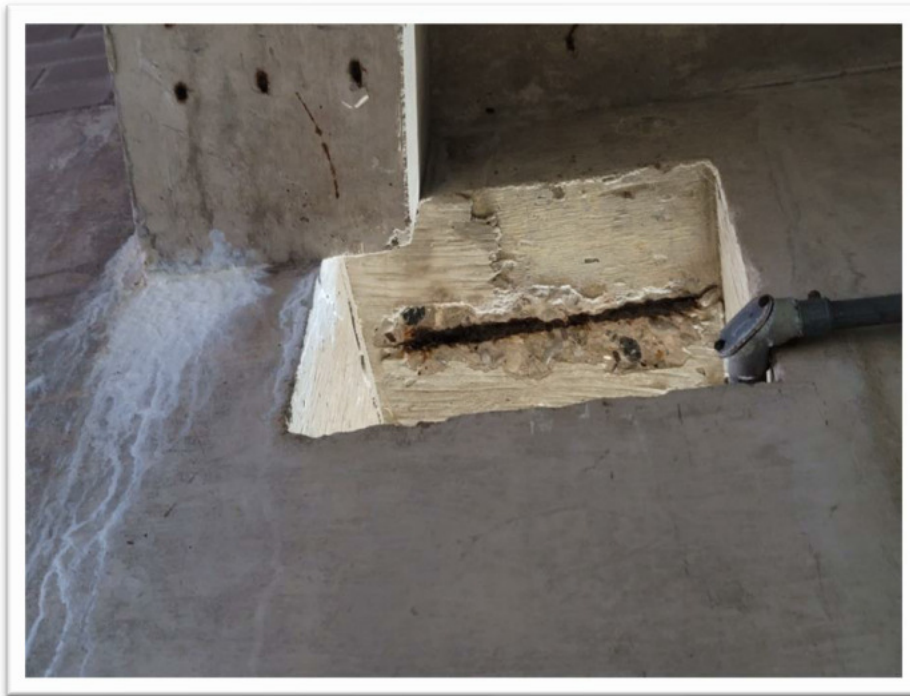
Figure 2.14 - Exposed corroded slab reinforcement.

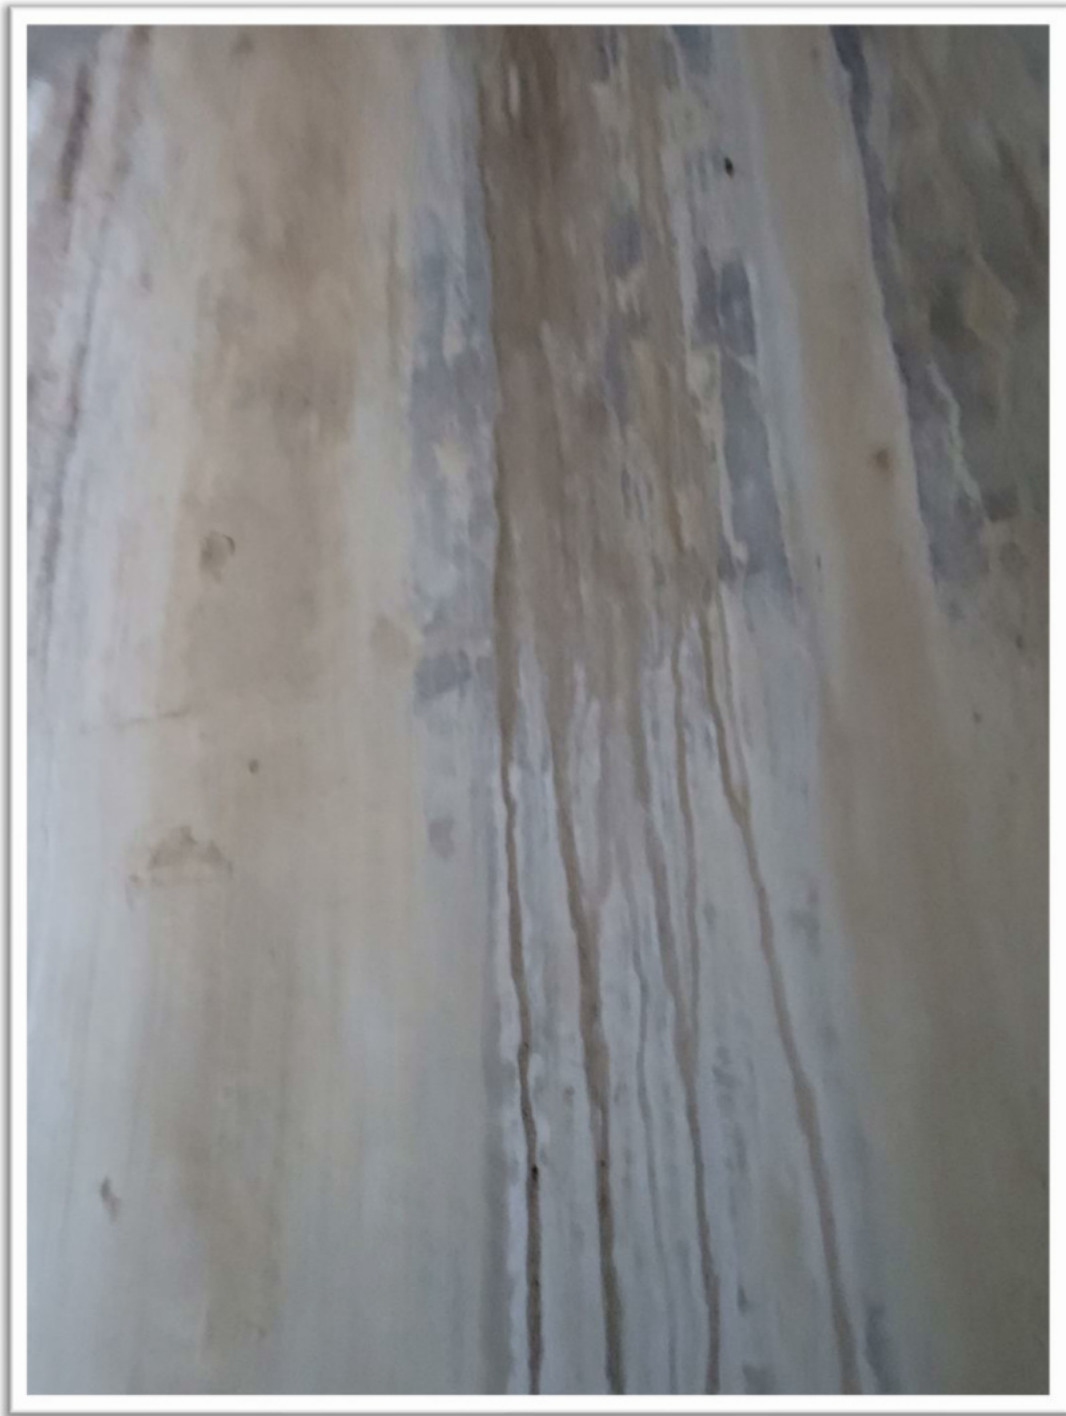
Figure 2.15 - Signs of old leakage through the mechanical room walls.

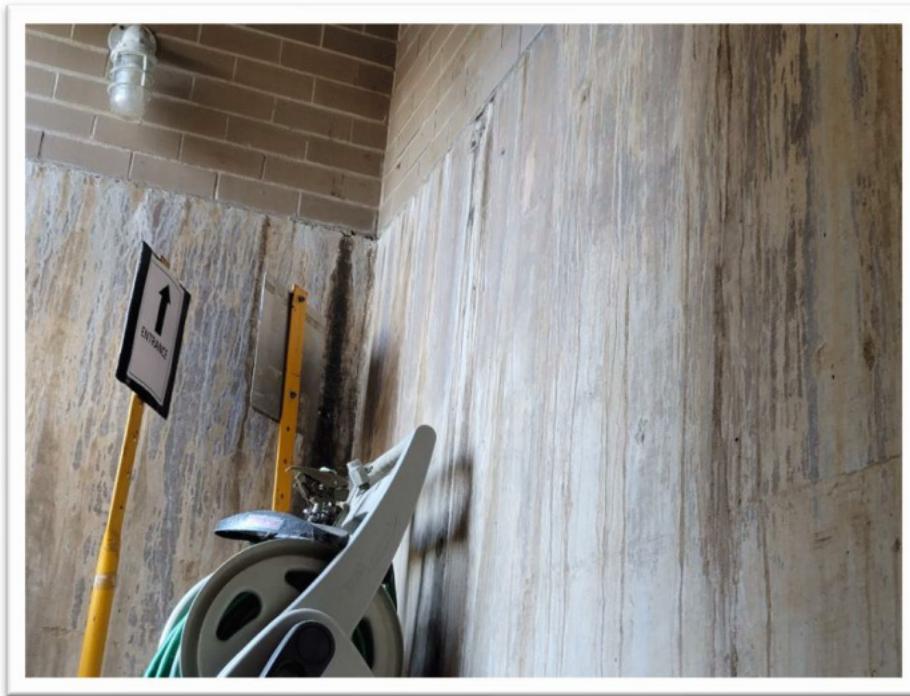
Figure 2.16 - Signs of old leakage through the mechanical room walls.

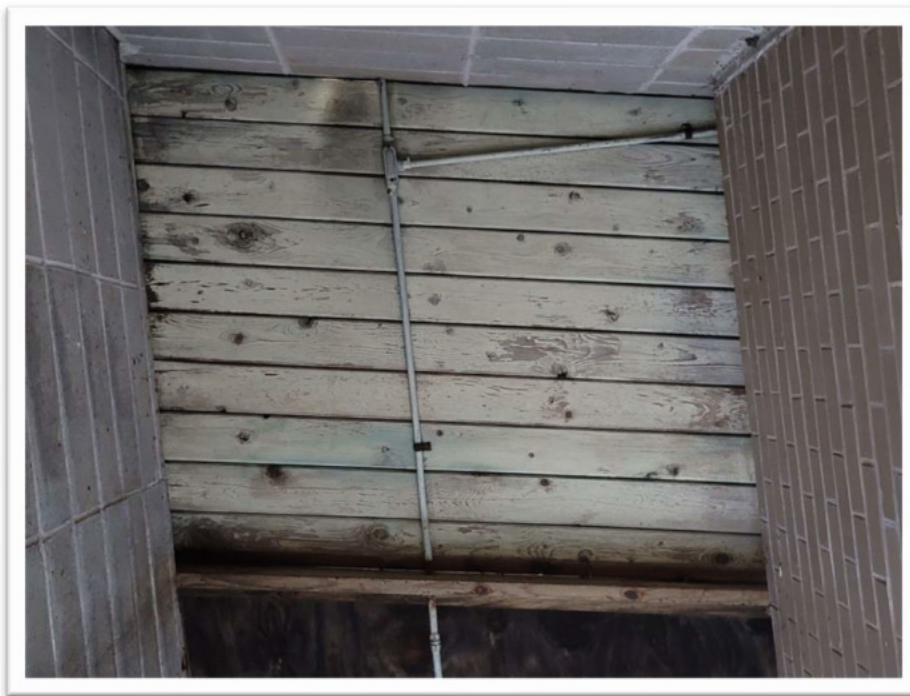
Figure 2.17 - Rotted roof joist.

- Remove any rotted wood covering, and use epoxy wood filler as needed.
- Sister the roof joists as needed.

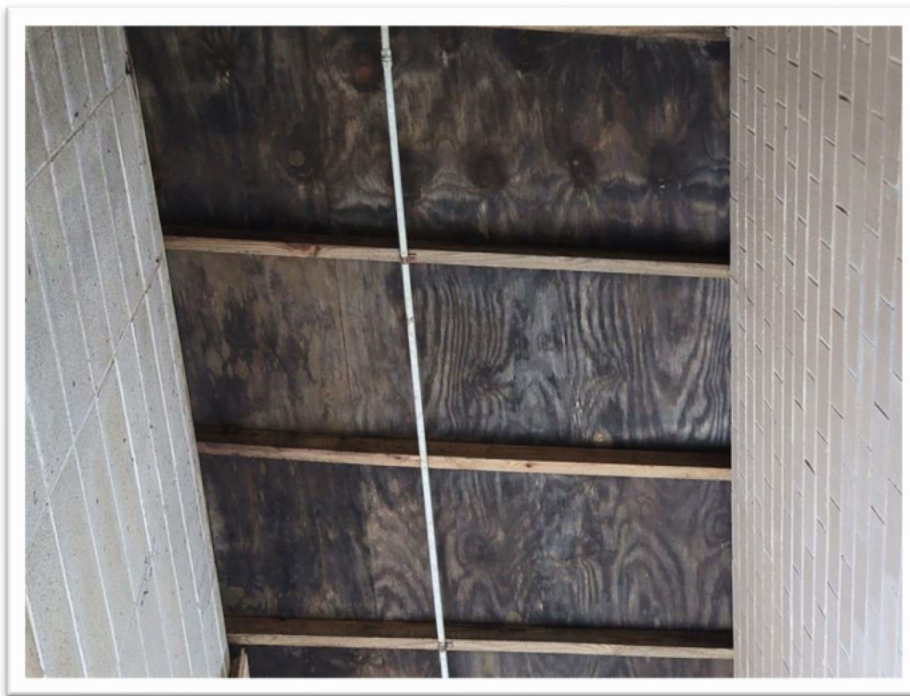
Figure 2.19 - Signs of severe leakage and rot to the roof plywood cover.

- Install new roof with new drainage system with gutters and downspouts. Use sloped flashing at to drain the water away and prevent water puddling.

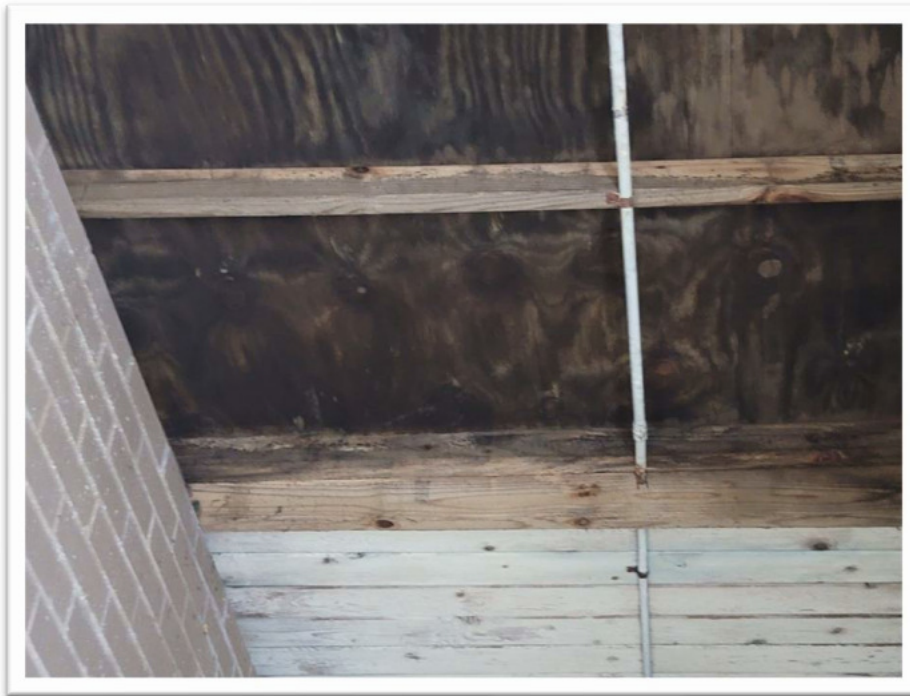
Figure 2.20 - Signs of severe leakage and rot to the roof plywood cover.

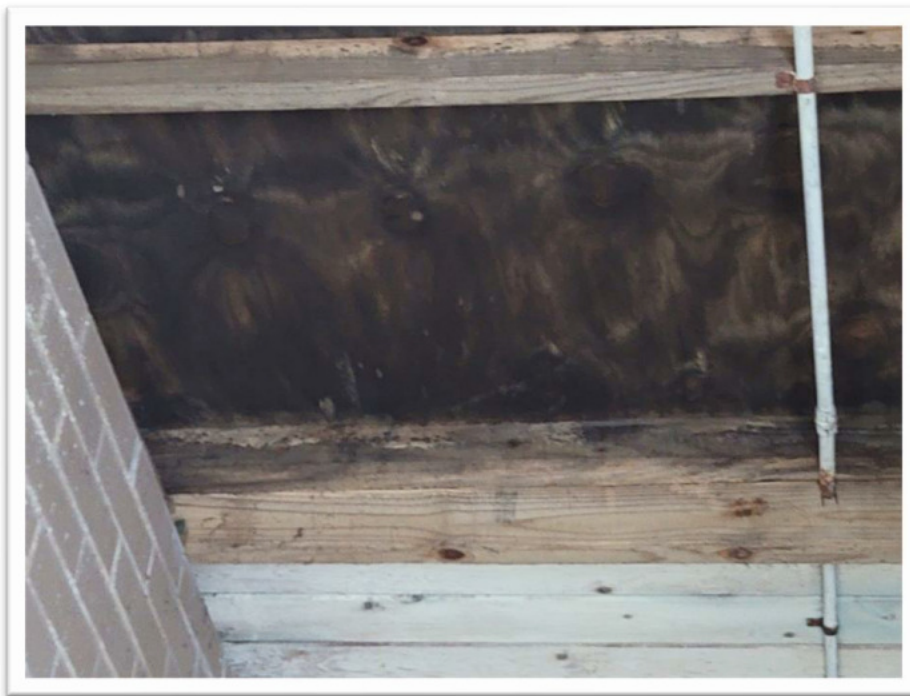
Figure 2.21 - Signs of severe leakage and rot to the roof plywood cover.

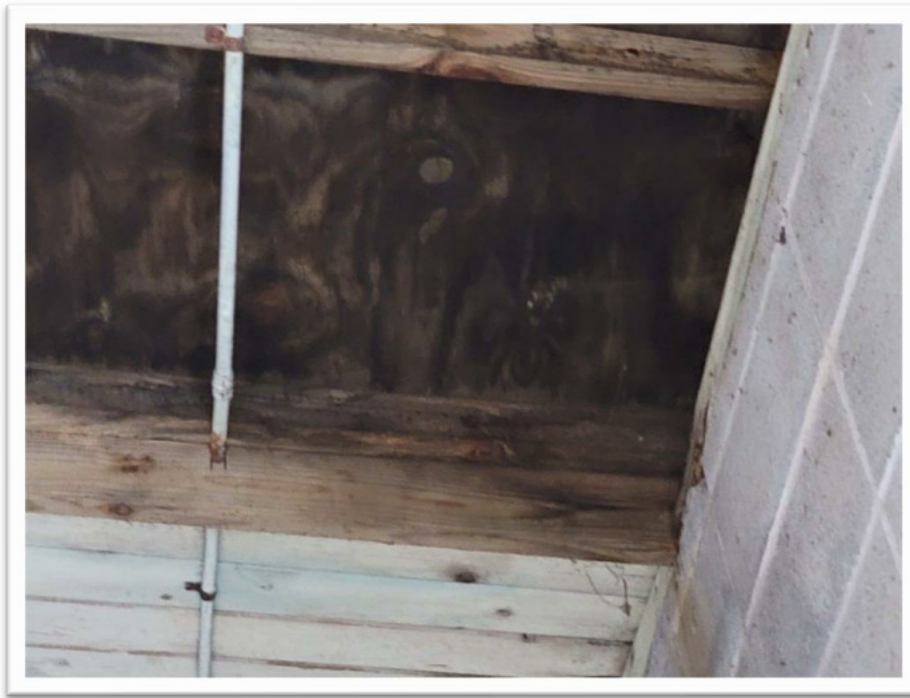
Figure 2.22 - Signs of severe leakage and rot to the roof plywood cover.

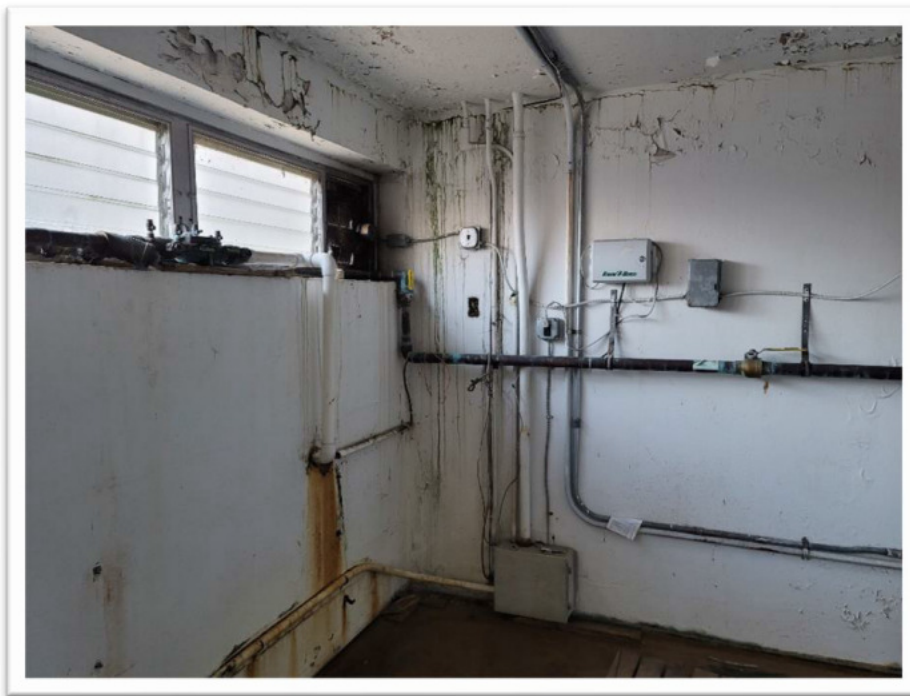
Figure 3.1 - Changing Rooms - Peeled painting due to severe leakage.

- Remove the efflorescence deposits, wall tiles, and peeled paints, and wash the walls with bleach before starting any repairs.
- Change all the plumbing systems, including all the plumbing connections through the walls.

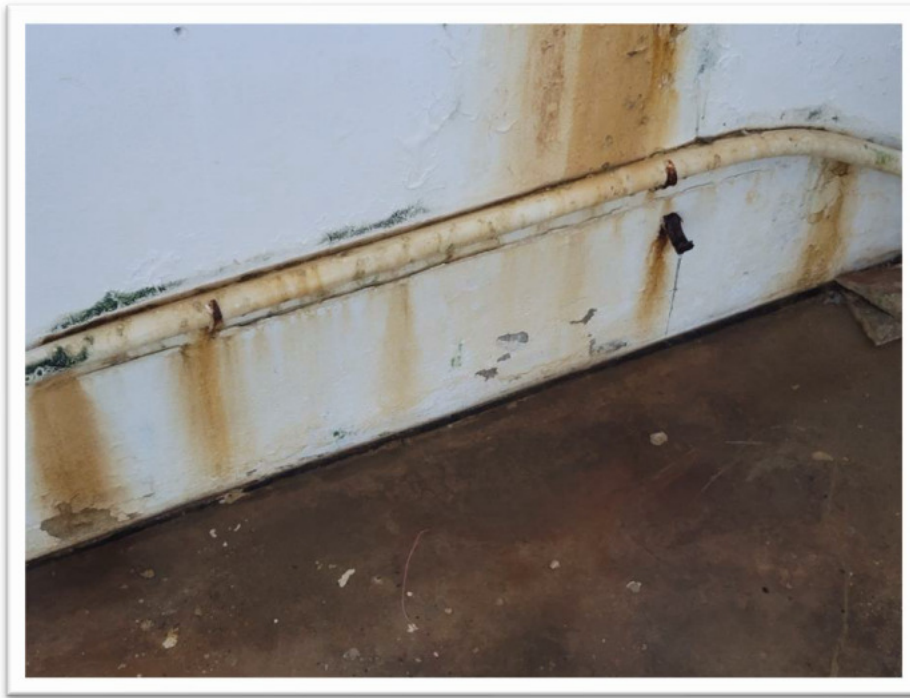
Figure 3.2 - Changing Rooms - Water stains due to severe leakage.

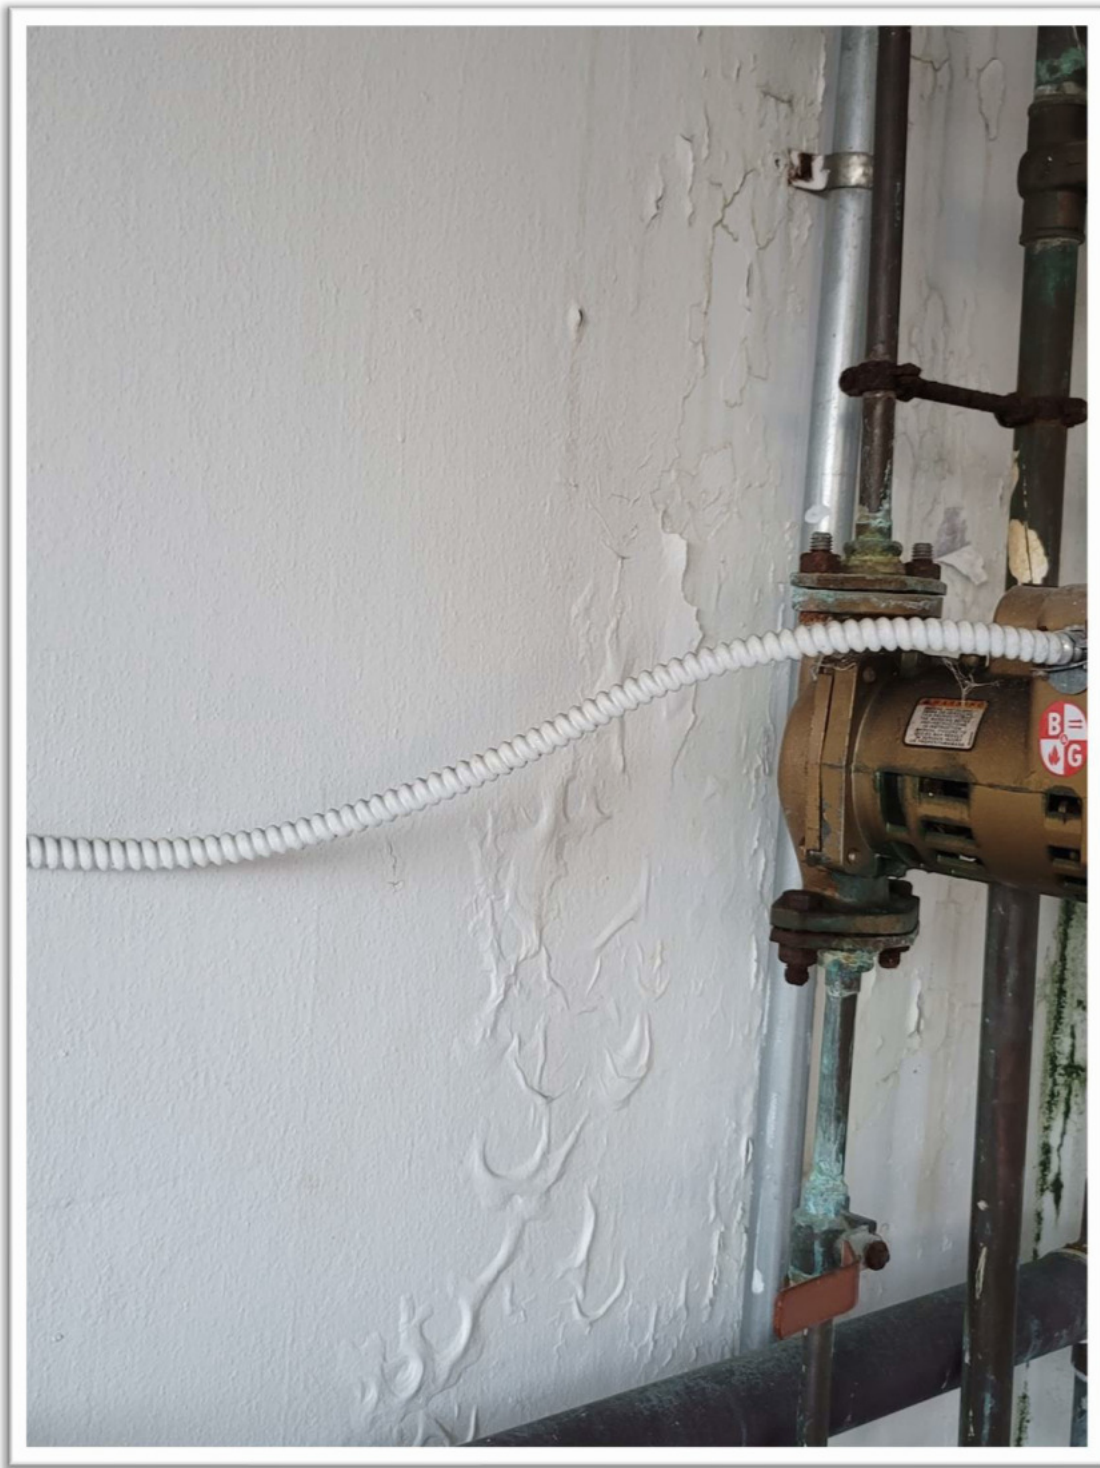
Figure 3.6 - Peeled painting due to severe moisture damage from leakage.

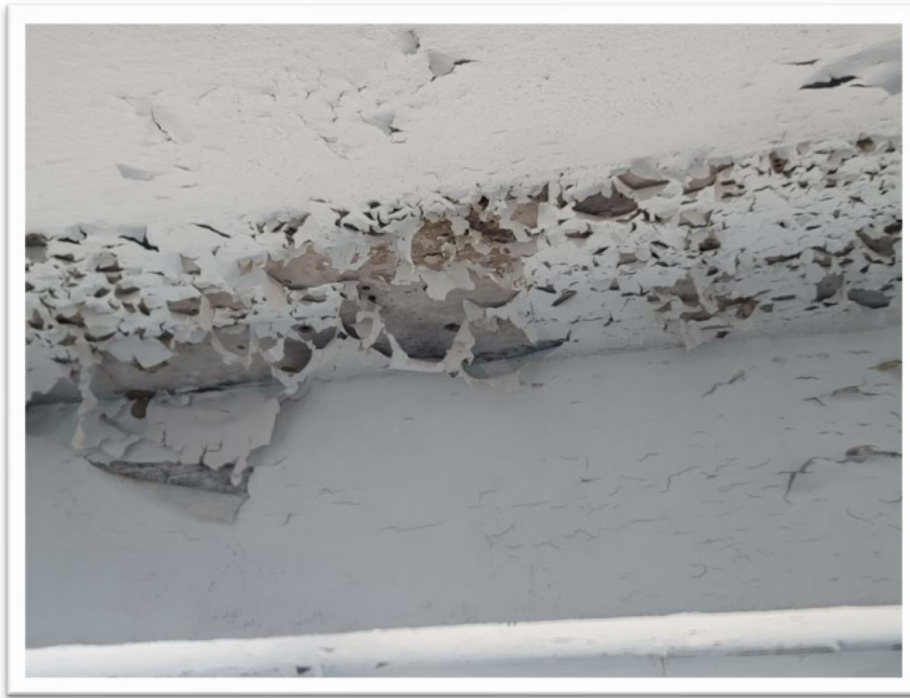
Figure 3.9 - Peeled painting due to severe moisture damage from leakage.

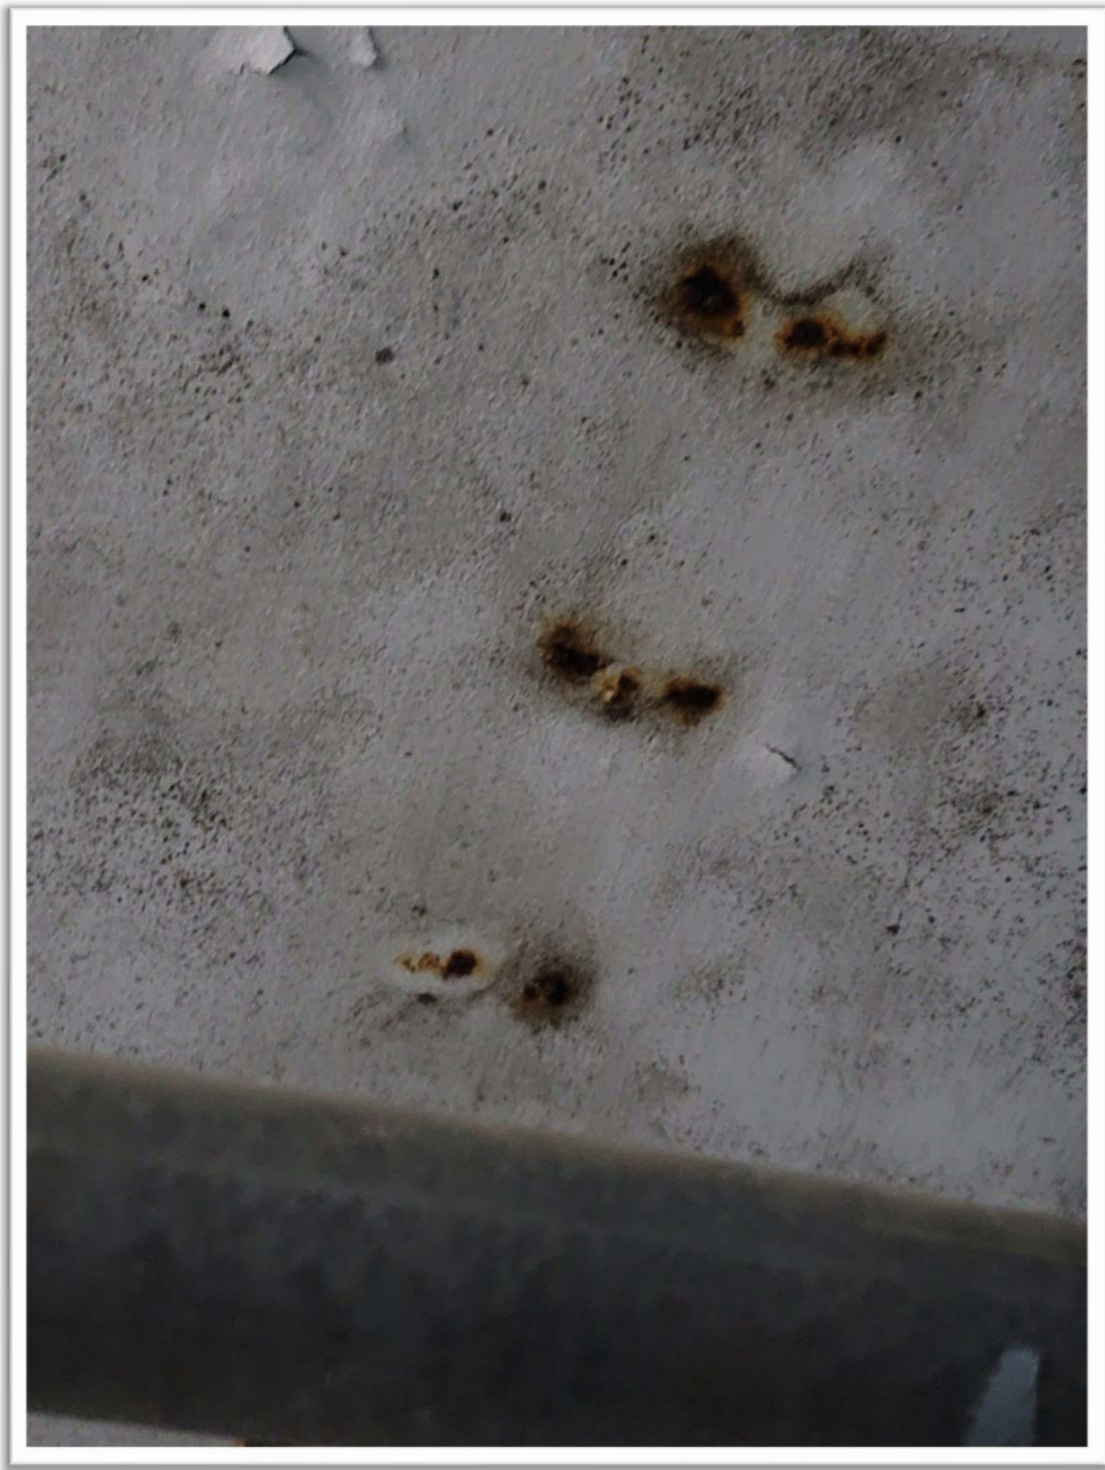
Figure 3.23 - Mold through the ceiling.
