**Re: Structural Assessment at:**  
2401 Pennsylvania Ave.  
Wilmington DE 19806

# Structural Assessment Report

Prepared for:  
Stacey Temple  
Devon Condominium  
2401 Pennsylvania Ave.  
Wilmington DE 19806

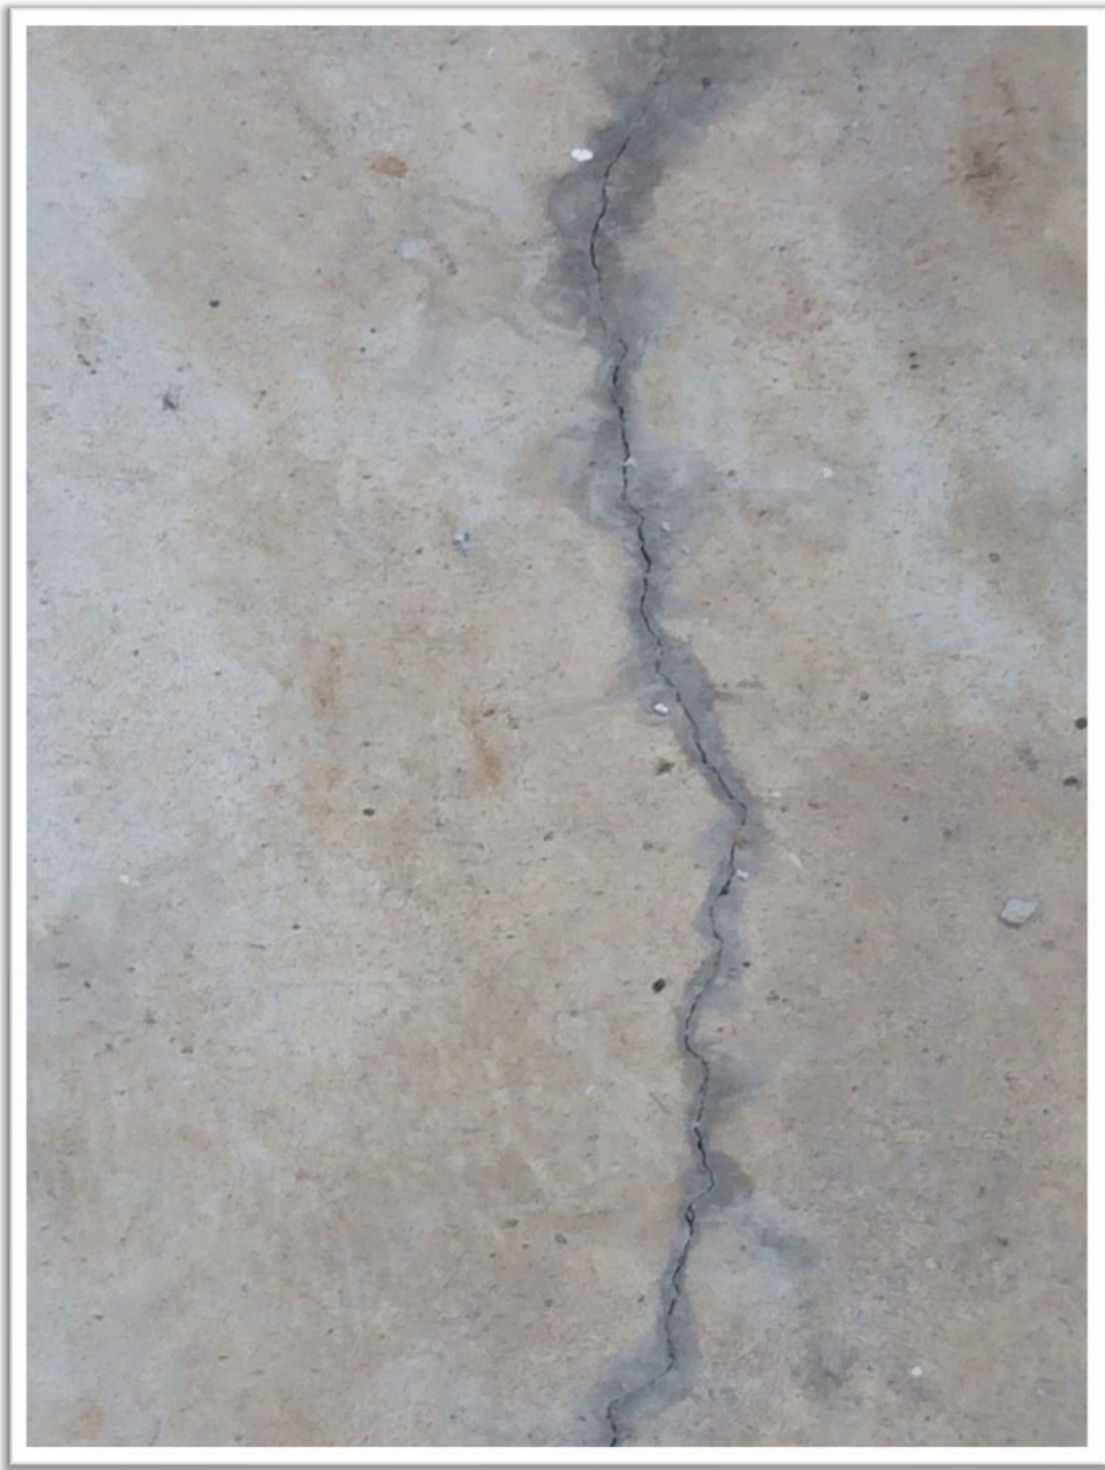
Figure 3.25 - Cracks through the Slab.

- Remove any soft spots or easy-punched concrete from the slab. Pour a concrete pad overlay over the existing slab. Pour a minimum of a 1.5-inches thick concrete with a welded wire mesh (WWM) 3x3 to level the slab. Use epoxy-modified concrete overlay between the old concrete and the new concrete. Kiro Engineering, LLC will review the overlay products at no additional cost.

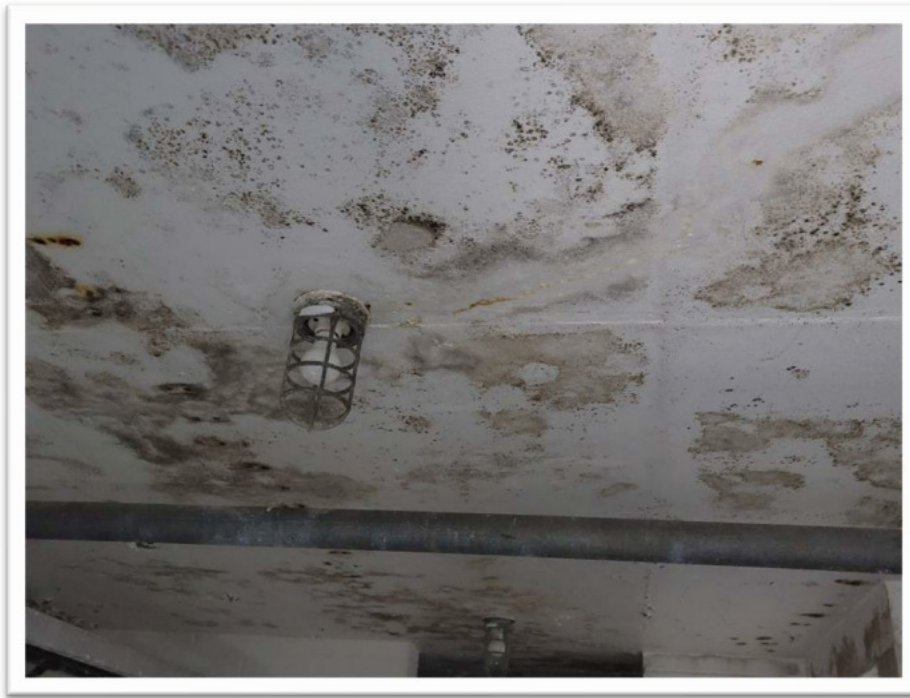
Figure 3.28 - Mold and Severe peeled painting through the ceiling from moisture damage.

- Remove the efflorescence deposits, wall tiles, and peeled paints, and wash the walls with bleach before starting any repairs.
- Change all the plumbing systems, including all the plumbing connections through the walls.

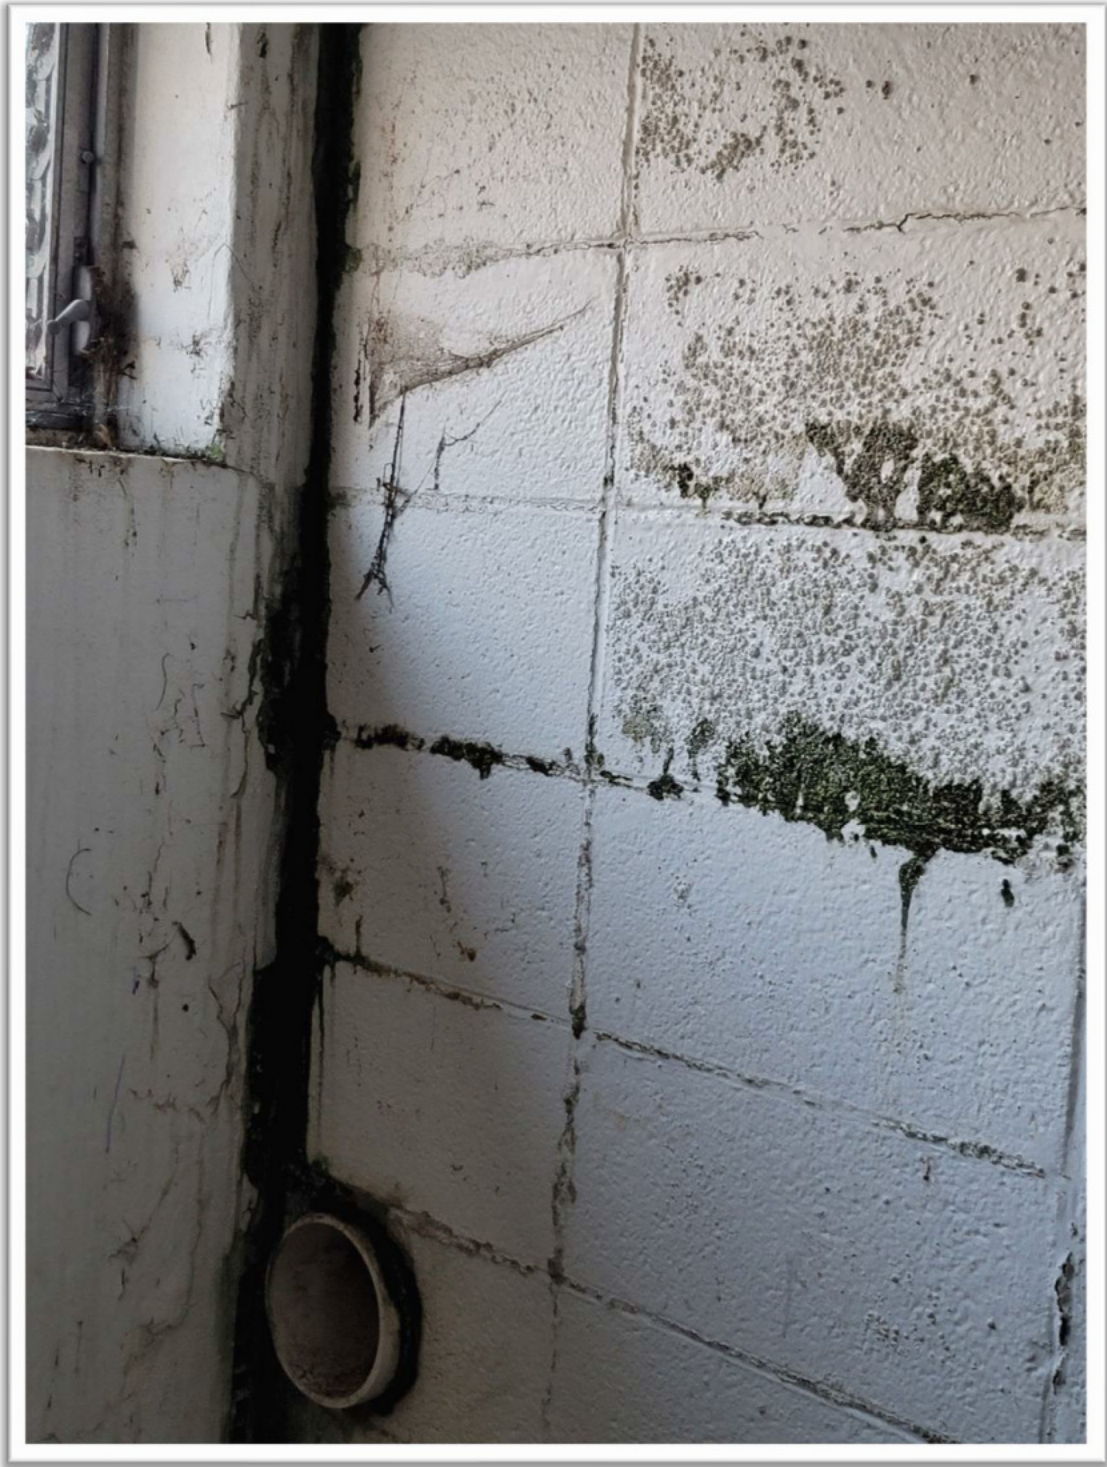
- g. Efflorescence (white powdery deposits) visible on the surface of the foundation walls is an indication of moisture intrusion all over the perimeter of the rooms. Efflorescence can also damage materials and encourage the growth of microbes such as mold.

Figure 3.30 - Efflorescence deposits from moisture intrusion.

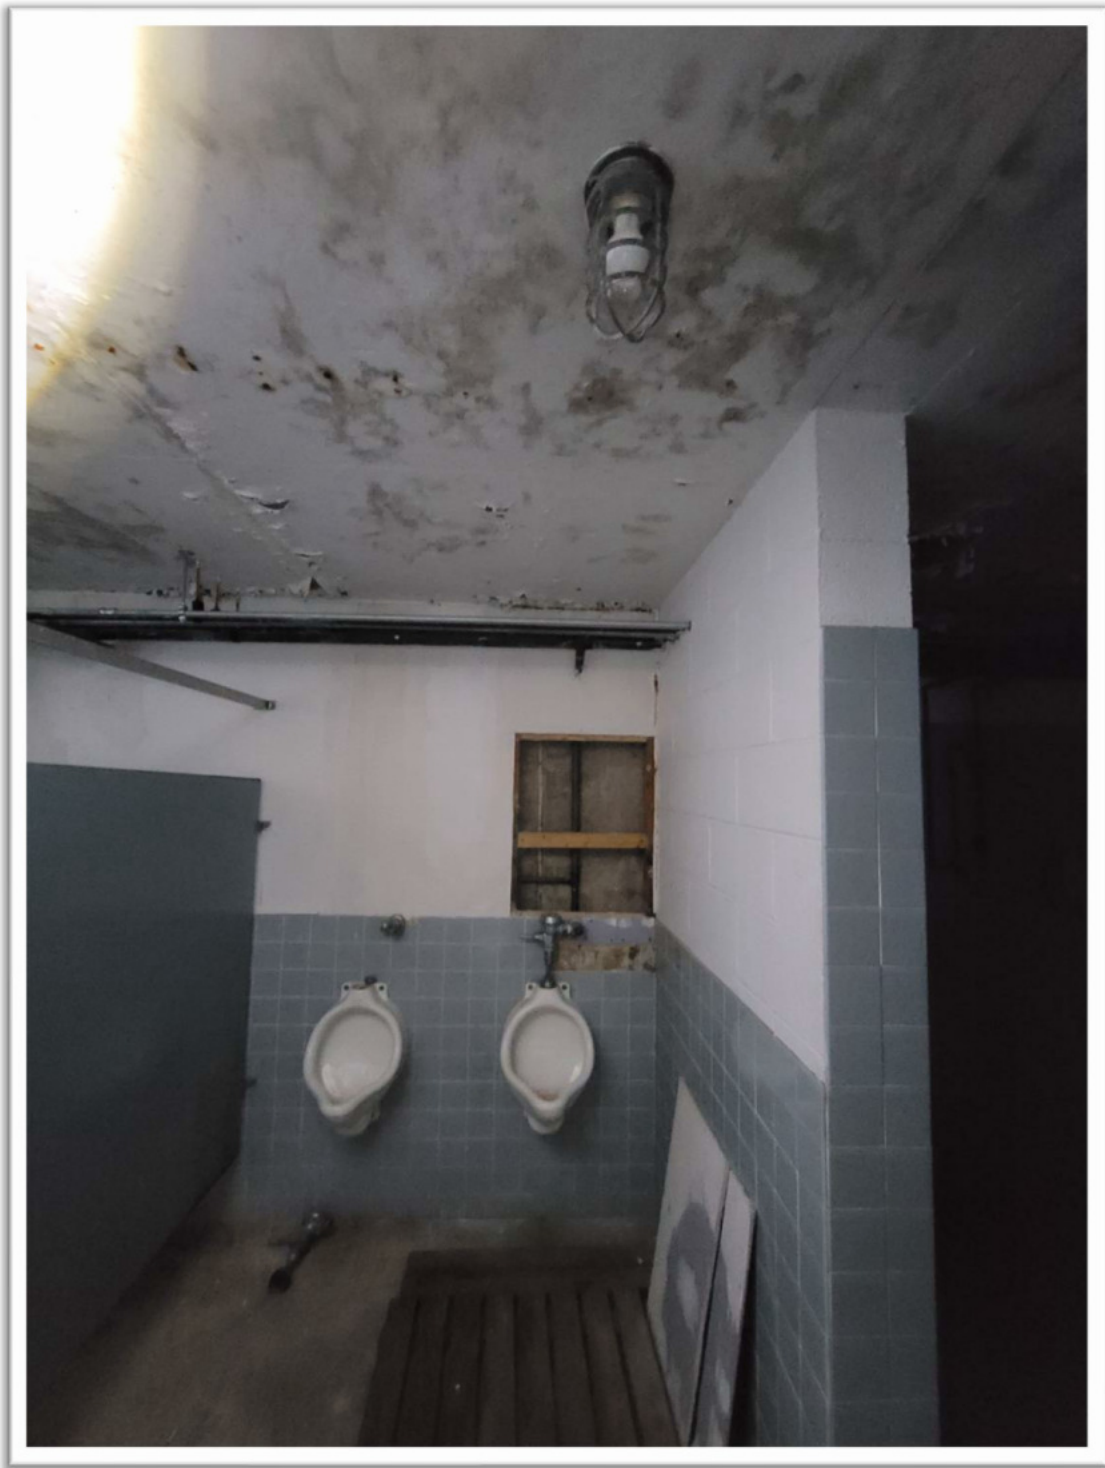
Figure 3.31 - Mold through the ceiling due to high moisture content.

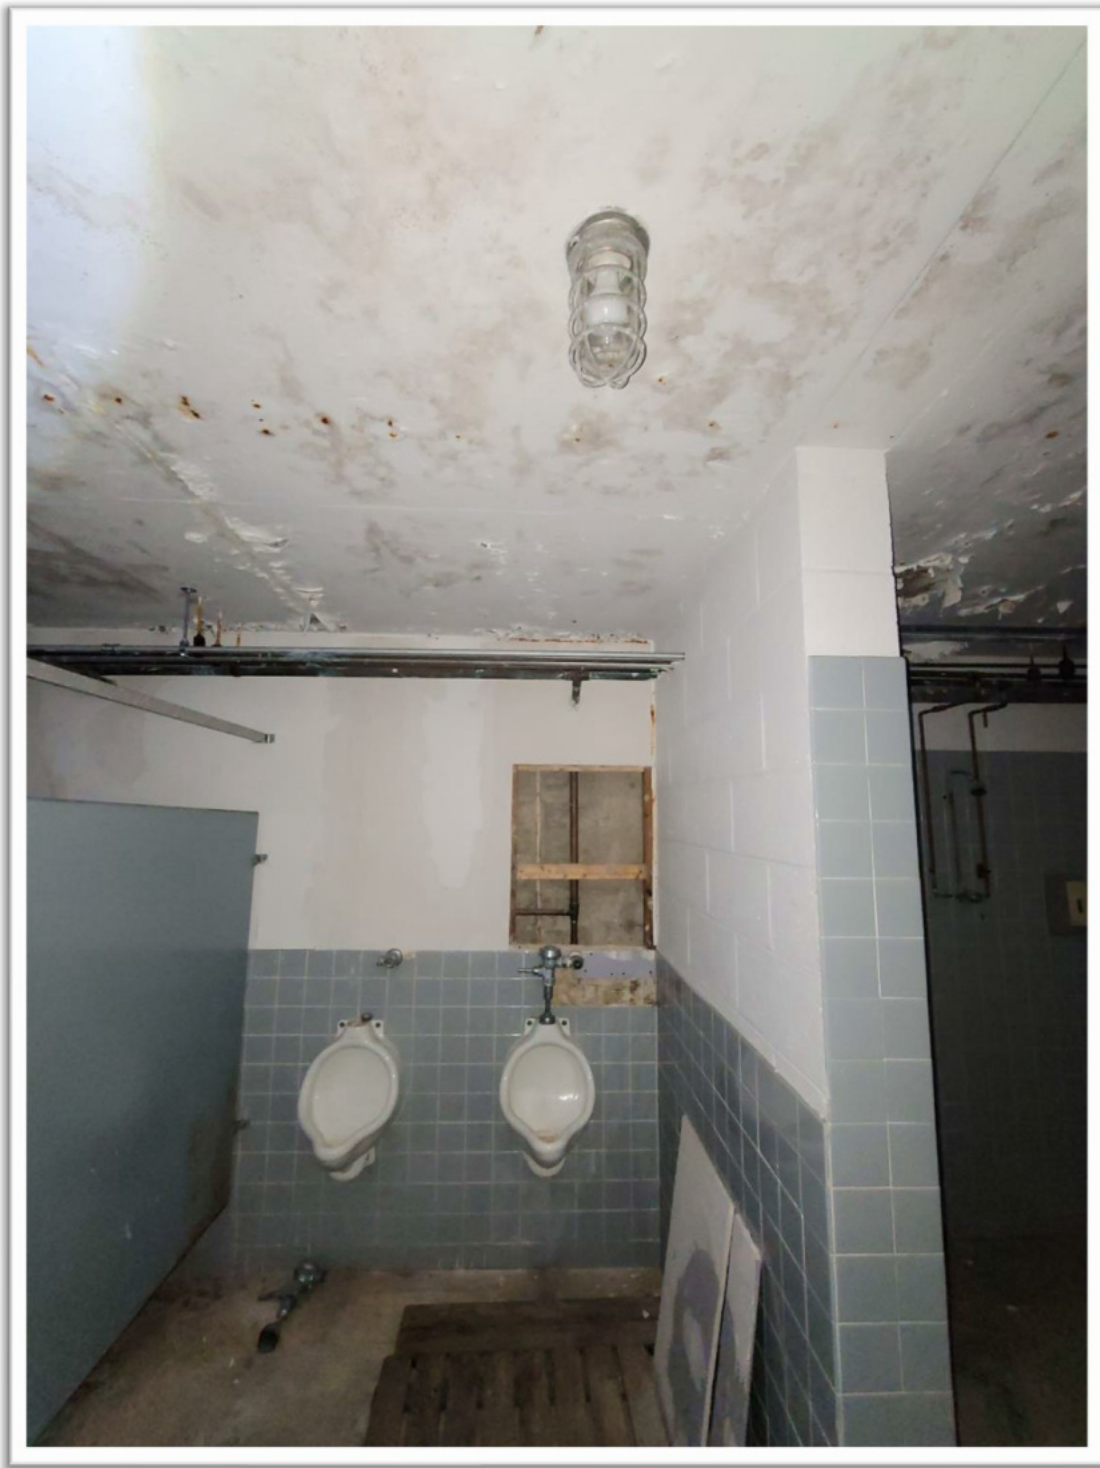
Figure 3.32 - Mold through the ceiling due to high moisture content.

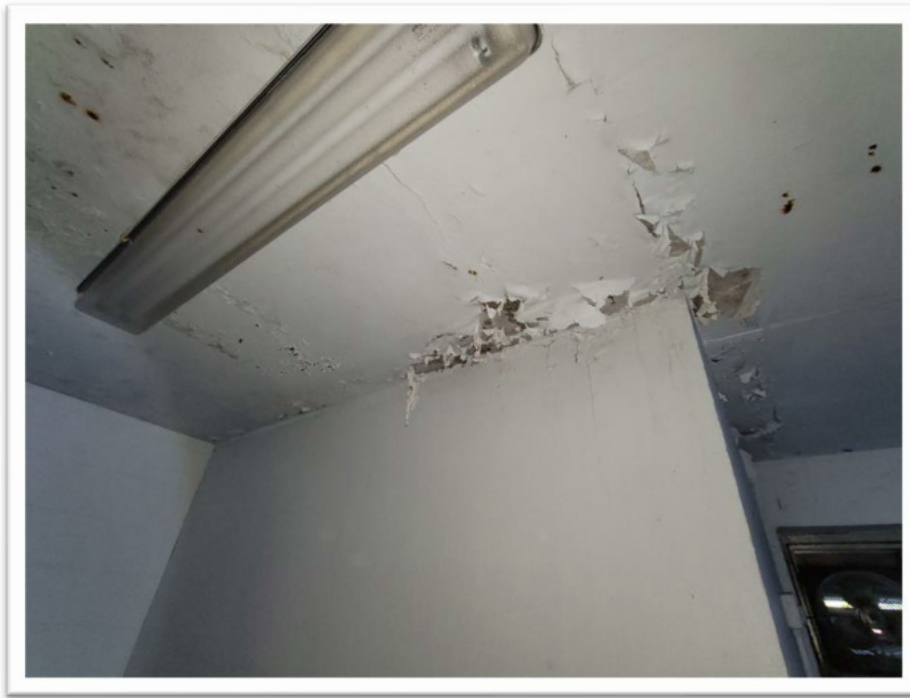
Figure 3.35 - Peeled painting through the ceiling from moisture damage.

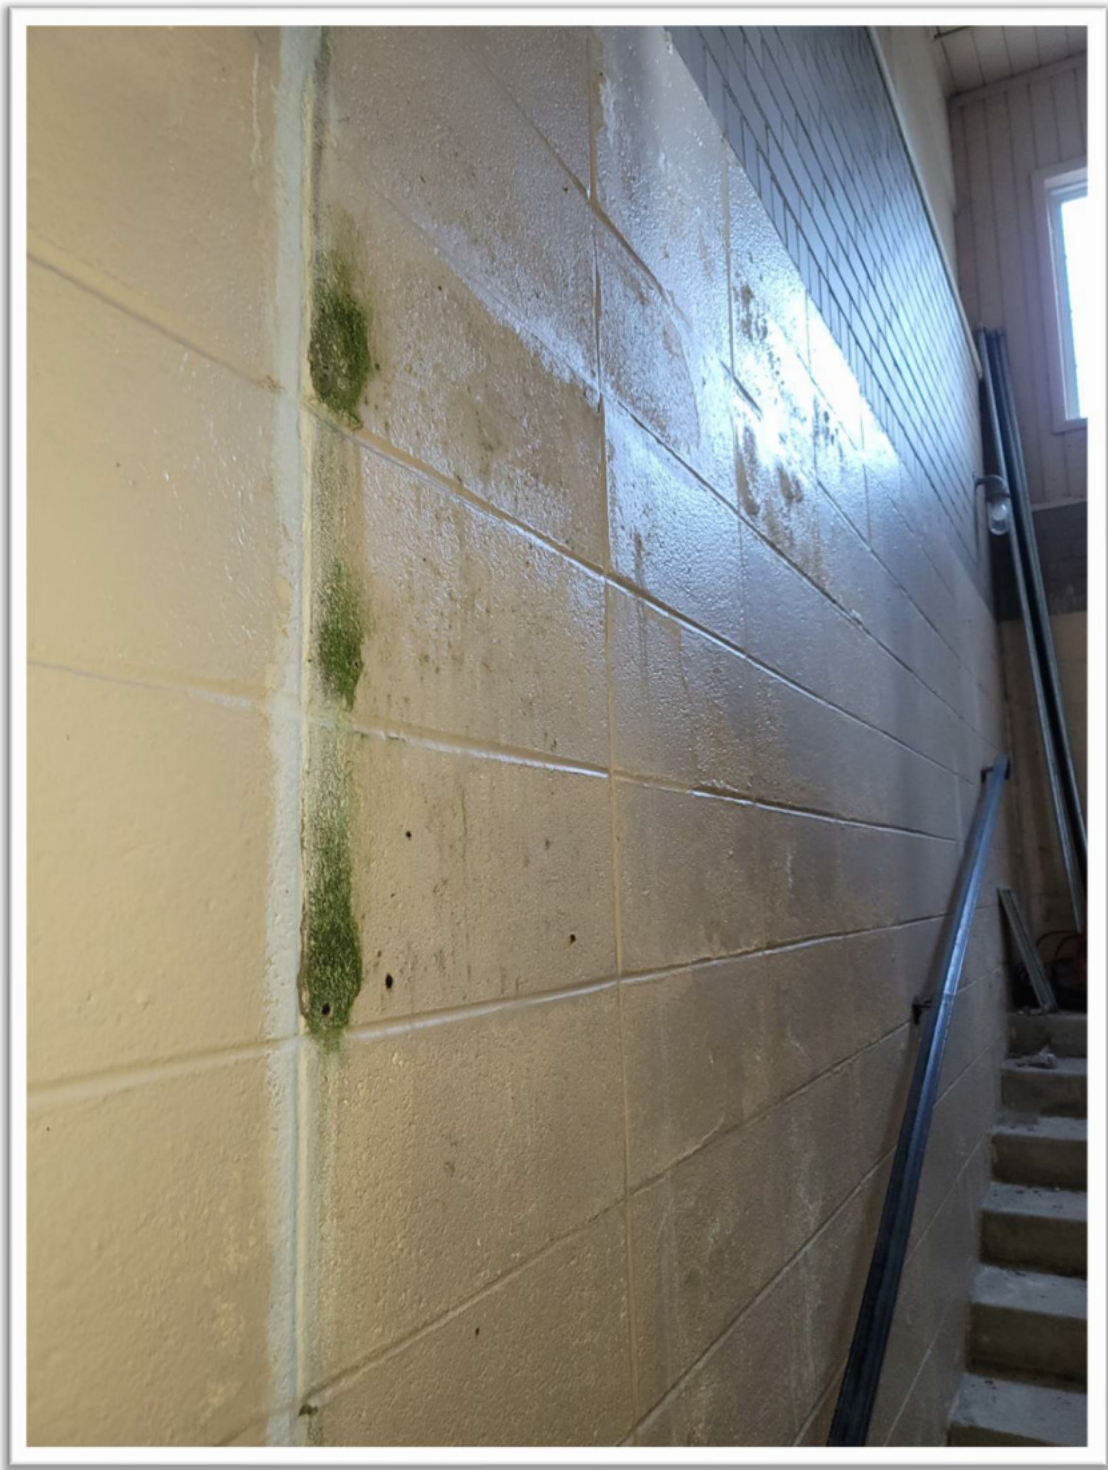
Figure 3.37 - Moisture stains.

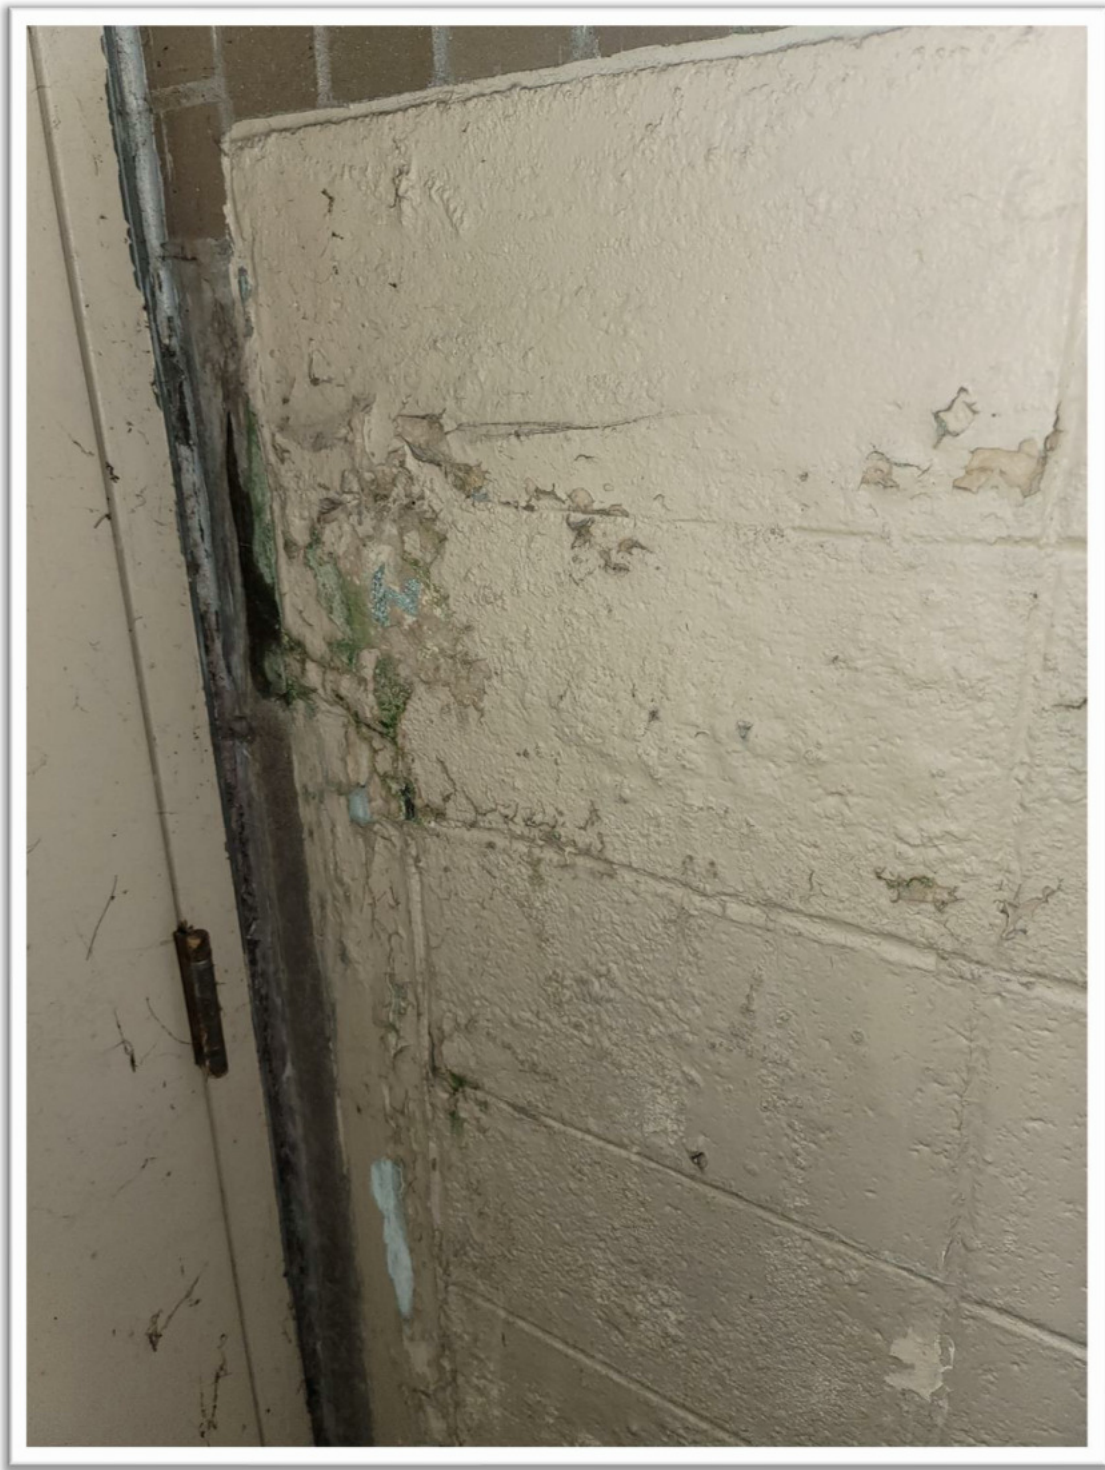
Figure 3.38 - Efflorescence deposits and moisture stains..

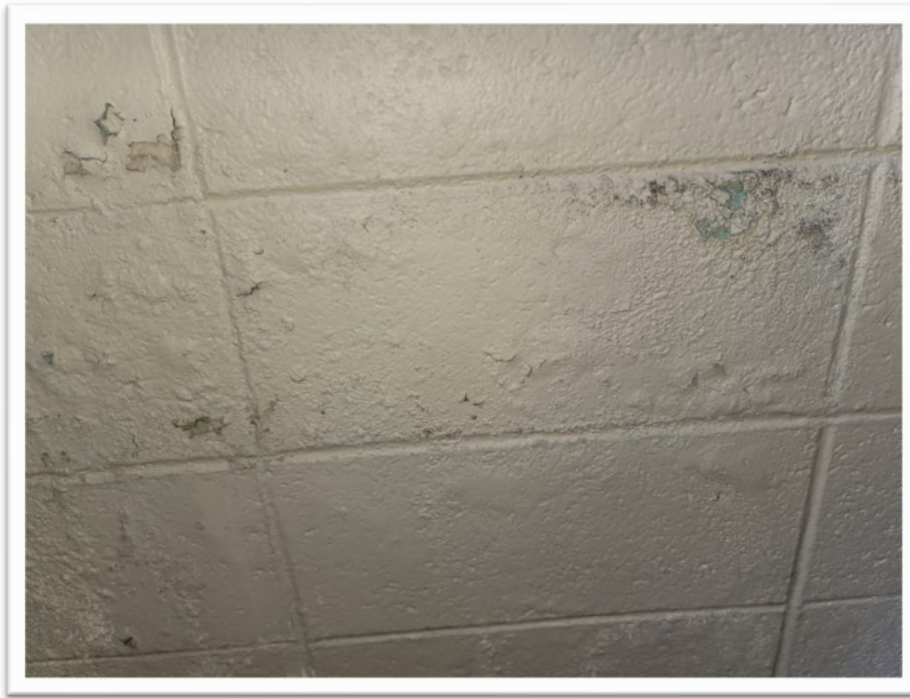
Figure 3.39 - Peeled painting and efflorescence deposits.

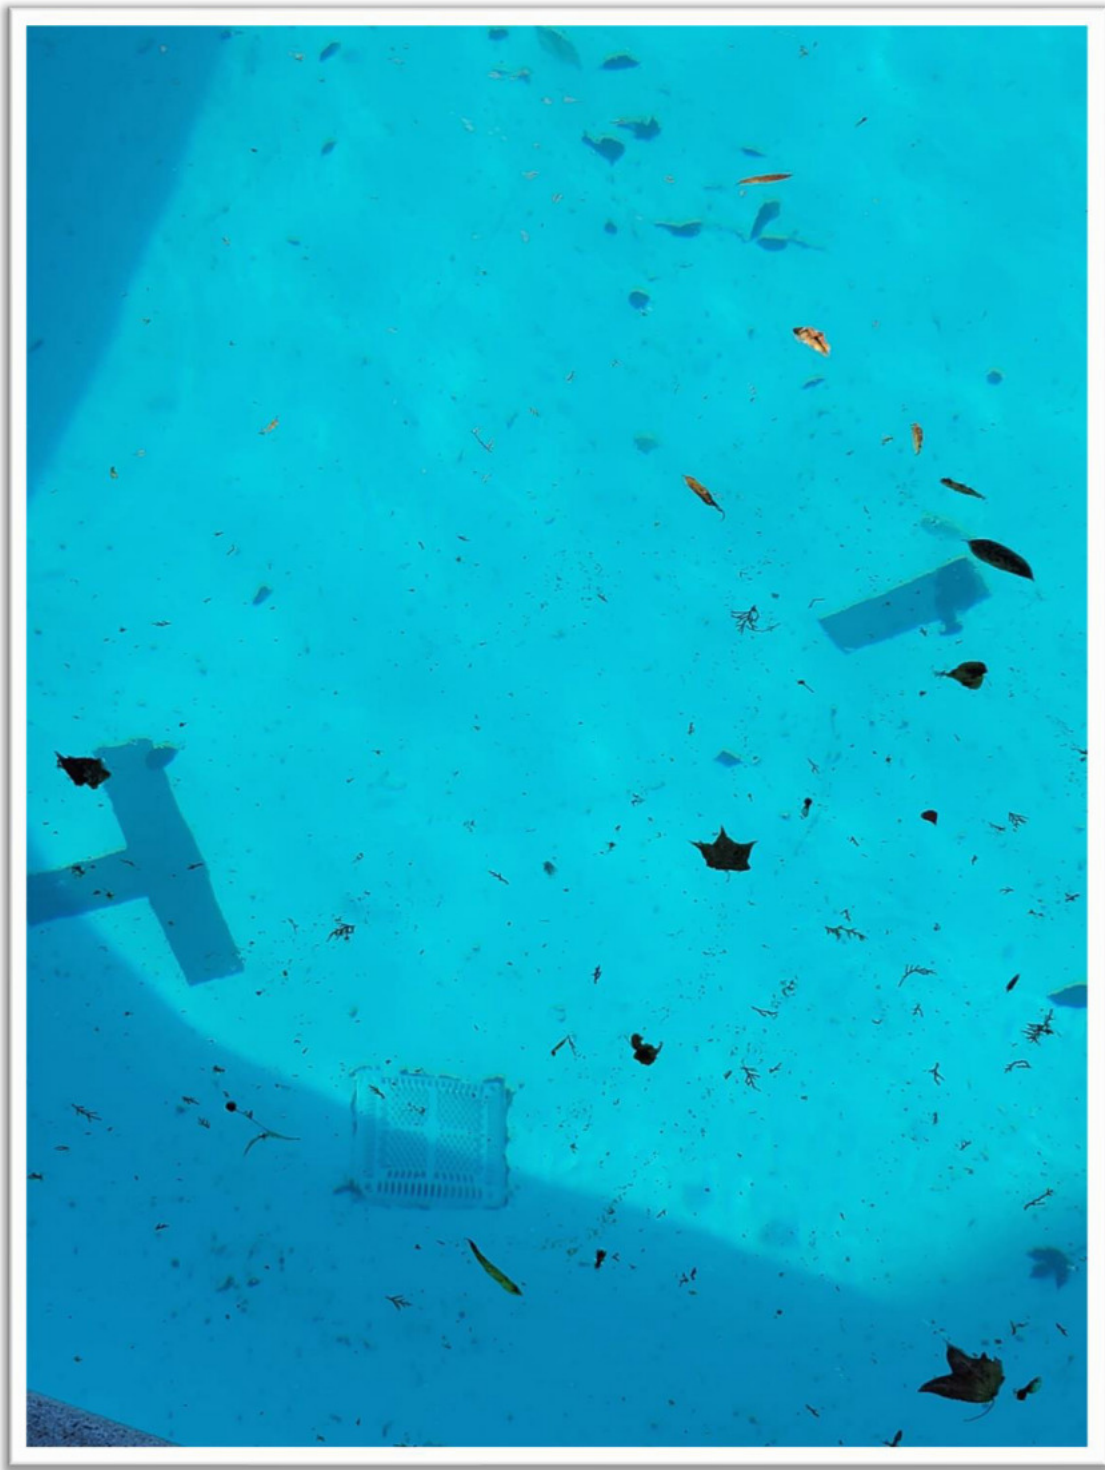
- c. We observed a few cracks in the pool flooring. The condition can lead to water penetration underneath the slab, causing structural instability pool.
- d. We observed poor sealant around the coping. The condition can lead to water penetration underneath the deck slab, causing local settlement cracks around the deck slab.

Figure 4.9 - Cracks in the pool flooring.

- It is highly recommended to further investigate the bottom of the pool via a pool inspector.
- It is required to reduce the water elevation in the pool to complete the repairs. It is highly recommended to remove the peeled parts of the walls and re-paint/re-seal them.
- Complete resealing of the coping with high elasticity modulus Polyurethane-Epoxy material. Kiro Engineering, LLC will review the sealing products at no additional costs.

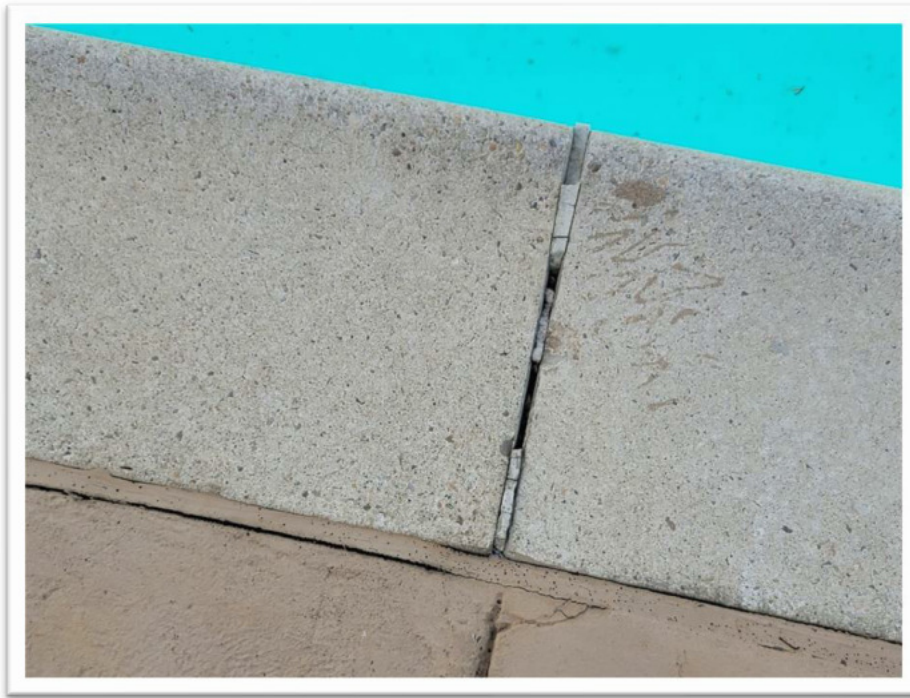
Figure 4.10 - Poor Sealant around the coping.

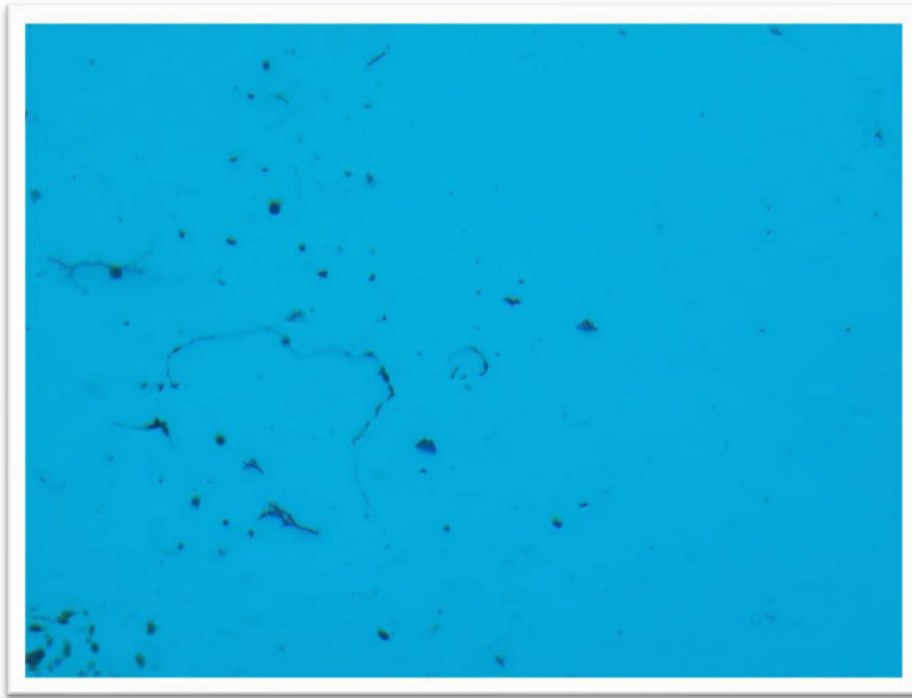
Figure 4.12 - Cracks in the pool flooring.

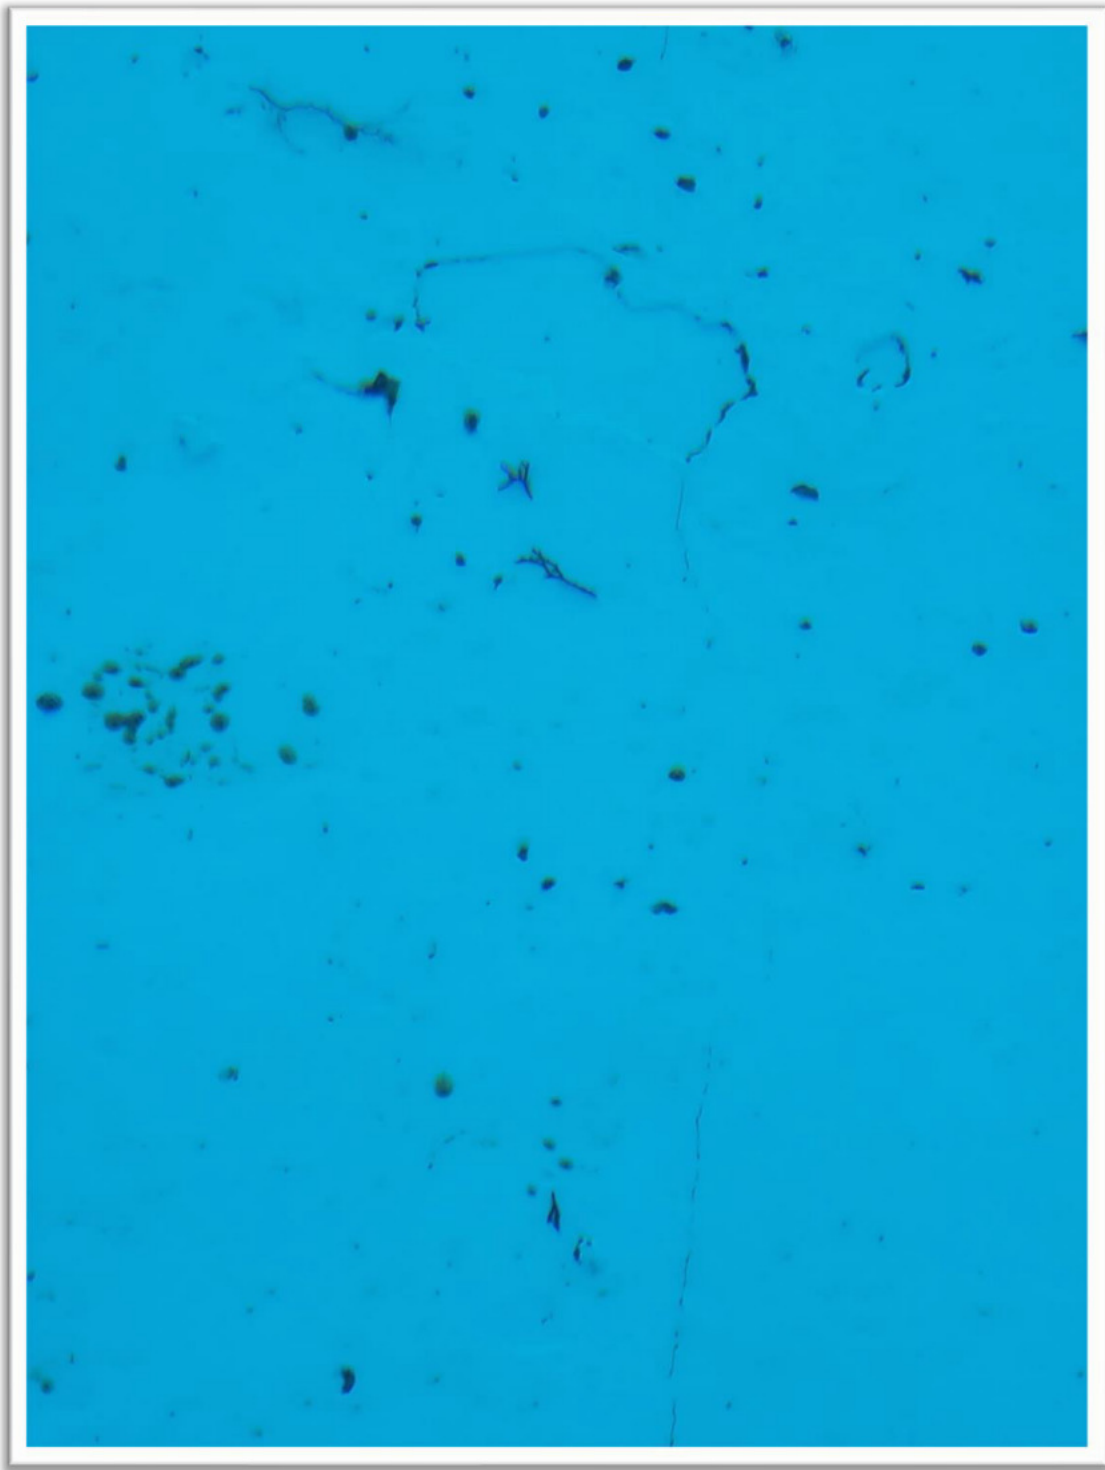
Figure 4.13 - Cracks in the pool flooring.
