**Re: Structural Assessment at:**  
2401 Pennsylvania Ave.  
Wilmington DE 19806

# Structural Assessment Report

Prepared for:  
Stacey Temple  
Devon Condominium  
2401 Pennsylvania Ave.  
Wilmington DE 19806

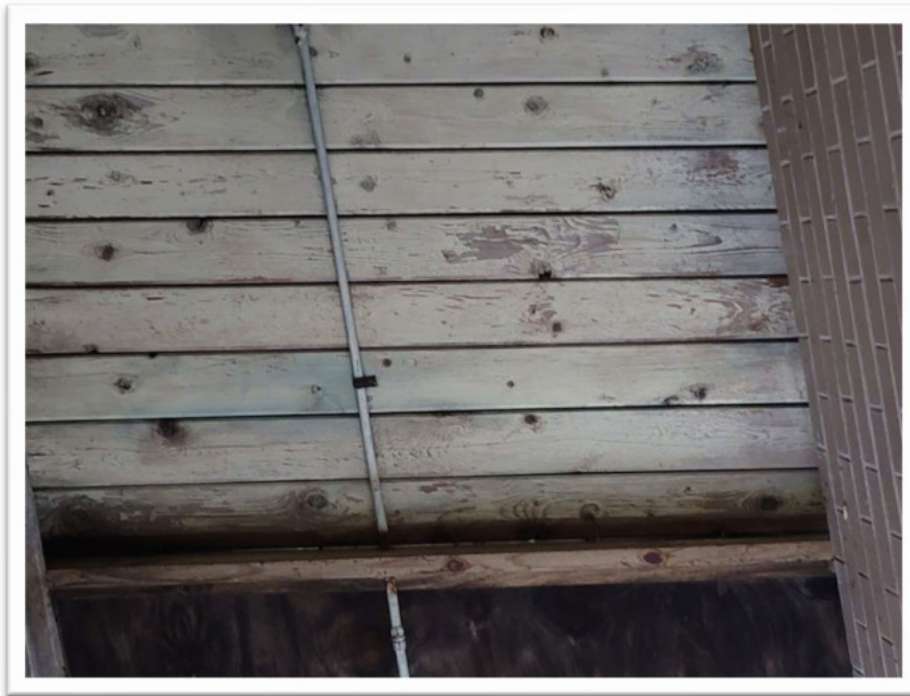
- d. The moisture and leakage caused mold and air quality.
- e. The moisture and leakage caused minor to moderate damage to the wall and slab. We noticed soft and wet spots and other spots with easily punched concrete.
- a. The concrete ceilings have moderate to severe concrete spalling and other spots with severe crumbling surfaces. Parts of the ceiling reinforcement are exposed and severely corroded after the concrete covering spalling away.
- f. Efflorescence (white powdery deposits) visible on the surface of the foundation walls is an indication of moisture intrusion all over the perimeter of the rooms. Efflorescence can also damage materials and encourage the growth of microbes such as mold.
- g. The moisture and leakage caused moderate to severe wood decay and rot to the interior roof cover and rotted roof joists.

Figure 2.18 - Rotted roof joist.

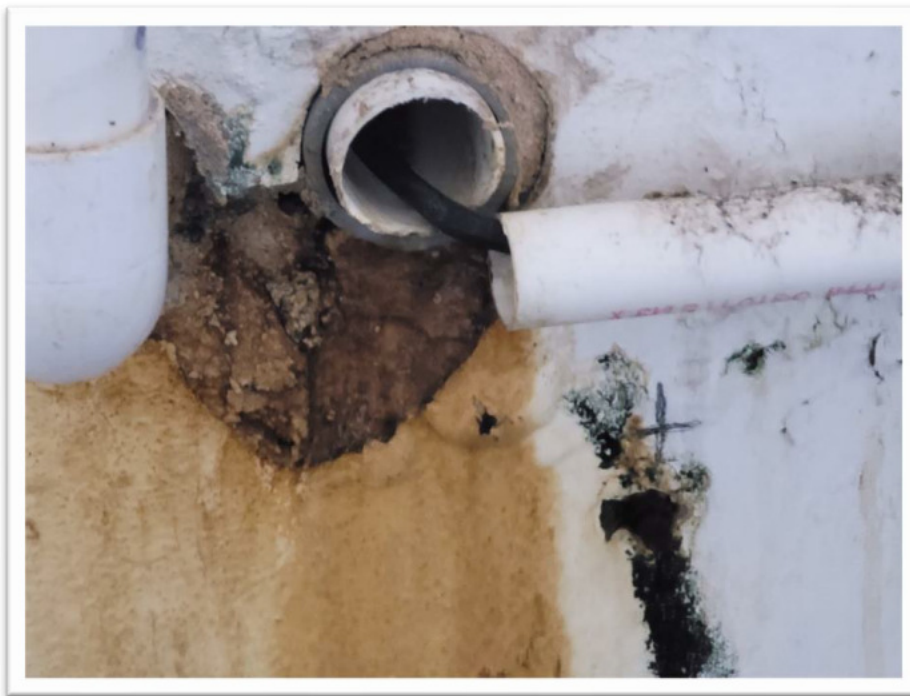
- a. The overall structural condition of the exterior is poor.
- b. The plumbing system is in very poor condition, with severe leakage points and loose plumbing connections all over the rooms. The plumbing system is beyond repair and must be replaced.

Figure 3.3 - Severe leakage damage.

- Remove the efflorescence deposits, wall tiles, and peeled paints, and wash the walls with bleach before starting any repairs.
- Change all the plumbing systems, including all the plumbing connections through the walls.

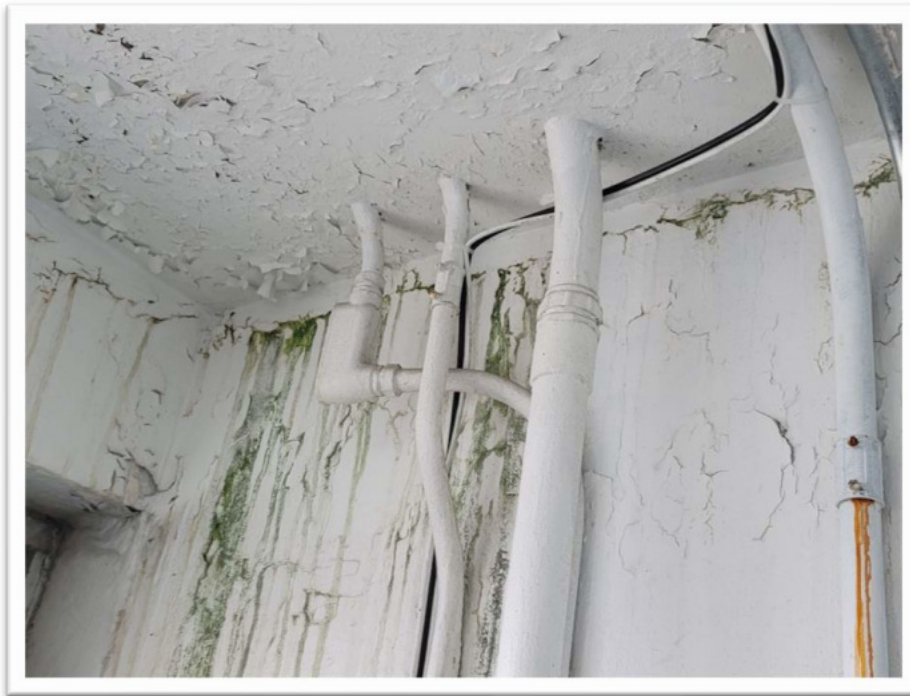
- c. The severe leakage and moisture caused the wall paint to peel all over the rooms.
- d. The moisture and leakage caused mold and air quality issues all over the rooms.

Figure 3.4 - Peeled painting due to severe moisture damage from leakage.

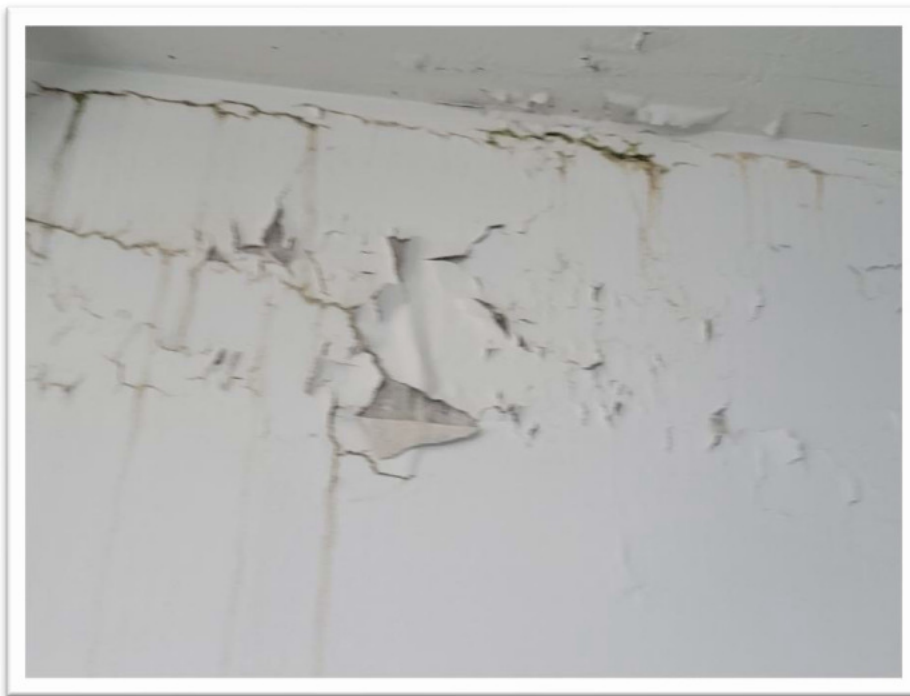
Figure 3.5 - Peeled painting due to severe moisture damage from leakage.

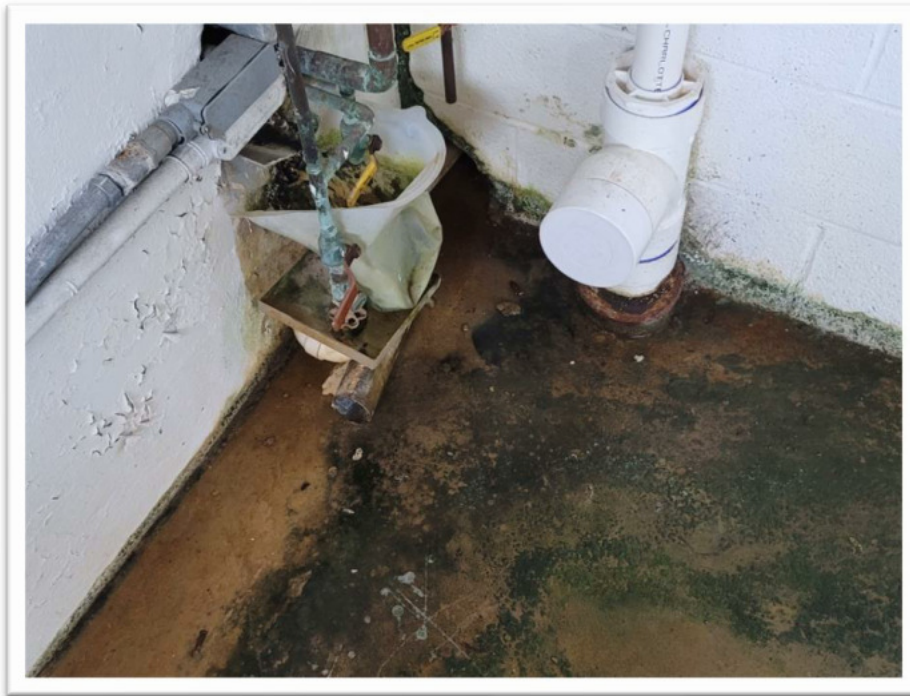
Figure 3.7 - Poor plumbing connections causing water damage to the slab.

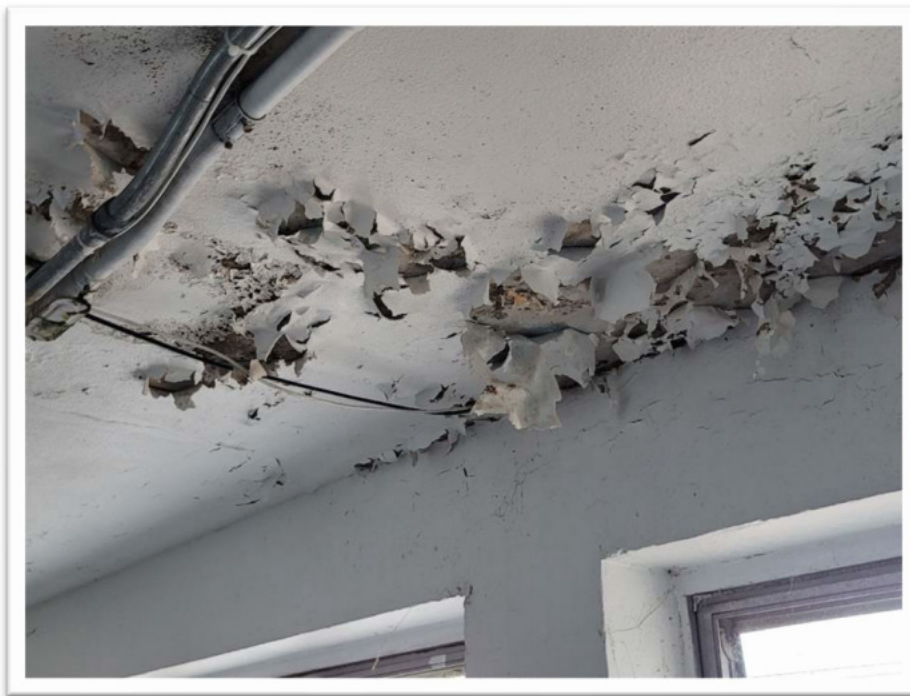
Figure 3.8 - Peeled painting due to severe moisture damage from leakage.

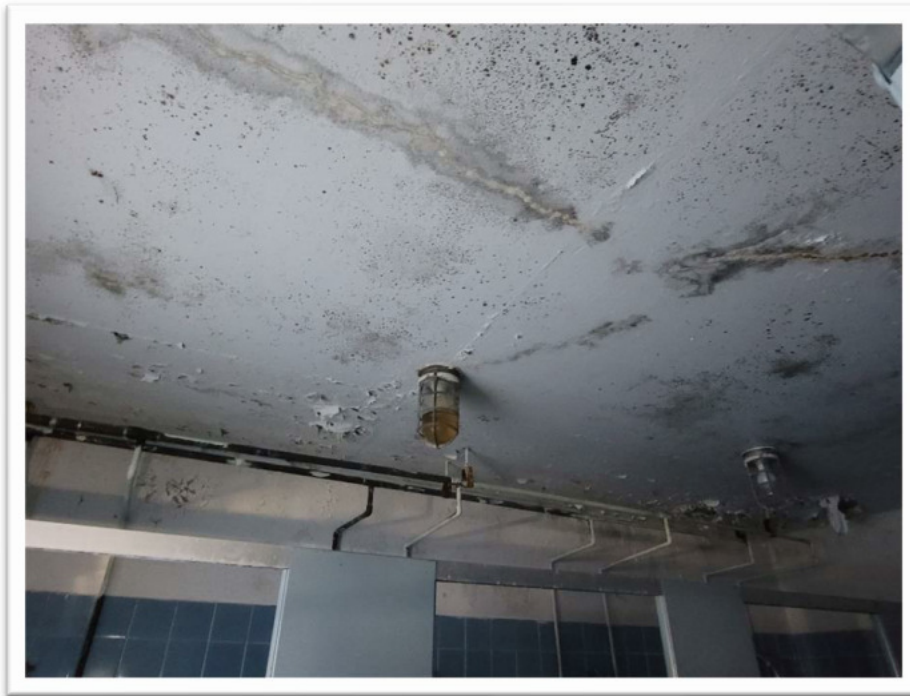
Figure 3.11 - Moisture damage and mold.

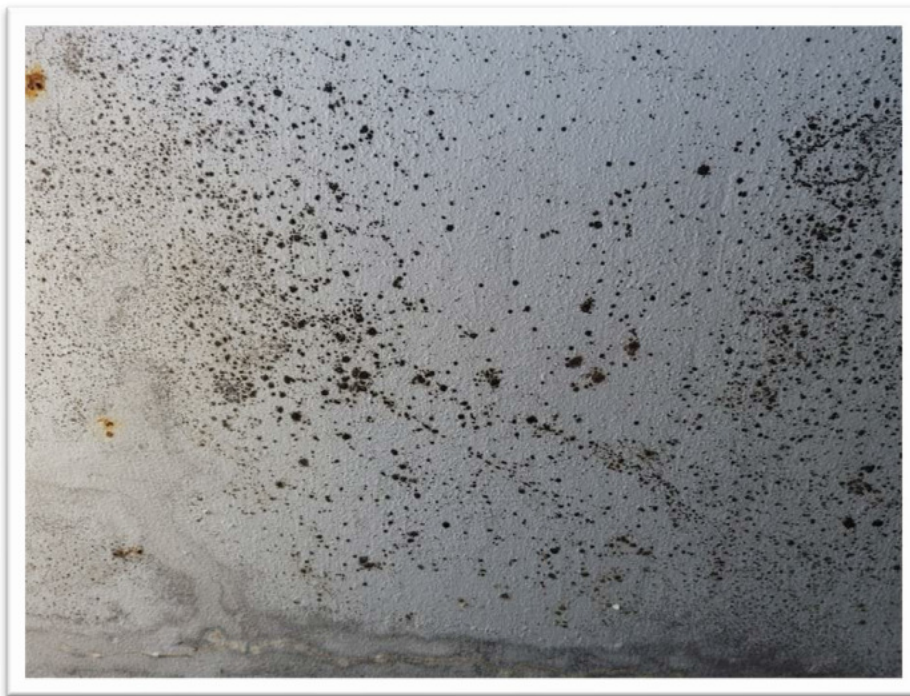
Figure 3.12 - Moisture damage and mold.

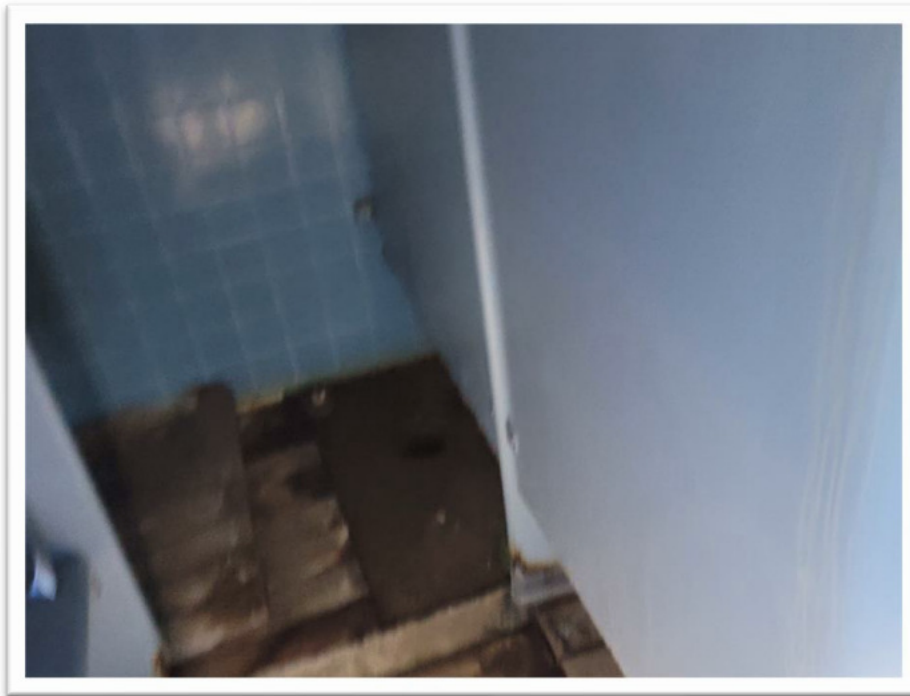
- e. The moisture and leakage caused severe damage to the wall tiles and slab. We noticed many soft and wet spots and other spots with easily punched concrete.

Figure 3.13 - Water damage to the floors.

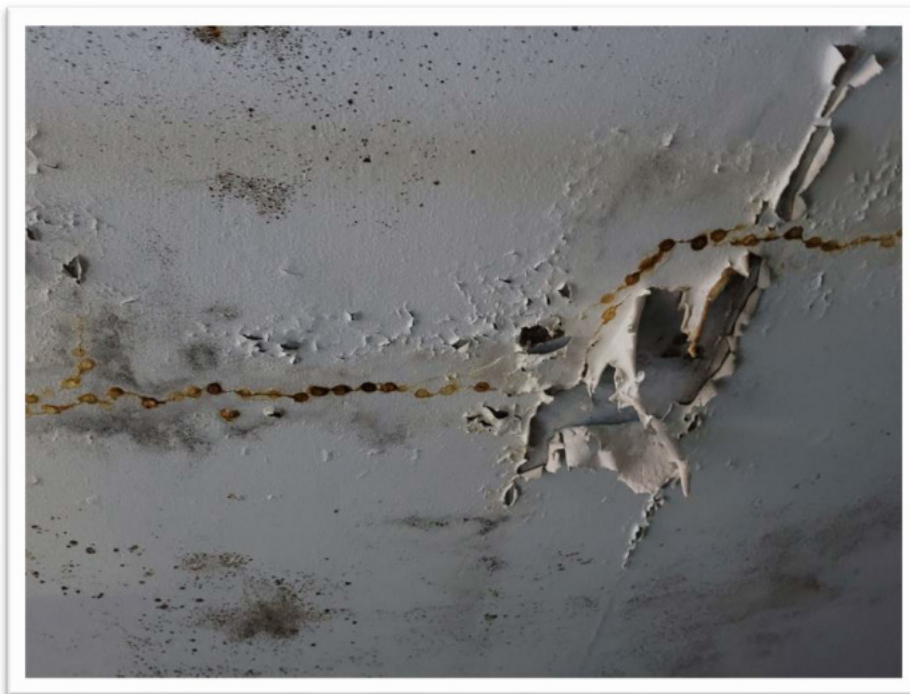
Figure 3.14 - Moisture damage, peeled painting and mold.

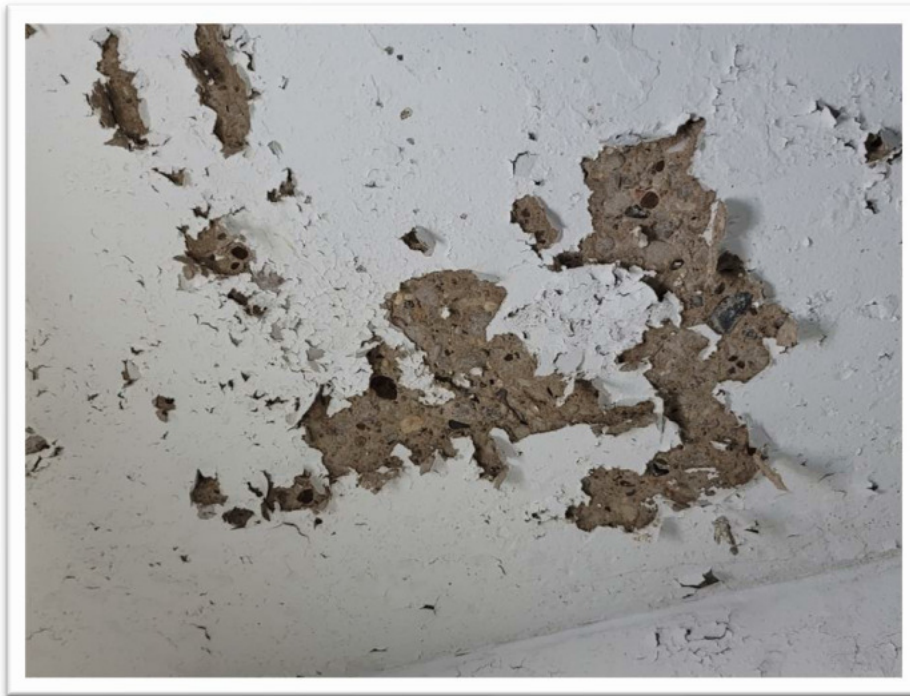
Figure 3.15 - Peeled painting and exposed concrete surface.

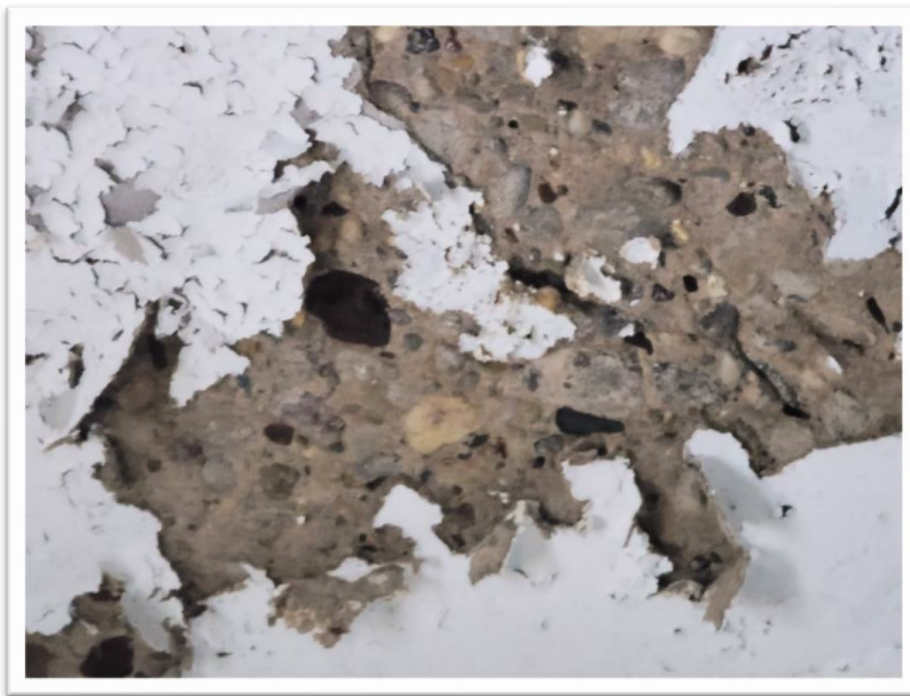
Figure 3.16 - Peeled painting and exposed concrete surface.

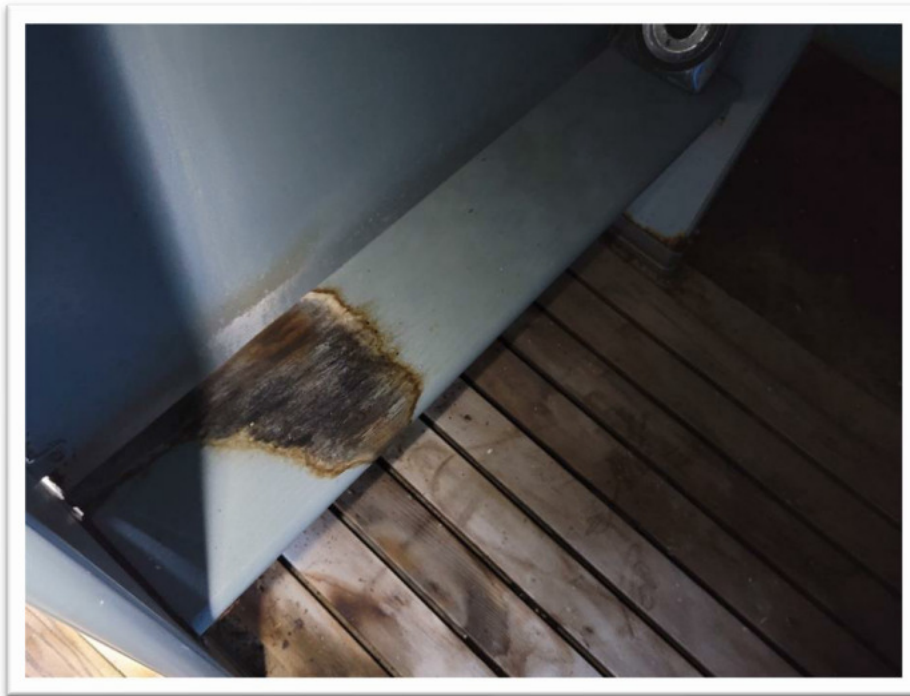
- h. The moisture and leakage caused moderate to severe wood decay and rot to the interior and exterior wooden members, including partitions and structural posts.

Figure 3.17 - Moisture and Rot Damage.

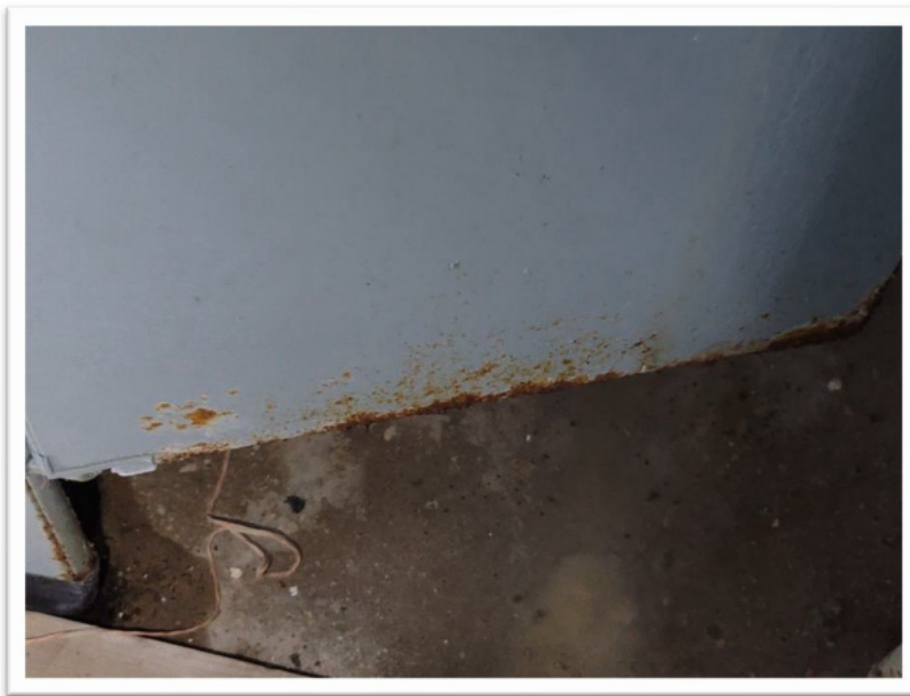
Figure 3.18 - Soft concrete and easily punched slab.

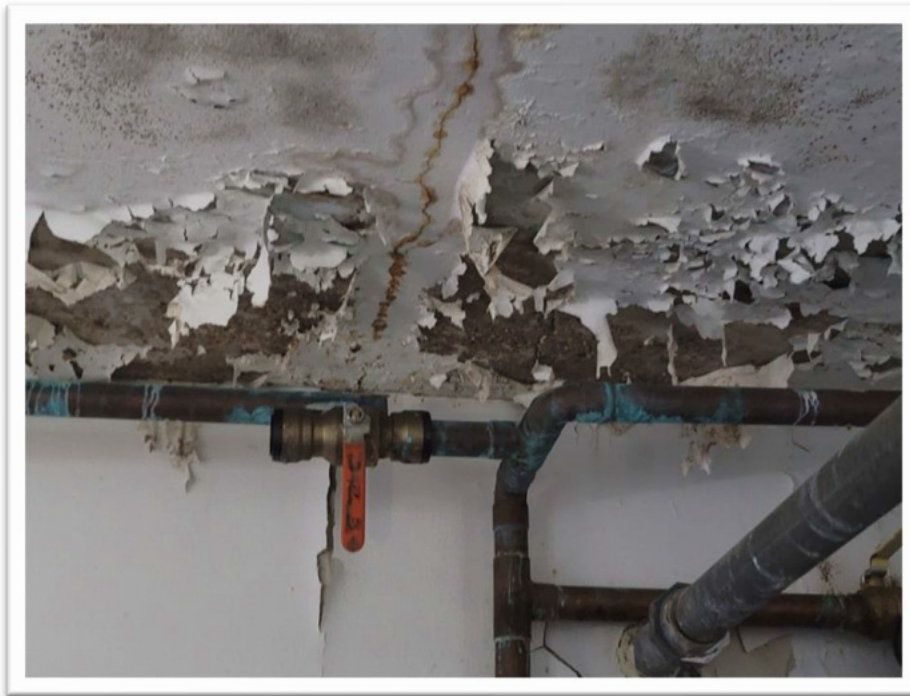
Figure 3.19 - Peeled painting and exposed concrete surface.

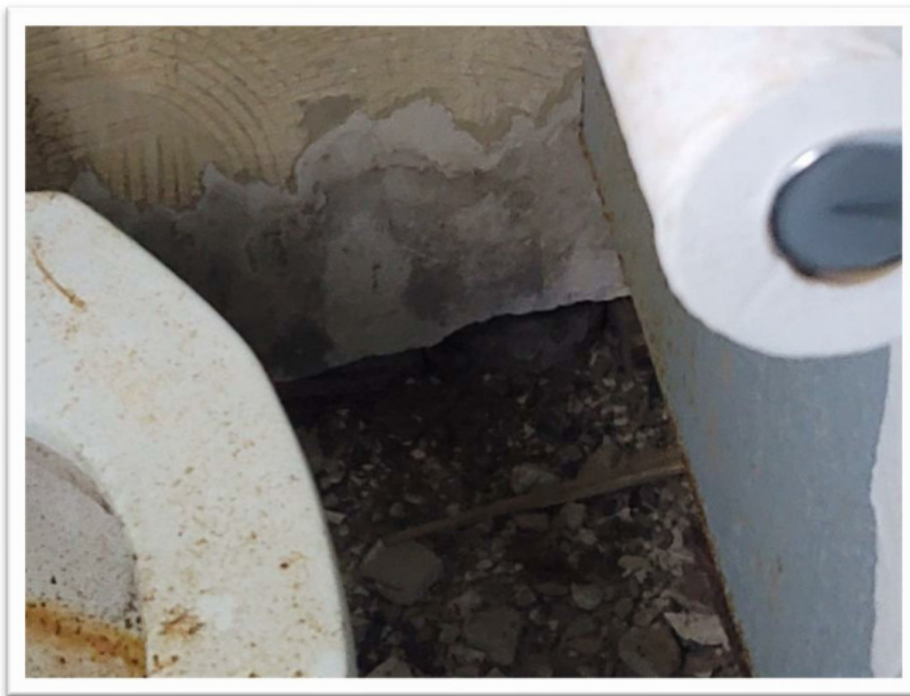
Figure 3.20 - Damage to the floor slab.

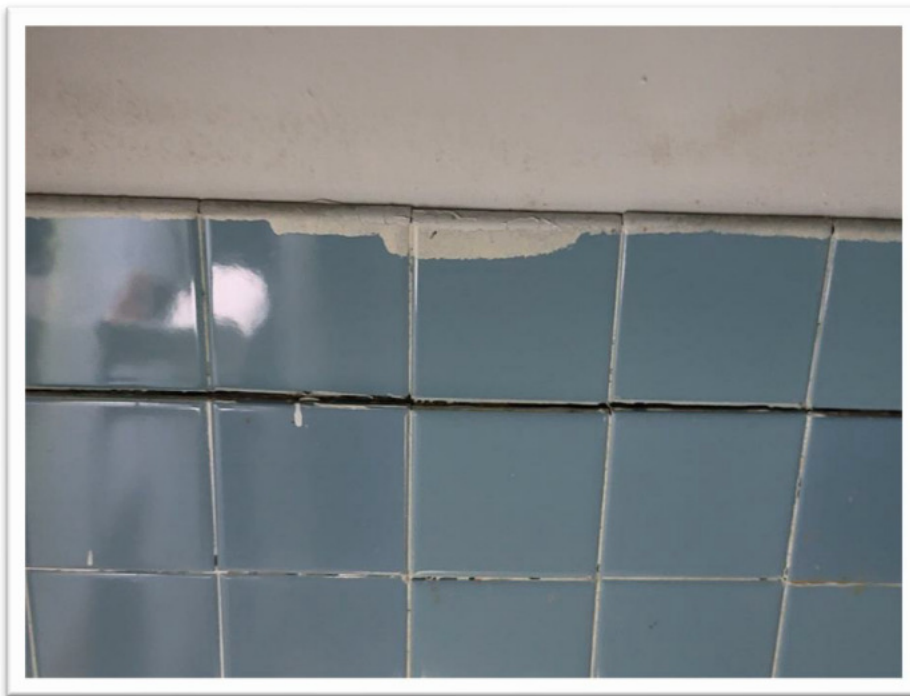
Figure 3.22 - Damage to the tile from the moisture.

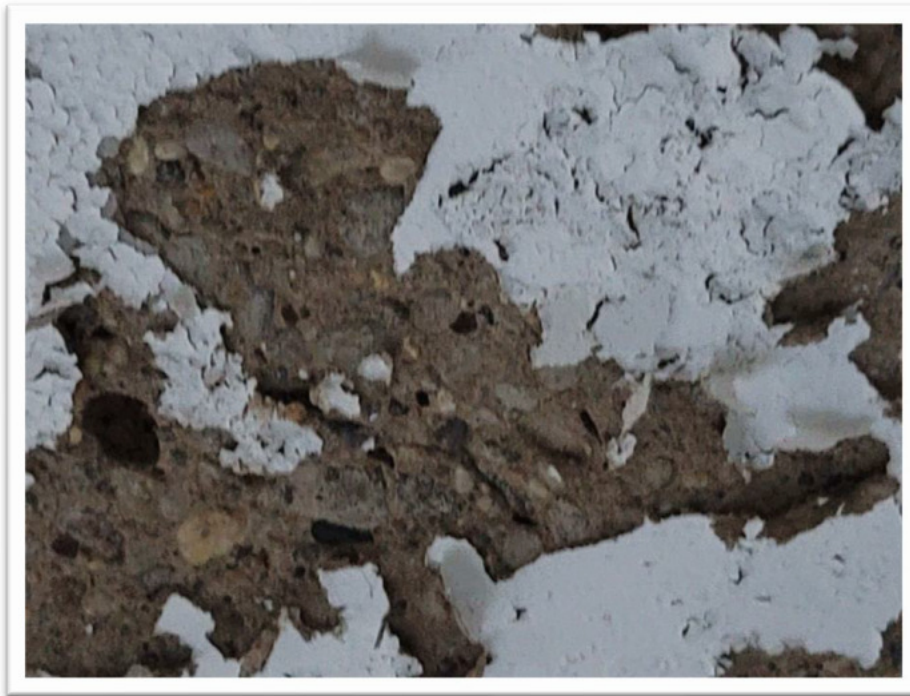
Figure 3.24 - Exposed concrete surface due to moisture damage.

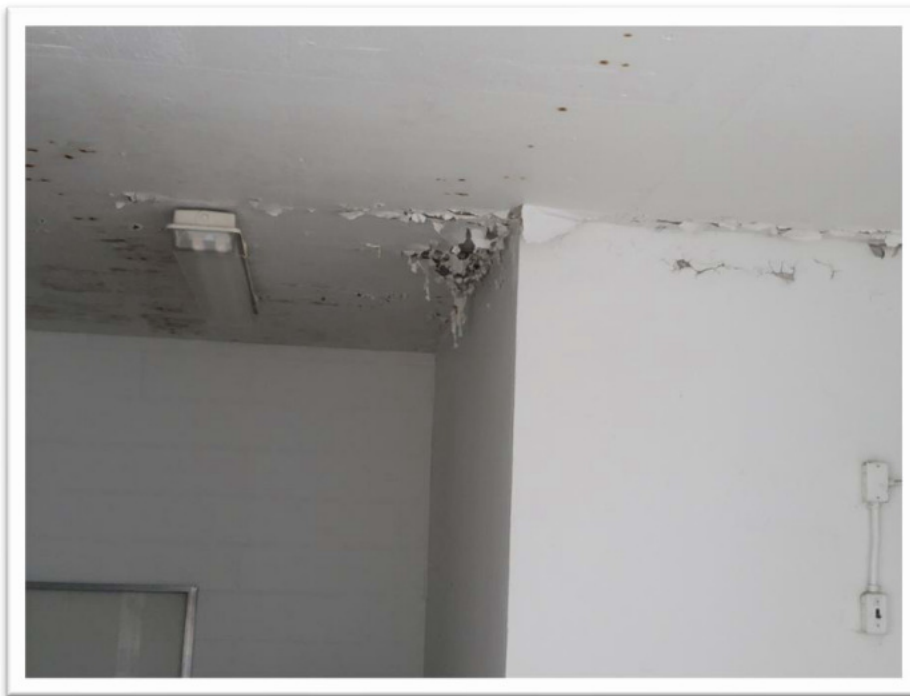
Figure 3.29 - Peeled painting through the ceiling from moisture damage.

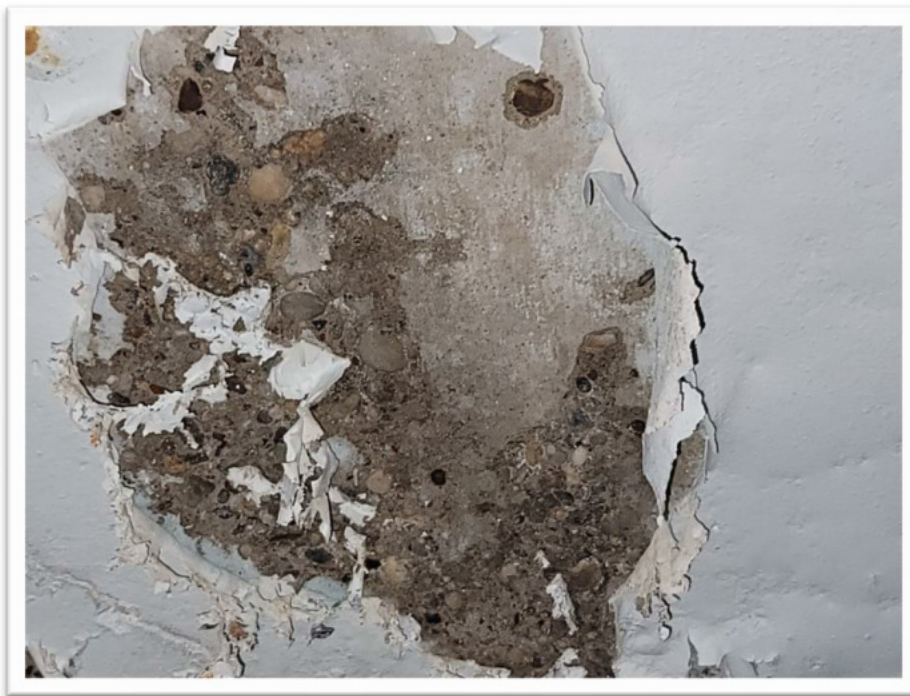
- f. The concrete ceilings have moderate to severe concrete spalling and other spots with severe crumbling surfaces. Parts of the ceiling reinforcement are exposed and severely corroded after the concrete covering spalling away.

Figure 3.34 - Exposed and spalling concrete surface due to moisture damage.

- Clean the exposed reinforcement rebars, remove the rusted parts using a wire brush and high-pressure water, and use sandblasting if needed. Paint the exposed rebars with epoxy-supported sealants. Kiro Engineering, LLC will review the Contractor's means and methods at no additional cost.

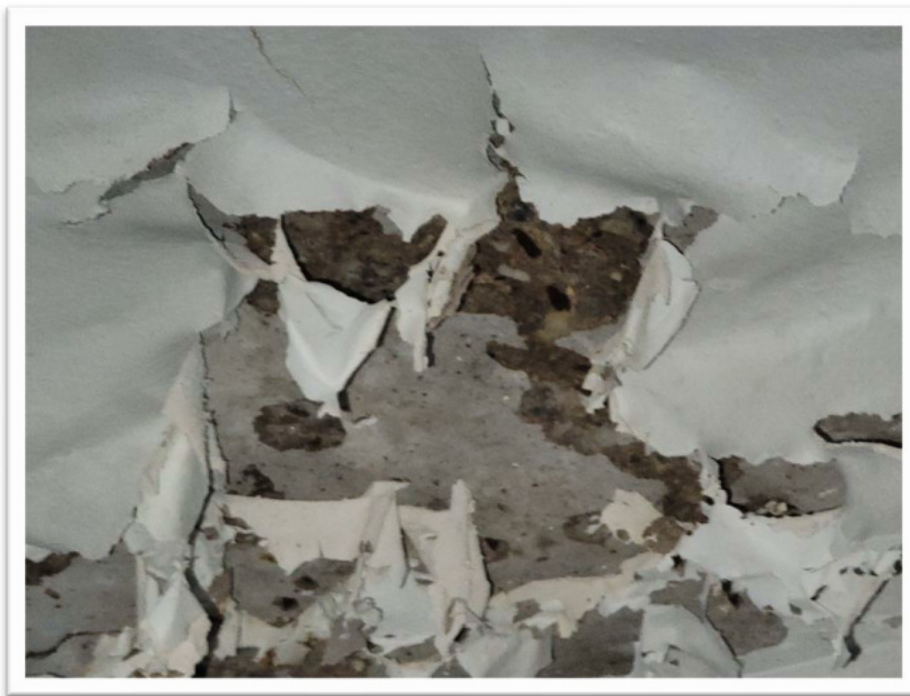
Figure 3.36 - Exposed and spalling concrete surface due to moisture damage.

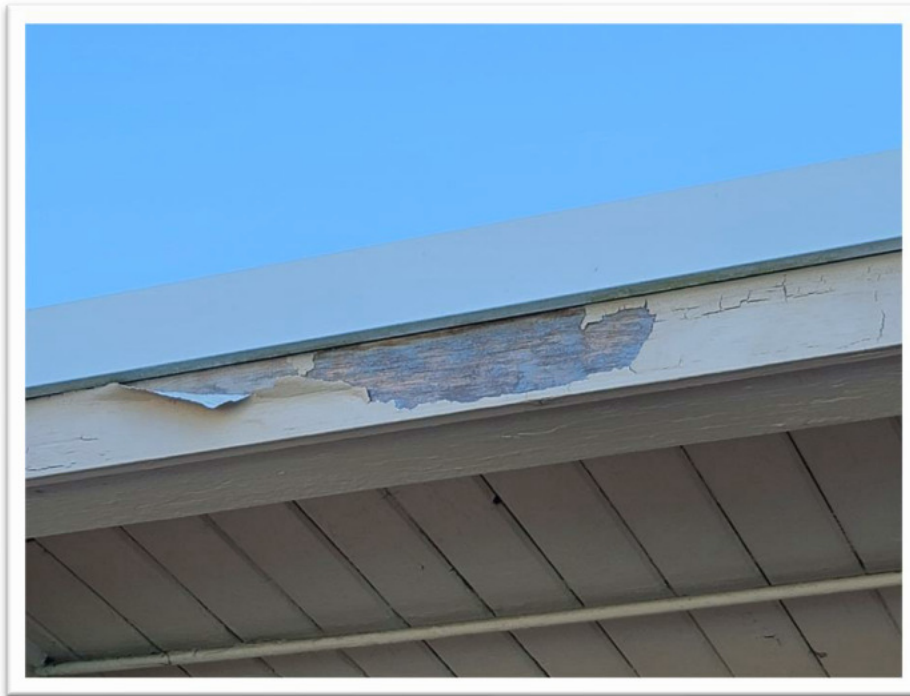
Figure 3.42 - Peeled painting to the fascia beam.

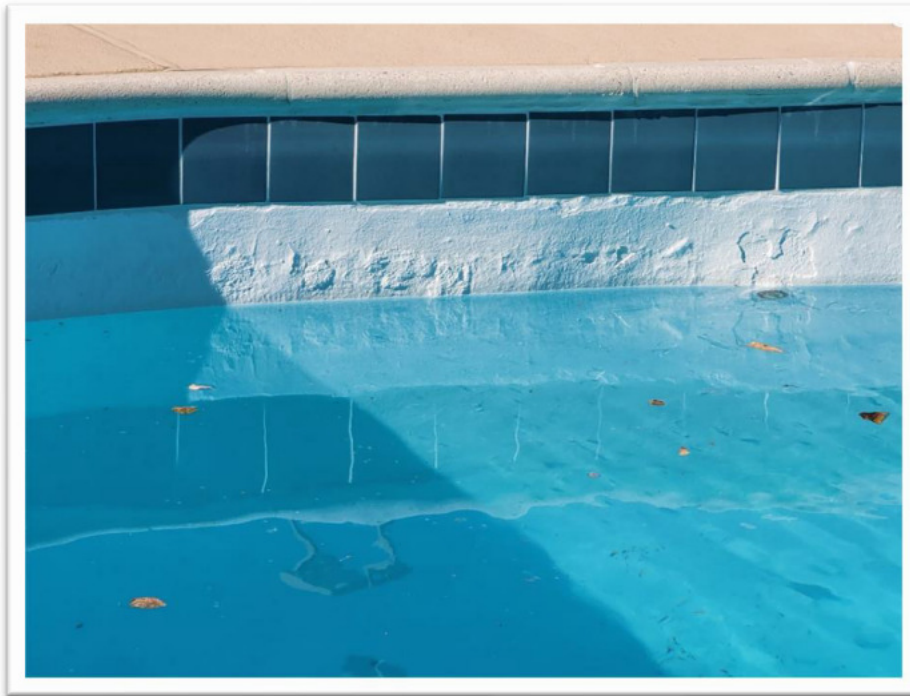
Figure 4.6 - Poor waterline tiles and peeled pool walls.

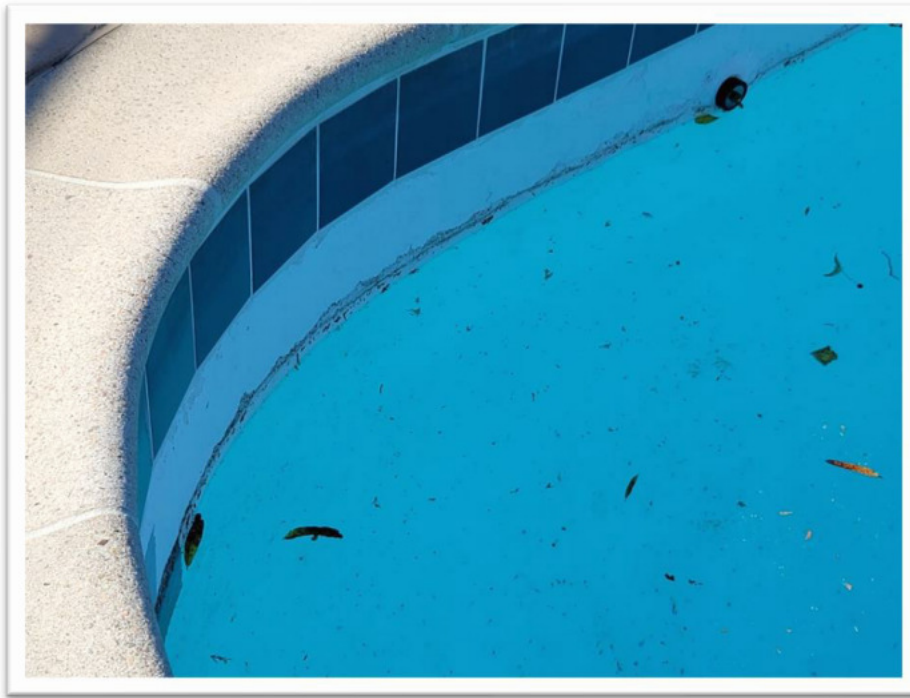
Figure 4.8 - Poor waterline tiles and peeled pool walls.
