**Re: Structural Assessment at:**  
2401 Pennsylvania Ave.  
Wilmington DE 19806

# Structural Assessment Report

Prepared for:  
Stacey Temple  
Devon Condominium  
2401 Pennsylvania Ave.  
Wilmington DE 19806

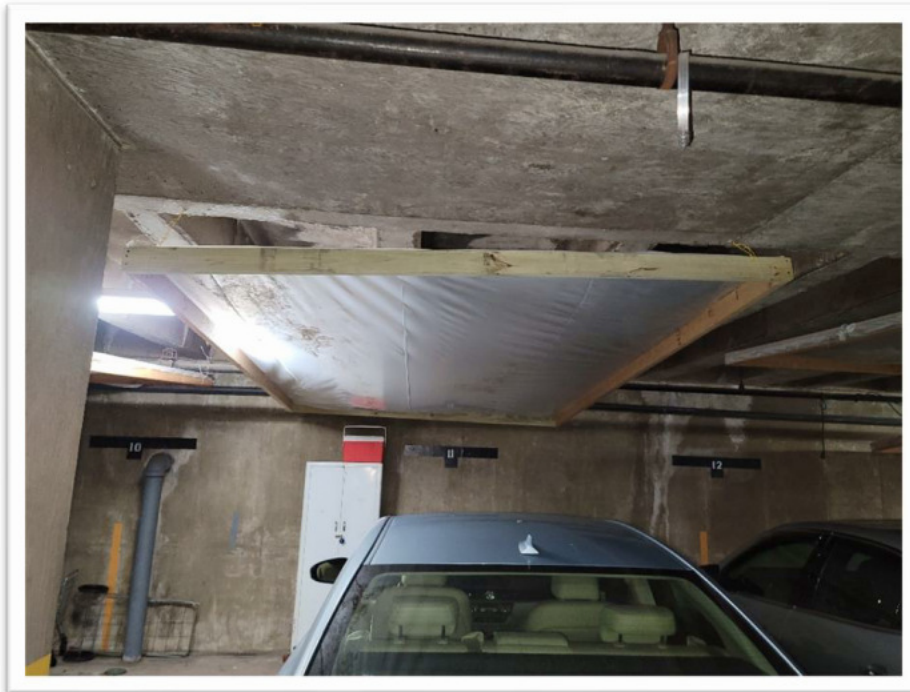
- a. The overall structural condition of the exterior is accepted.
- b. The sprinkler system is in poor condition, with severe leakage points above the vehicles. We noticed some owners used hanging plastic to cover their vehicles. The way they cover the vehicles are considered a falling hazard that can cause severe damage to cars if the cover can't handle the weight of the accumulated water.
- c. The concrete ceilings and beam girders have moderate to severe concrete spalling and other spots with severe crumbling surfaces. Parts of the ceiling reinforcement are exposed and severely corroded after the concrete covering spalling away.
- d. We noticed limited leakage by the boilers room. We were unable to gain access to the boilers room to further investigate the condition.

Figure 1.1 - Overhanging cover.

- Change all the sprinkler pipes systems, including all the plumbing connections through the garage, and remove any hanging cover
- Clean the exposed reinforcement rebars, remove the rusted parts using a wire brush and high-pressure water, and use sandblasting if needed. Paint the exposed rebars with epoxy-supported sealants. Kiro Engineering, LLC will review the Contractor's means and methods at no additional cost.

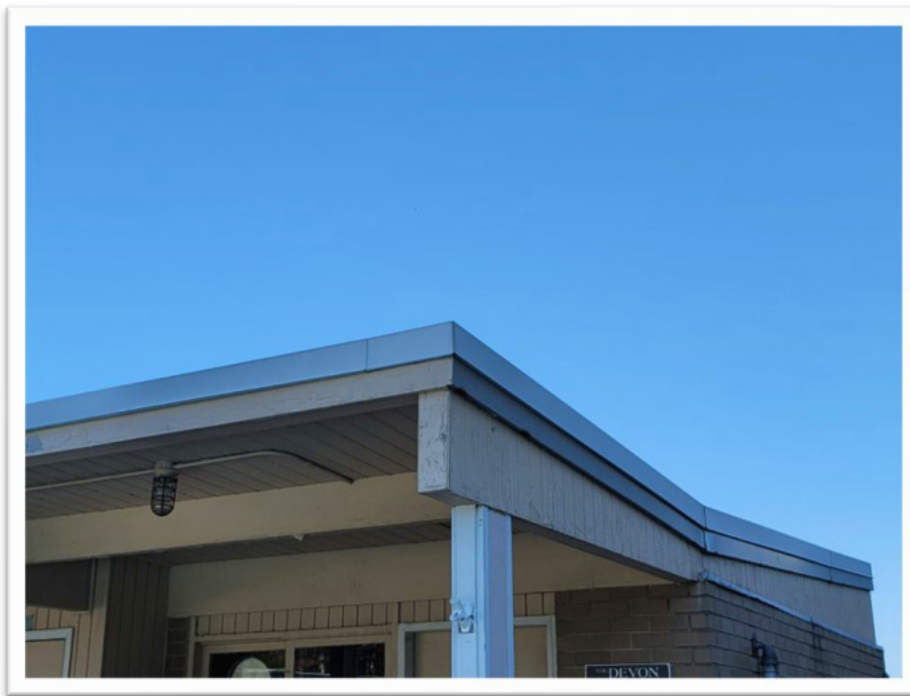
- i. The roof is a poor condition, including a poor drainage system that collects the water in the roof valley, leading to leakage problems (Figures 3.40 and 3.41).

Figure 3.40 - Poor roofing drainage.

Figure 3.41 - Poor roofing drainage.

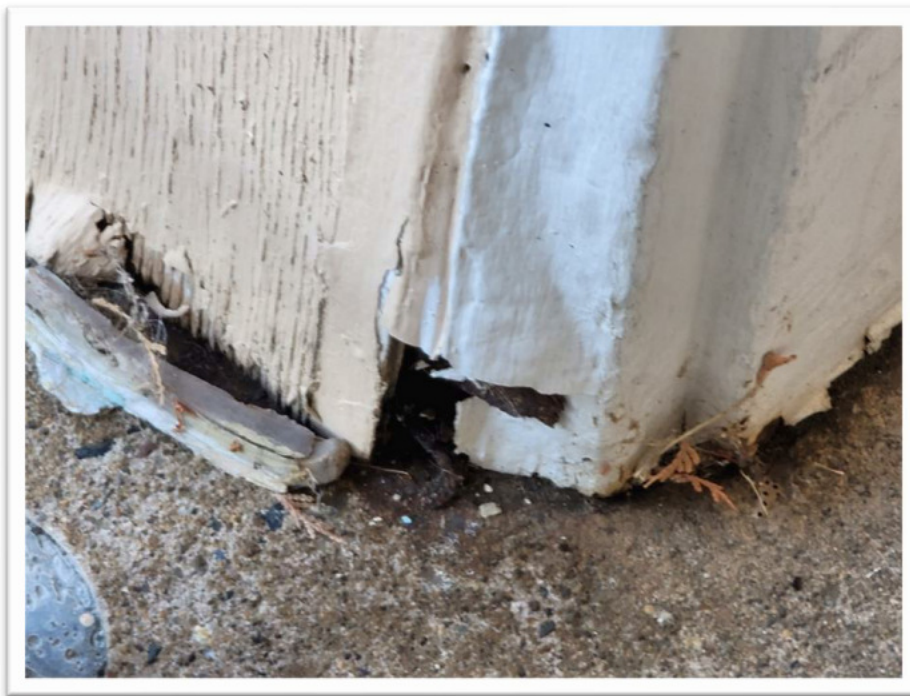
- h. The moisture and leakage caused moderate to severe wood decay and rot to the interior and exterior wooden members, including partitions and structural posts.

Figure 3.43 - Rot damage.
